VOLKSWAGEN Polo: 1FPQ746

Limited Technical Inspection

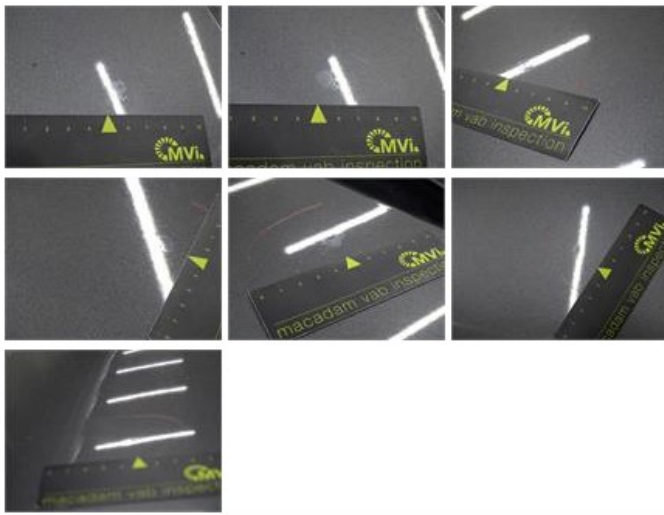
Bonnet, Chemical polution, LI - Repair and paint (complete) 256,06

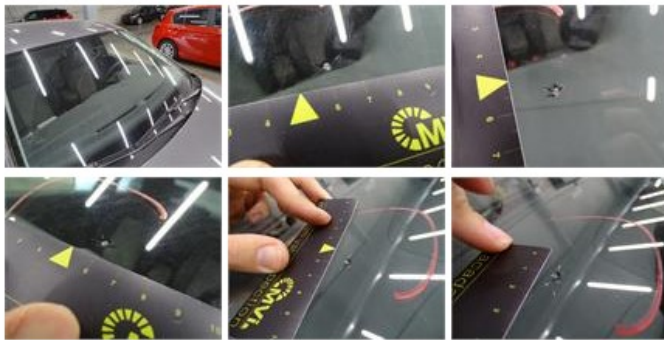
Windscreen, Stone chip(s), E - Replace

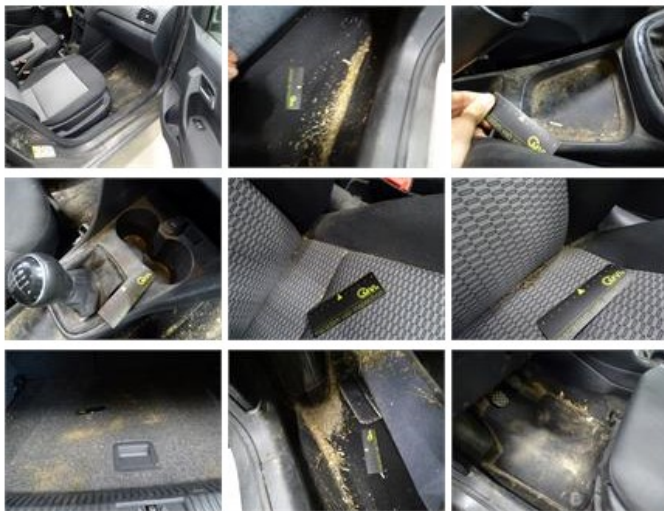
Interior, Dirty, Cleaning

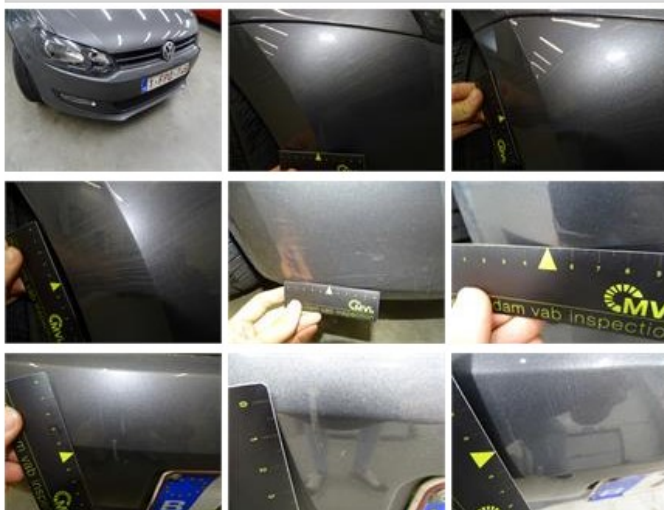
Bumper F, Scratch(es), LI - Repair and paint (complete)

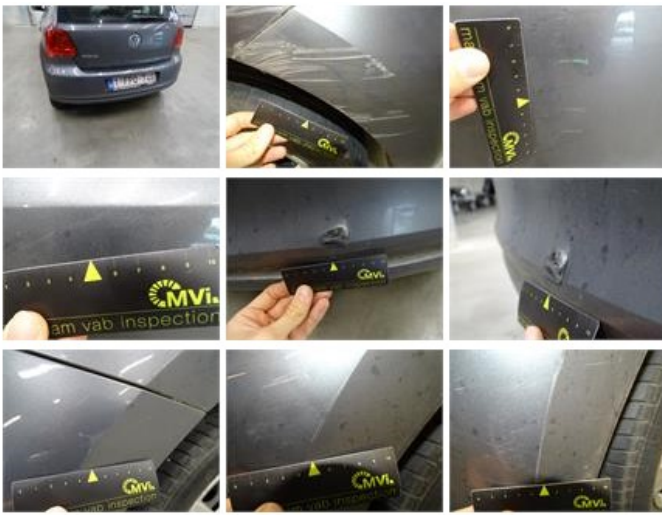
Bumper R, Dent(s) and scratch(es), LI - Repair and paint (complete)

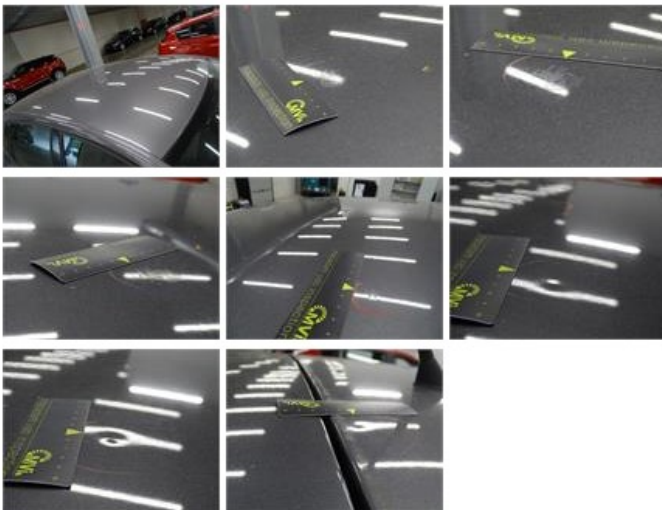
Roof, Chemical polition, LI - Repair and paint (complete)

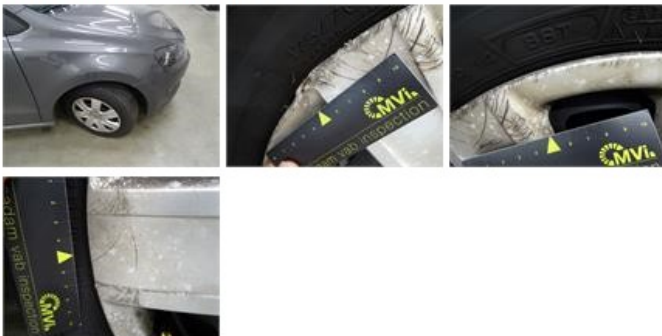
Wheel cover F R, Scratch(es), E - Replace

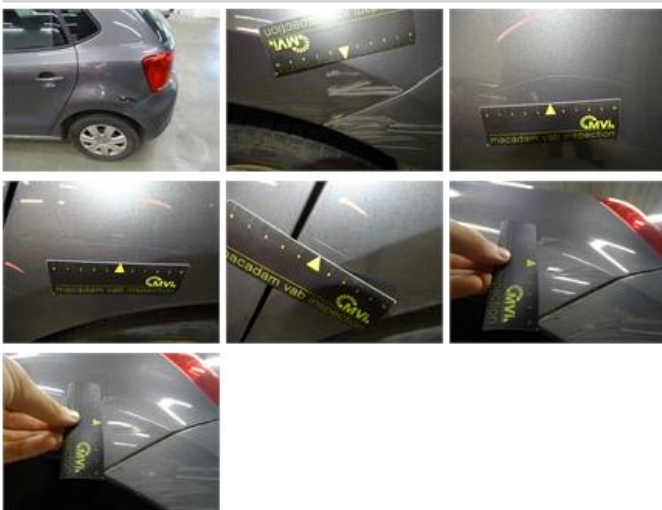
Wing R L, Dent(s) and scratch(es), LI - Repair and paint (complete)

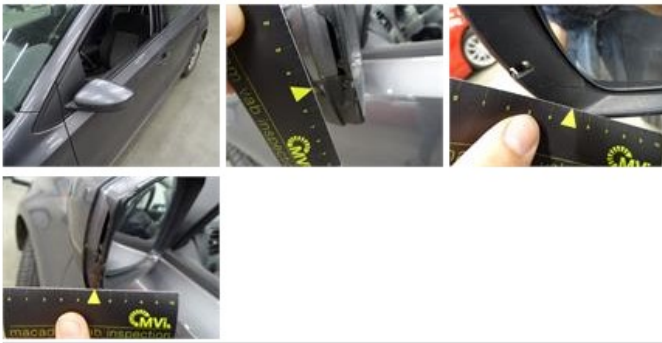
Rearview mirror basis L, Broken, E - Replace

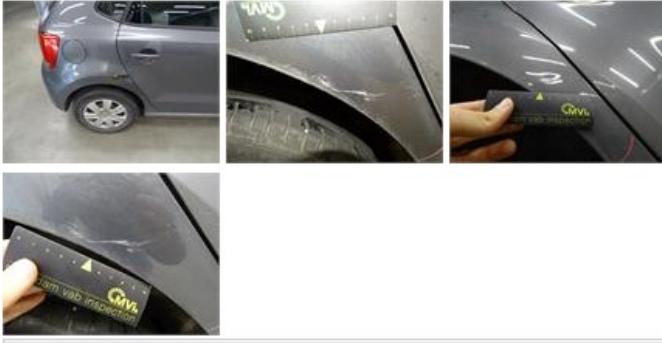
Wing R R, Dent(s) and scratch(es), LI - Repair and paint (complete) 246,56
