AUDI A5 SPORTBACK: 1KNY593

Limited Technical Inspection

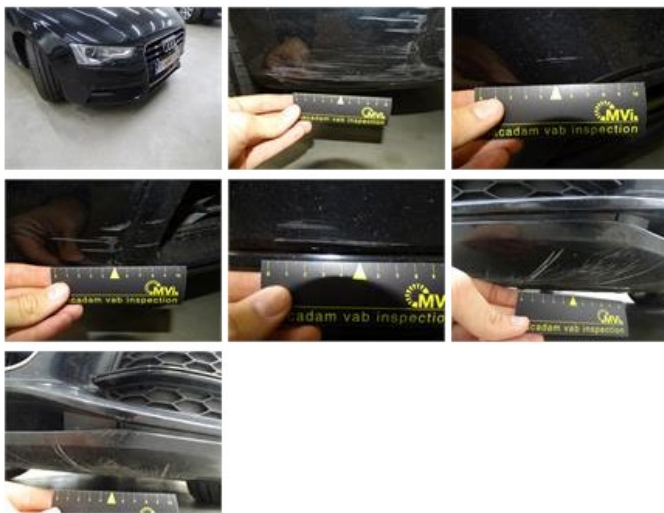
Total cost ex VAT	2894,79
Bumper F, Scratch(es), LI - Repair and paint (complete)	254,16

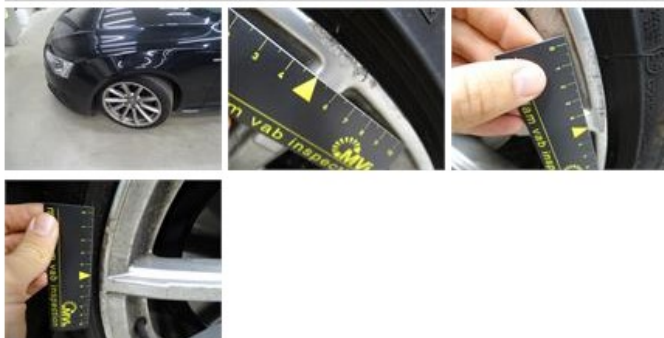
Alloy rim F L, Scratch(es), LI - Repair and paint (complete) 95,00

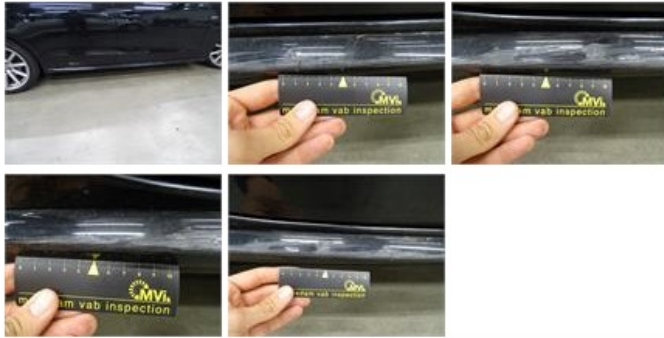
Sill outer R, Scratch(es), LI - Repair and paint (complete) 372,60

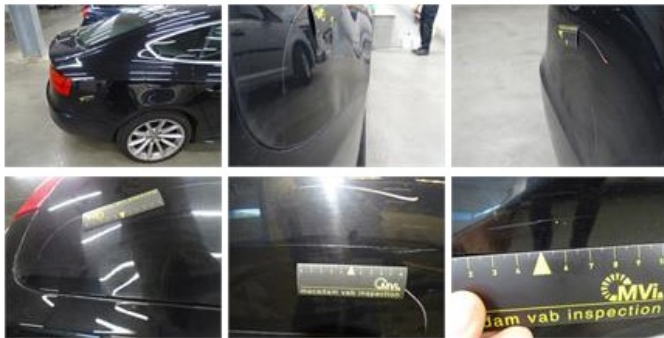
Wing R R, Dent(s) and scratch(es), LI - Repair and paint (complete) 369,84

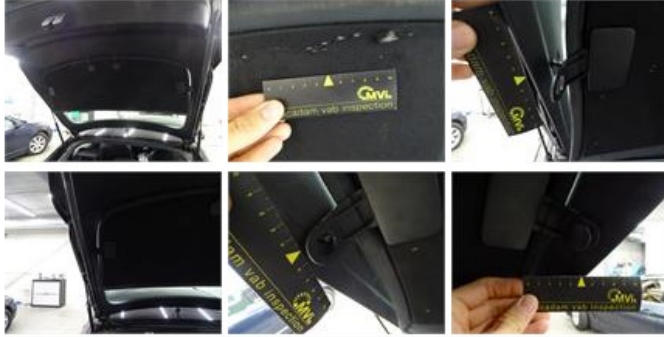
Boot cover, Broken, E - Replace 60,00

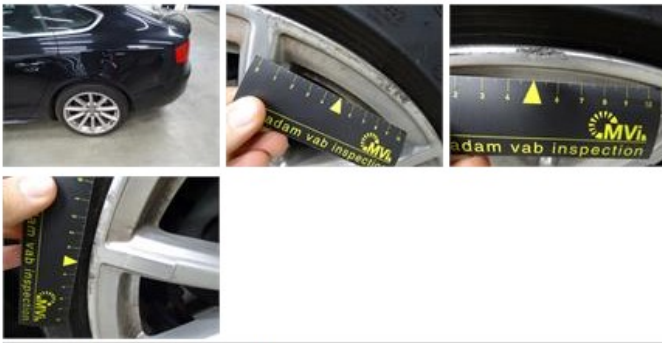
Alloy rim R L, Scratch(es), LI - Repair and paint (complete) 95,00

Alloy rim R L, Scratch(es), LI - Repair and paint (complete)

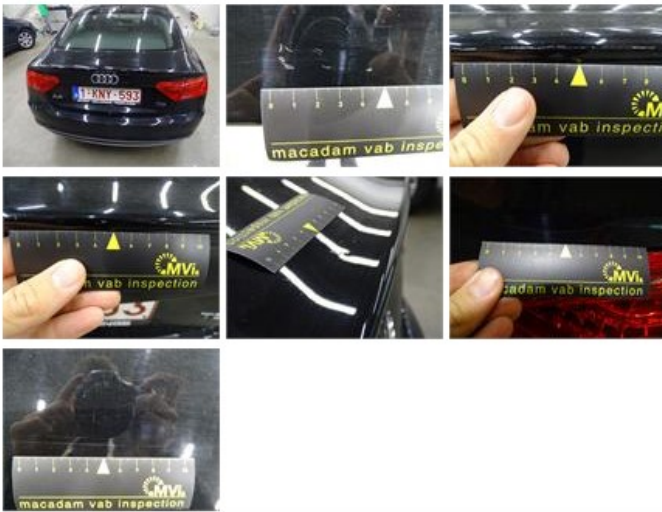
Tailgate, Dent(s) and scratch(es), LI - Repair and paint (complete) 362,02

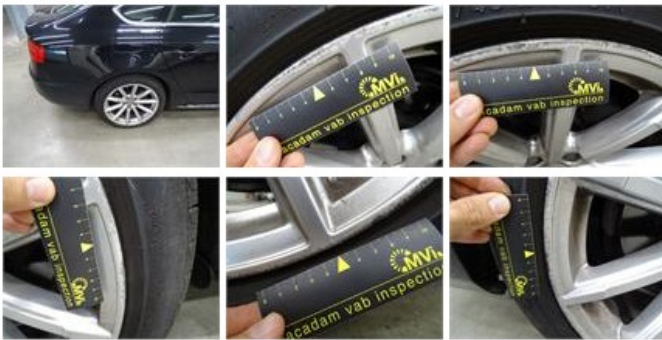
Alloy rim R R, Scratch(es), LI - Repair and paint (complete) 95,00

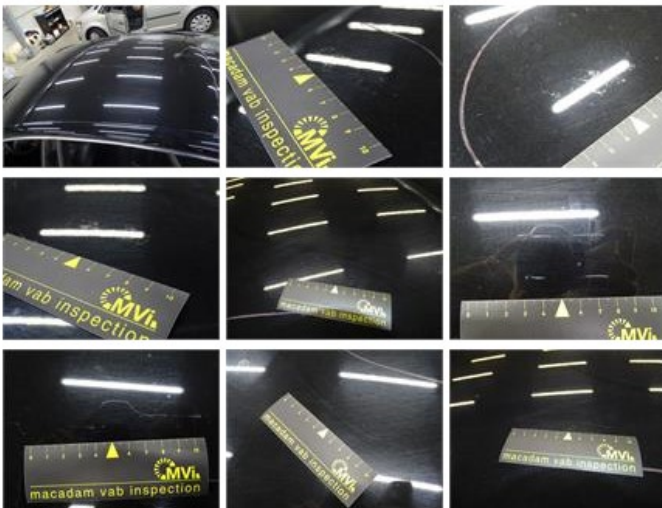
Roof, Chemical polution, LI - Repair and paint (complete) 577,80

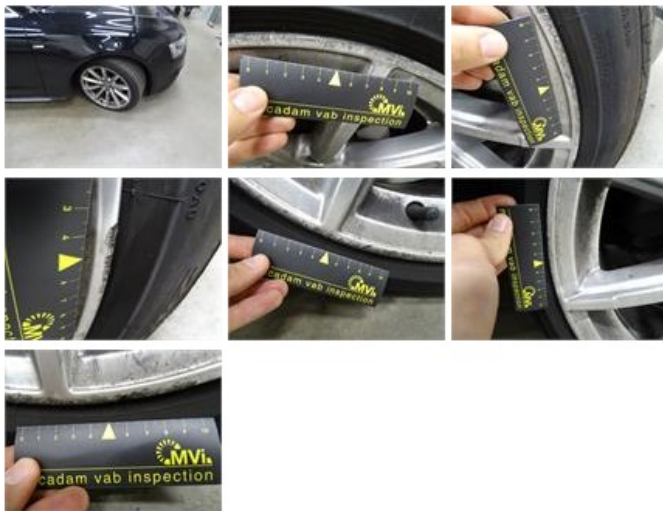
Alloy rim F R, Scratch(es), LI - Repair and paint (complete)

95,00

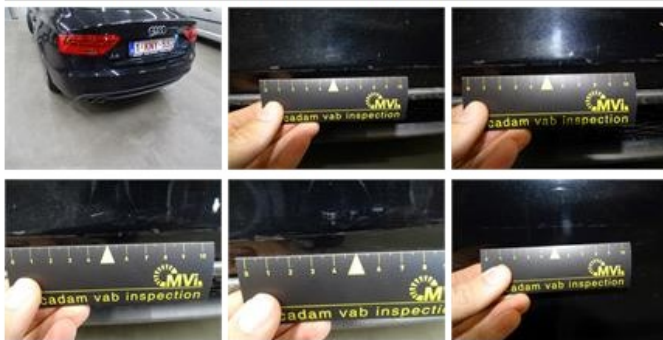
Bumper R, Scratch(es), LI - Repair and paint (complete)

254,16

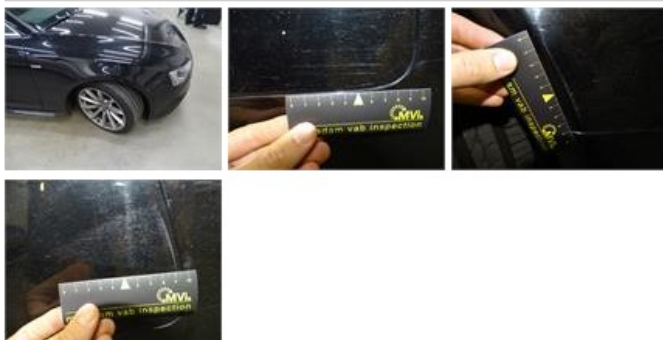
Wing F R, Scratch(es), LI - Repair and paint (complete)

264,21
