BMW 1 HATCH: 1NDK800

Limited Technical Inspection

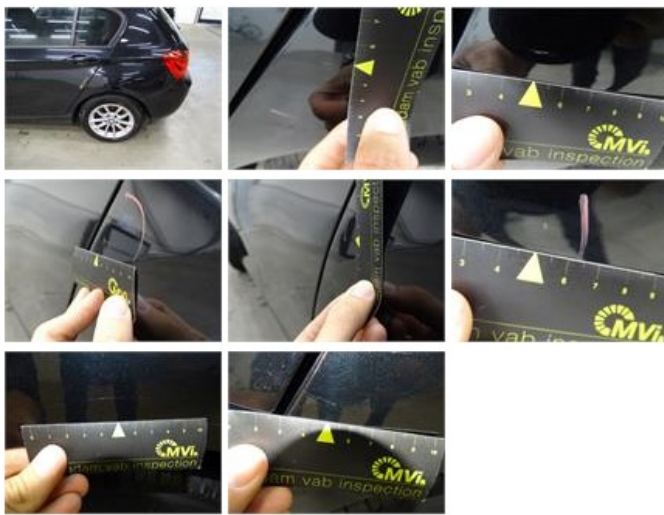
Total cost ex VAT	2593,59
Wing R L, Dent(s) and scratch(es), LI - Repair and paint (complete)	308,20

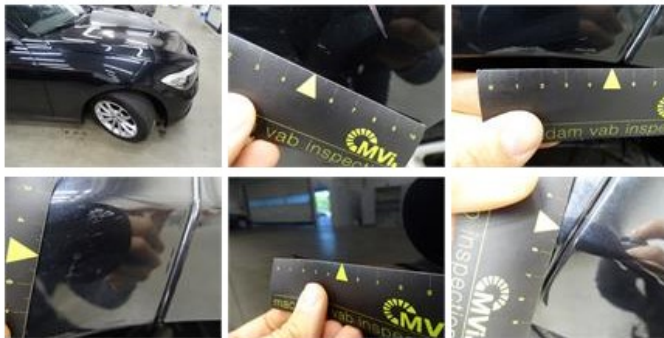
Wing F R, Scratch(es), LI - Repair and paint (complete)

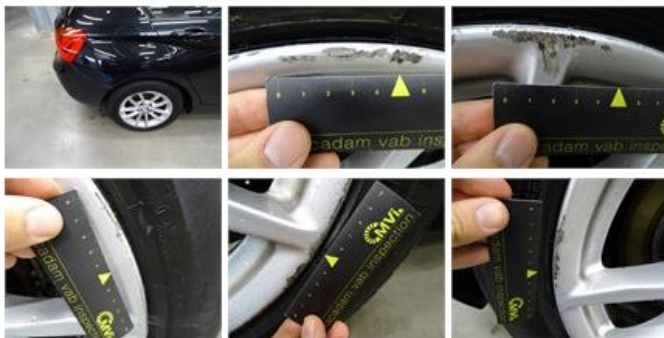
Alloy rim R R, Scratch(es), LI - Repair and paint (complete)

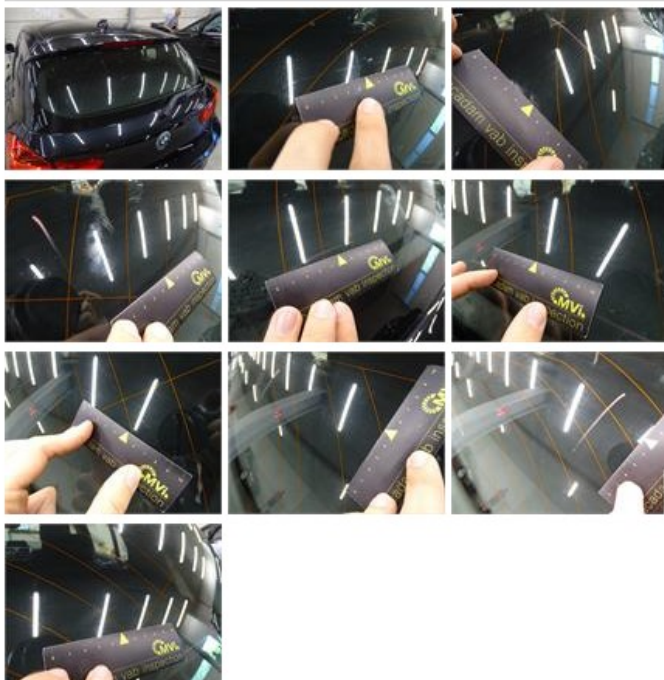
Rear window, Scratch(es), E - Replace

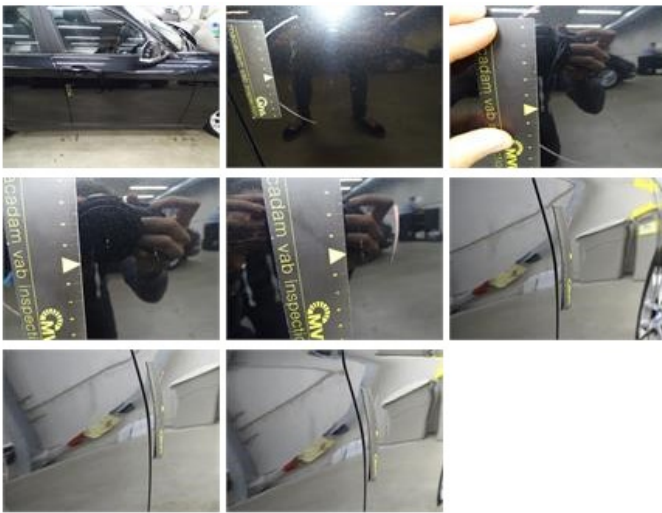
Door F R, Dent(s) and scratch(es), LI - Repair and paint (complete)

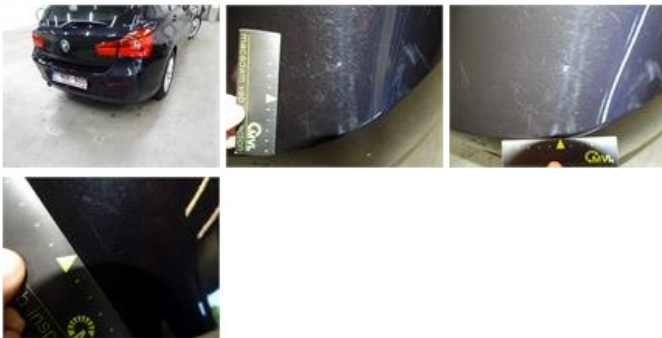
Bumper R, Scratch(es), LI - Repair and paint (complete) 211,80

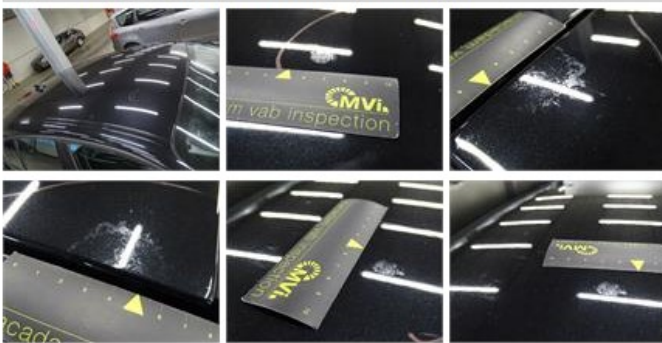
Roof, Chemical polution, LI - Repair and paint (complete) 481,50

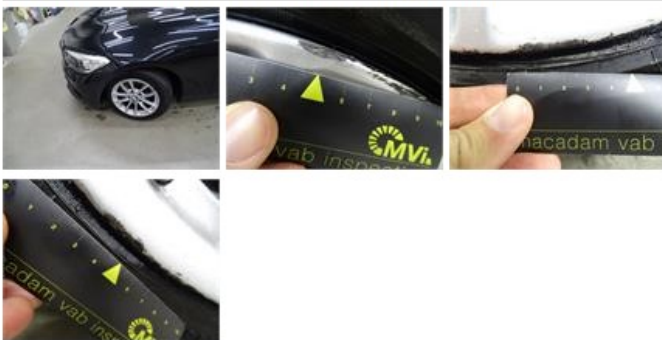
Alloy rim F L, Scratch(es), LI - Repair and paint (complete) 95,00
