AUDI A6: 1JAL818

Limited Technical Inspection

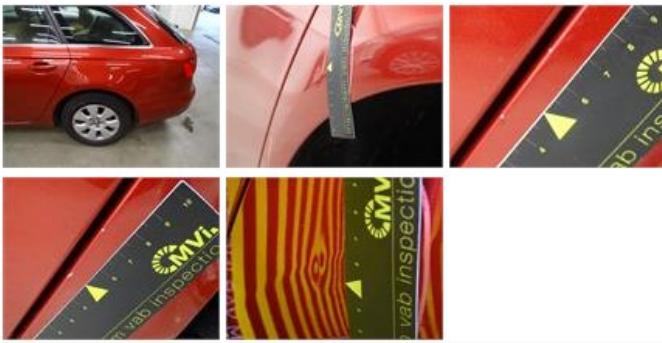
Wing R L, Dent(s) and scratch(es), LI - Repair and paint (complete) 369,84

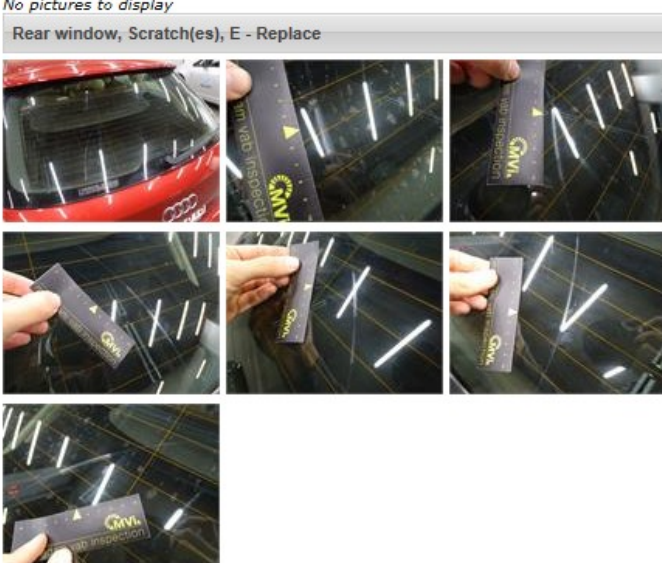
No pictures to display
Rear window, Scratch(es), E - Replace 420,00

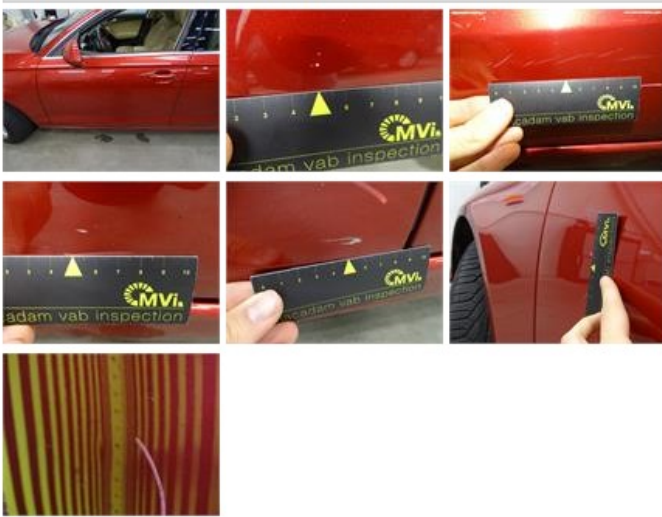
Door F L, Dent(s) and scratch(es), LI - Repair and paint (complete) 382,02

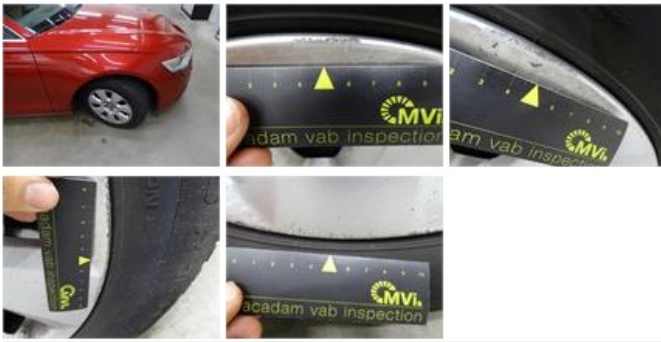
Alloy rim F R, Scratch(es), LI - Repair and paint (complete)

95,00

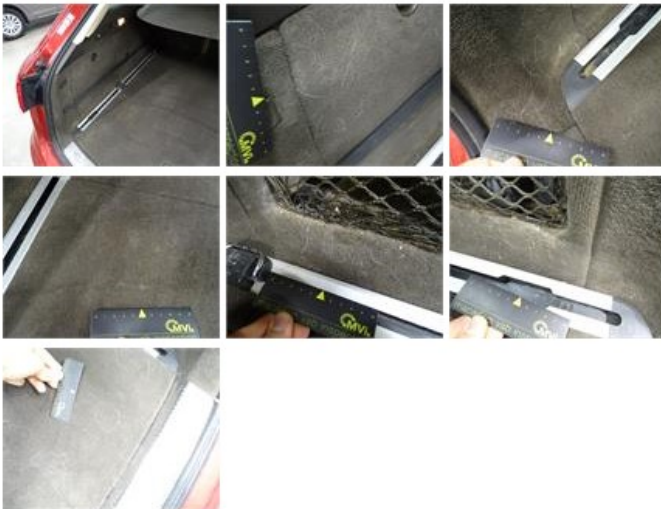
Interior, Dirty, Chemical cleaning

25,00

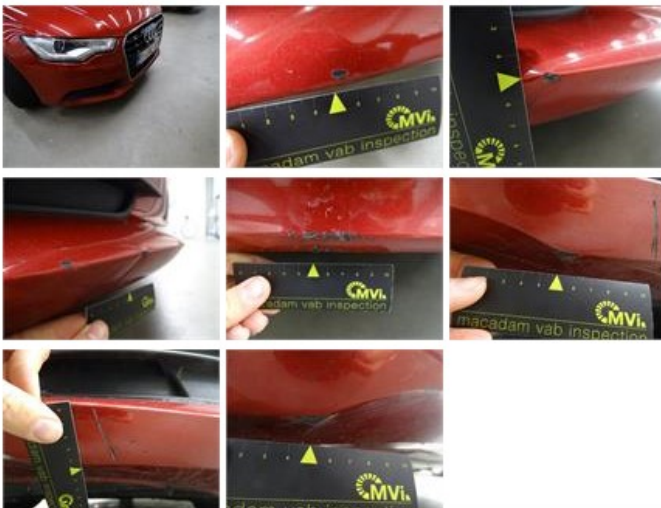
Bumper F, Dent(s) and scratch(es), LI - Repair and paint (complete)

254,16

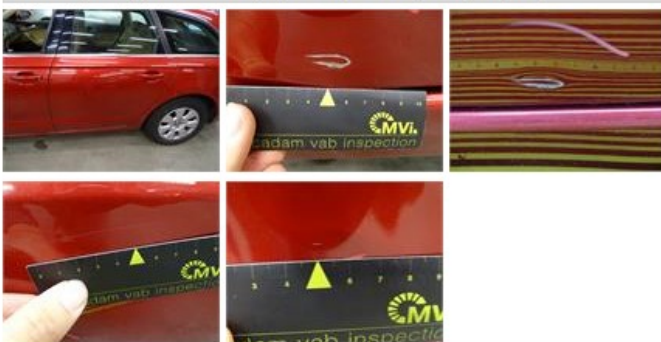
Door R L, Dent(s) and scratch(es), LI - Repair and paint (complete)

382,02

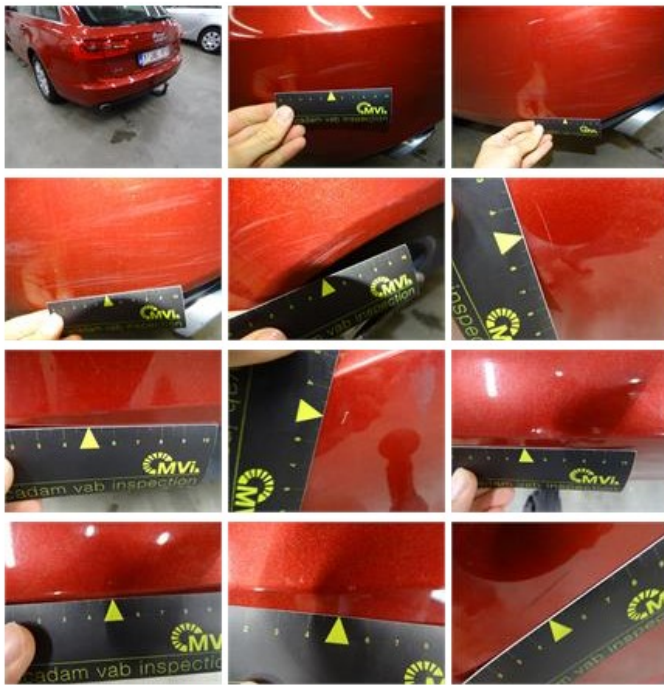
Bumper R, Scratch(es), LI - Repair and paint (complete)

254,16

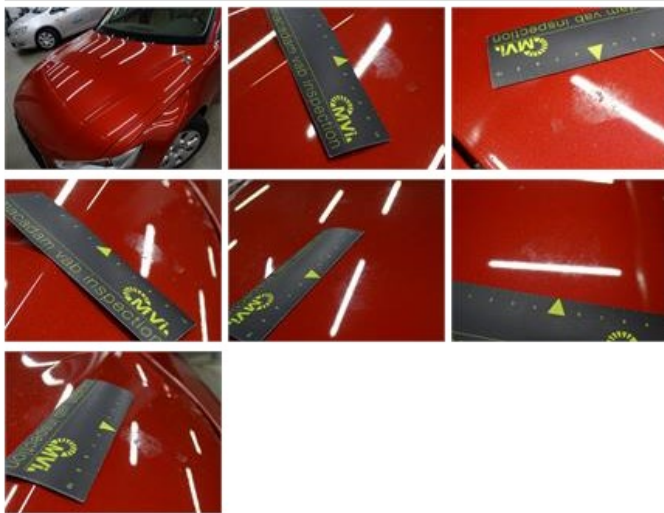
Bonnet, Chemical polution, LI - Repair and paint (complete)	348,09
---	--------
