BMW 2 ACTIVE TOURER: 1KNF905

Limited Technical Inspection

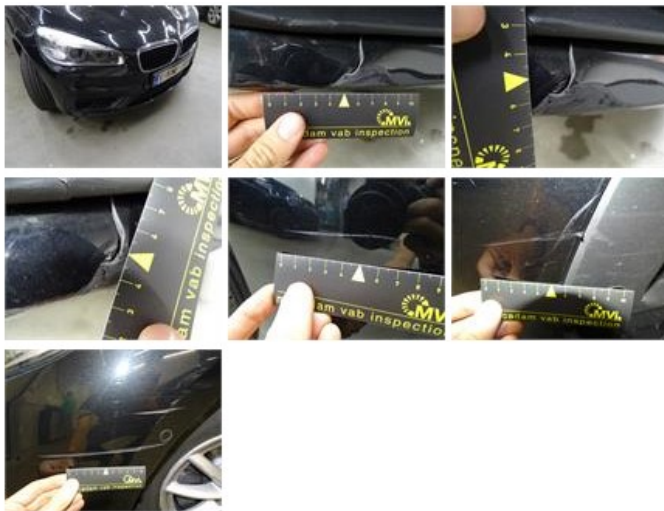
Total cost ex VAT	2796,53
Bumper F, Crack, Le - Replace and paint	735,00

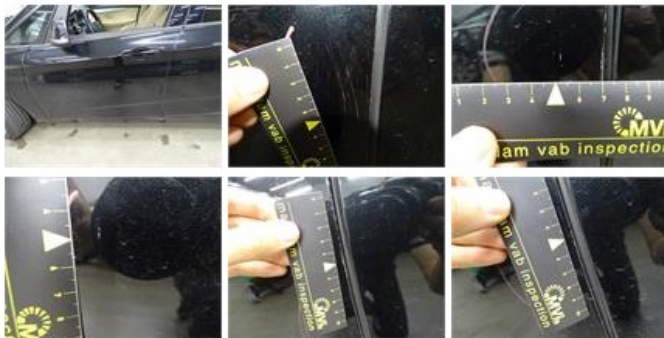
Door F L, Scratch(es), LI - Repair and paint (complete)

318,35

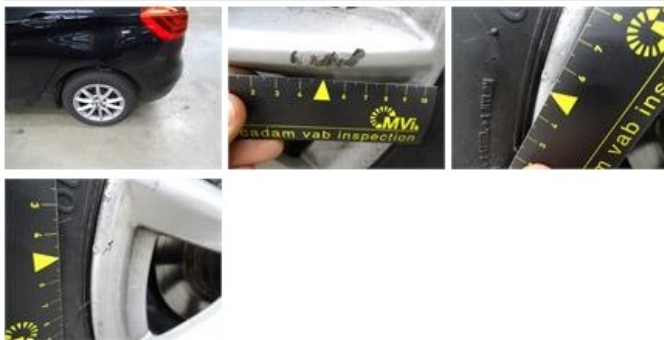
Alloy rim R L, Scratch(es), LI - Repair and paint (complete)

95,00

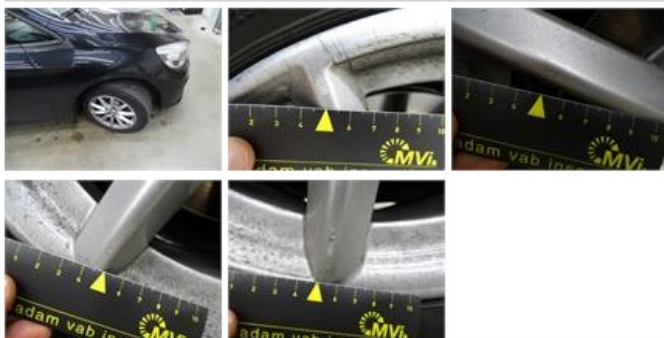
Alloy rim F R, Scratch(es), LI - Repair and paint (complete)

95,00

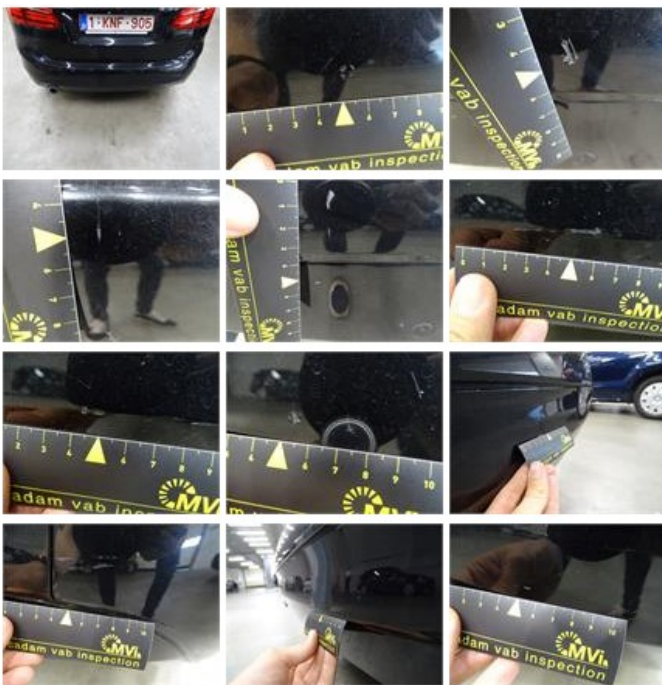
Bumper R, Dent(s) and scratch(es), LI - Repair and paint (complete)

211,80

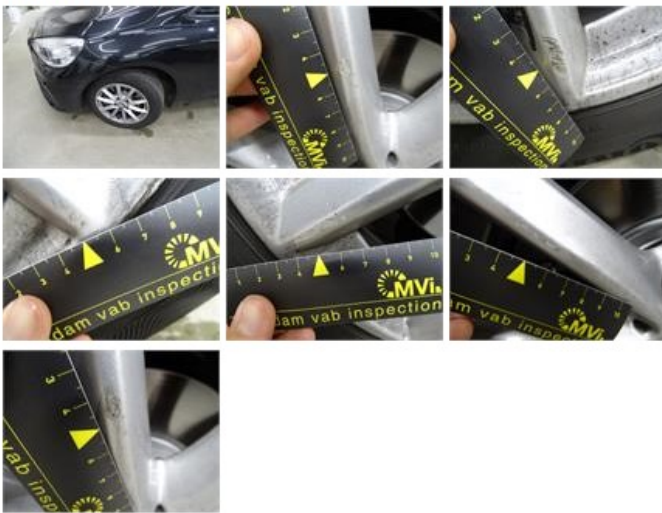
Alloy rim F L, Scratch(es), LI - Repair and paint (complete) 95,00

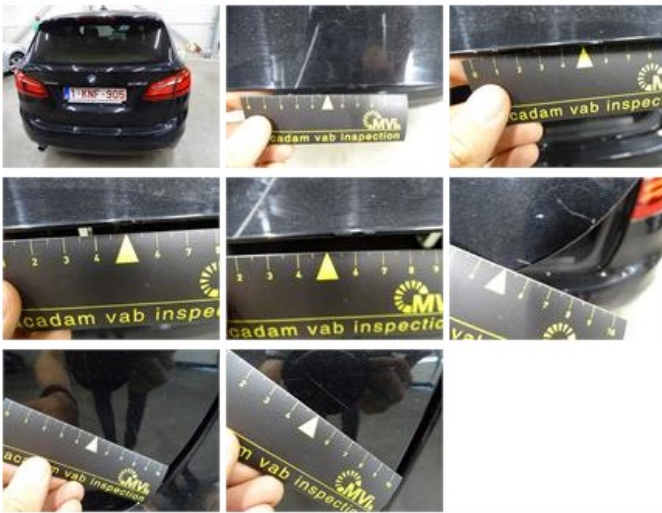
Tailgate, Scratch(es), LI - Repair and paint (complete) 301,68

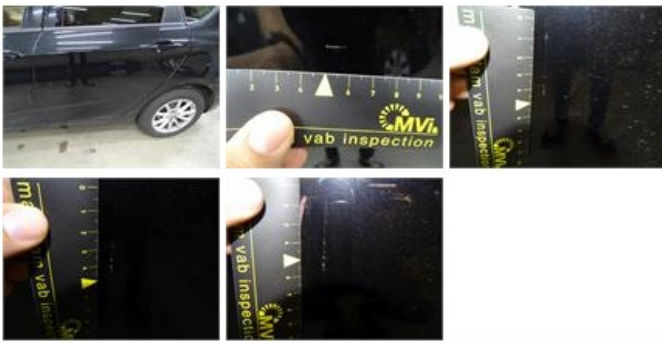
Door R L, Scratch(es), LI - Repair and paint (complete) 318,35

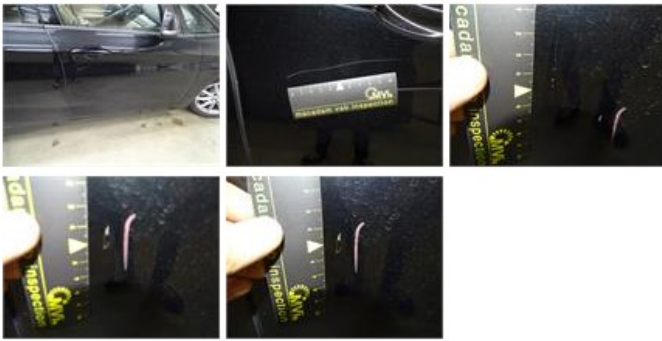
Door F R, Scratch(es), LI - Repair and paint (complete)

318,35
