**BMW 2 ACTIVE TOURER: 1KBD934**

**Limited Technical Inspection**

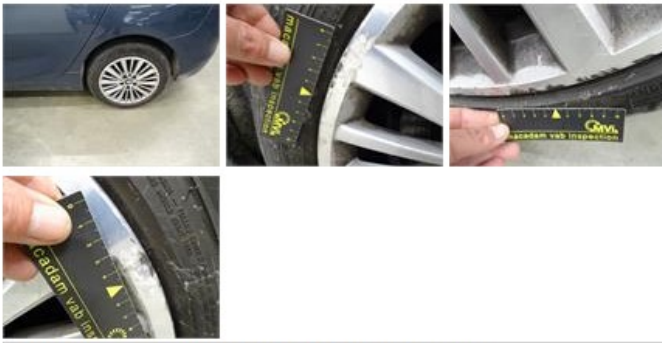
<b>Total cost ex VAT</b>	<b>480,08</b>
<b>Alloy rim R L, Scratch(es), LI - Repair and paint (complete)</b>	<b>95,00</b>
