PEUGEOT 308: 1GUH311

Limited Technical Inspection

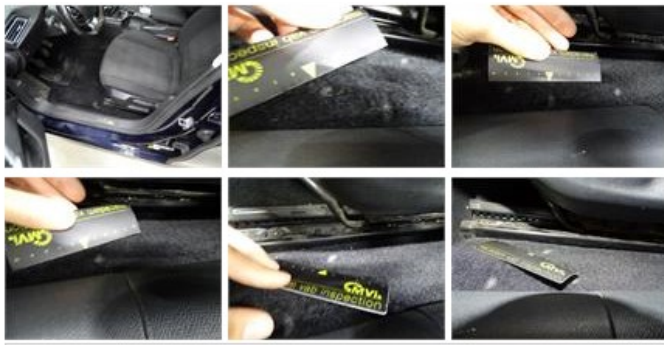
Total cost ex VAT	4059,93
Windscreen, Stone chip(s), Acceptable	0,00
<i>No pictures to display</i>	
Floor covering F L, Burned, E - Replace	252,00

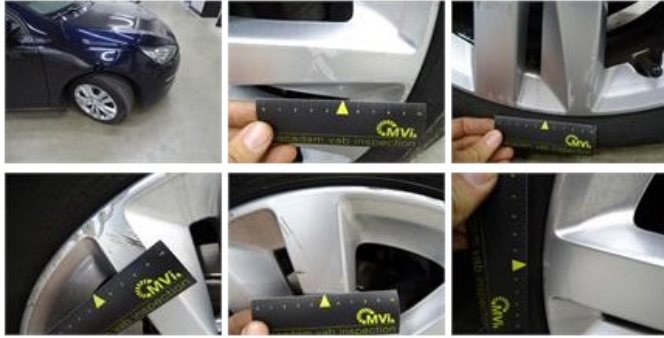
Alloy rim F R, Scratch(es), LI - Repair and paint (complete)

95,00

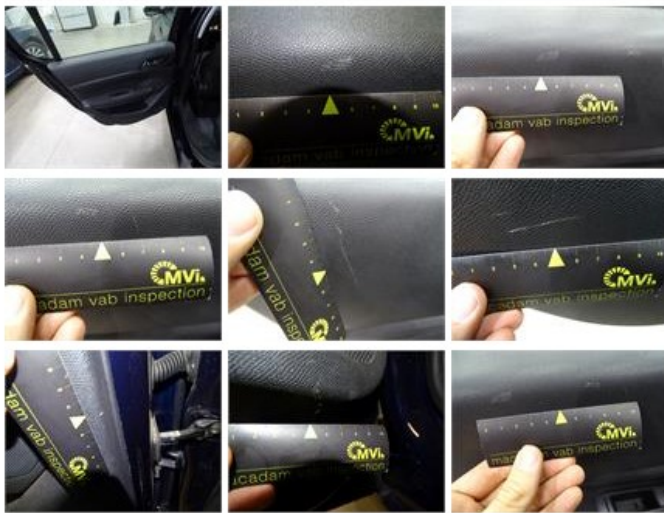
Door panel R L, Scratch(es), Smart repair

110,64

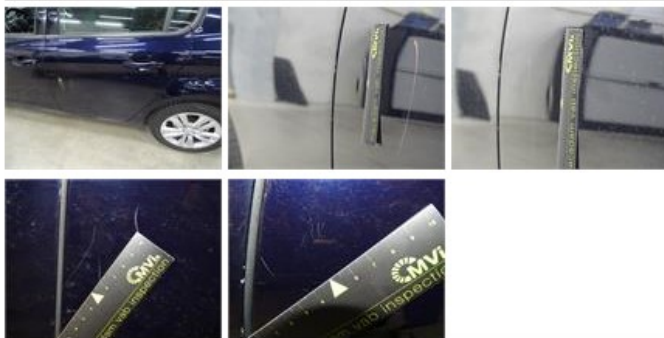
Door R L, Dent(s) and scratch(es), LI - Repair and paint (complete)

318,35

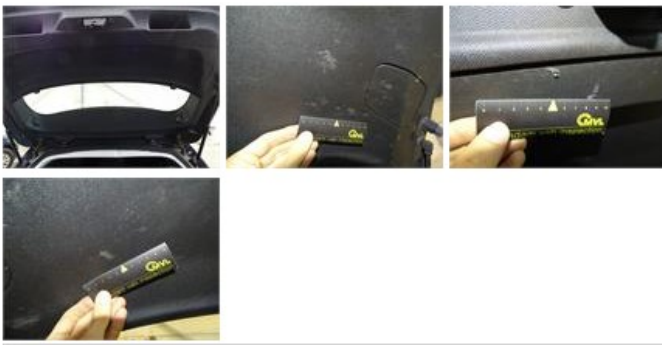
Trunk lid covering R, Scratch(es), Smart repair

110,64

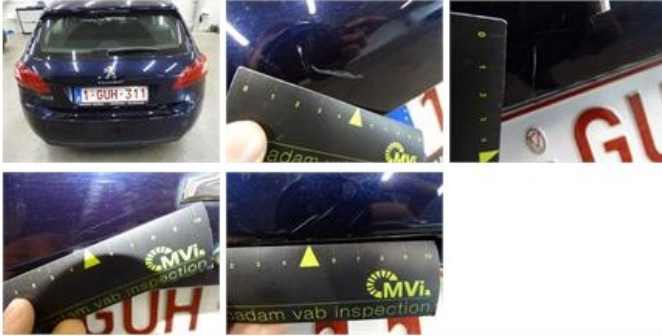
Tailgate, Scratch(es), LI - Repair and paint (complete) 301,68

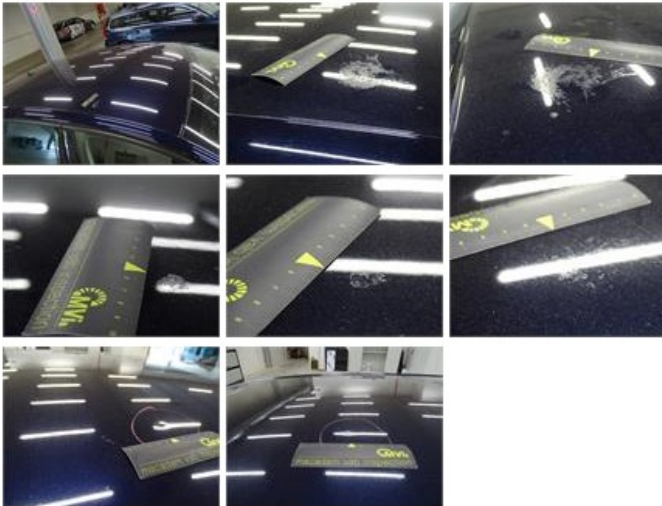
Roof, Chemical pollution, LI - Repair and paint (complete) 529,50

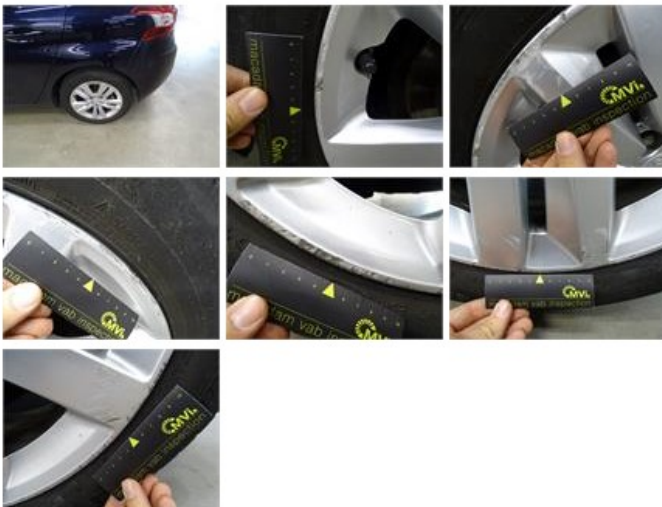
Alloy rim R L, Scratch(es), LI - Repair and paint (complete) 95,00

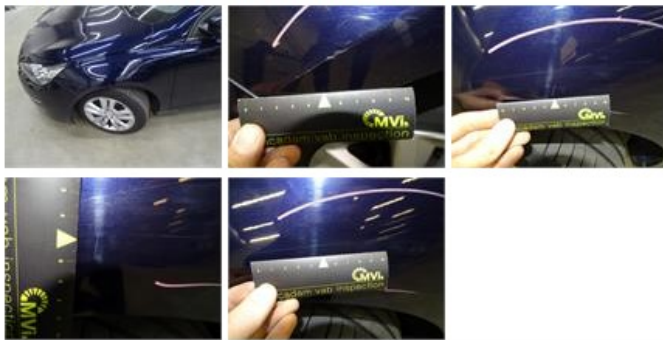
Wing F L, Scratch(es), LI - Repair and paint (complete)

220,18

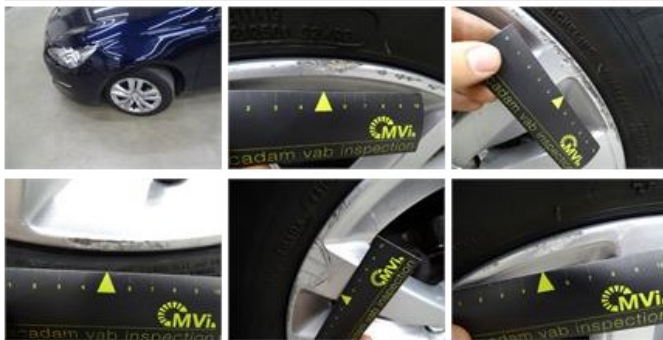
Alloy rim F L, Scratch(es), LI - Repair and paint (complete)

95,00

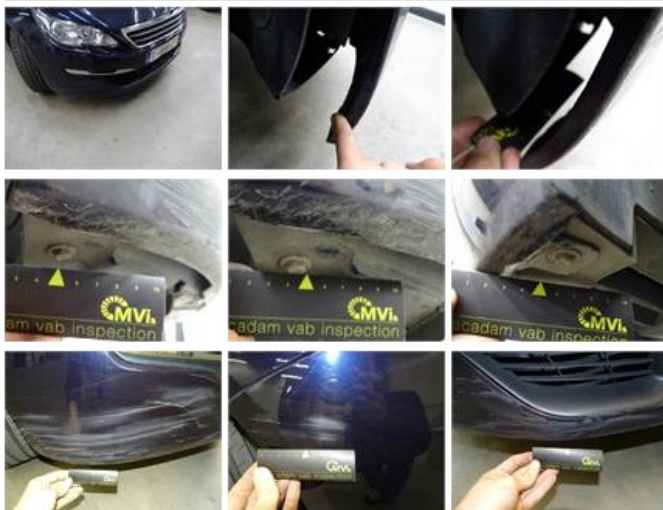
Bumper F, Broken, Le - Replace and paint

735,00

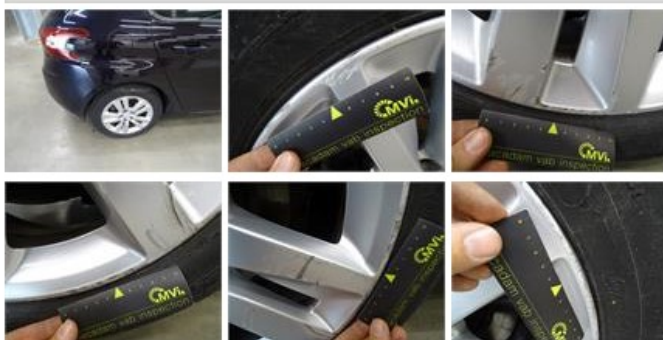
Alloy rim R R, Scratch(es), LI - Repair and paint (complete)

95,00

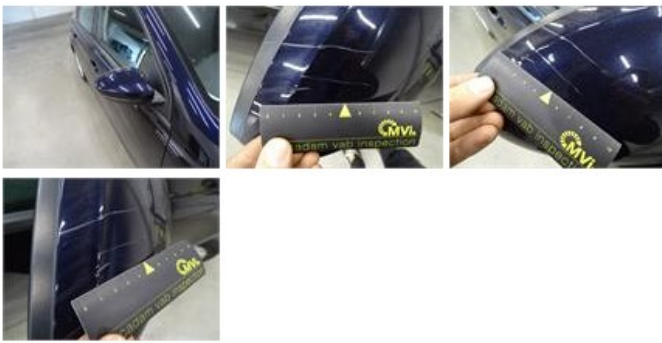
Rearview mirror housing R, Scratch(es), LI - Repair and paint (complete)

115,56

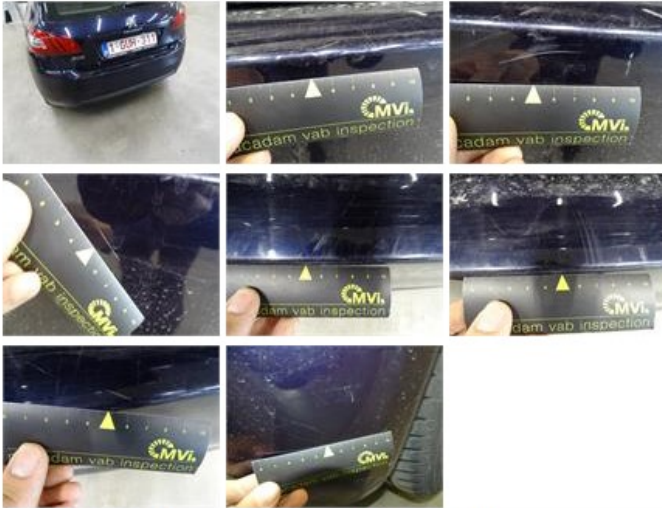
Bumper R, Scratch(es), LI - Repair and paint (complete) 211,80

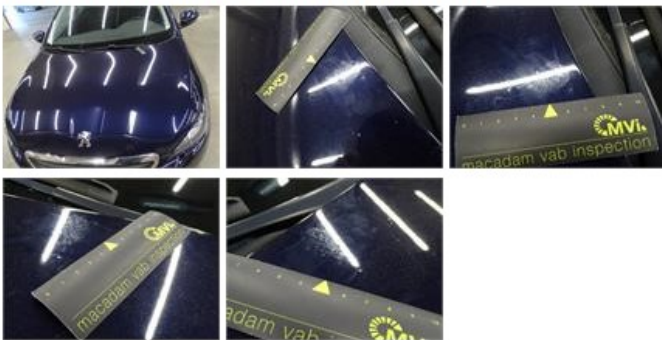
Bonnet, Chemical polution, LI - Repair and paint (complete) 290,08
