**Ford focus: 1UBG426**

**Limited Technical Inspection**

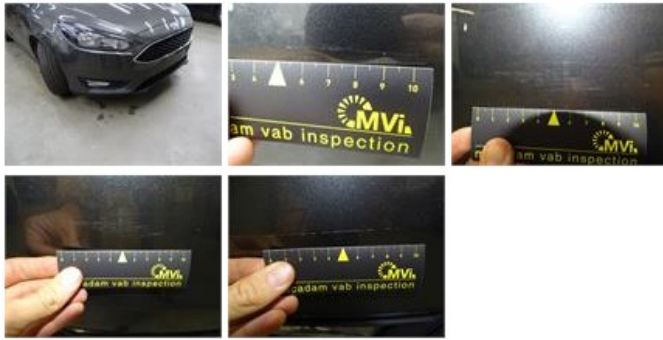
Bumper F, Scratch(es), LI - Repair and paint (complete)

211,80

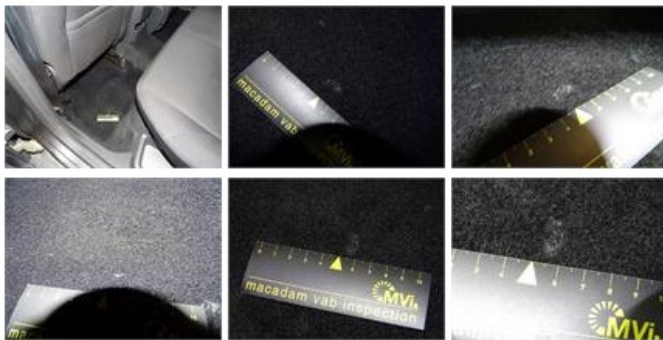
Floor covering R, Burned, Smart repair

64,32

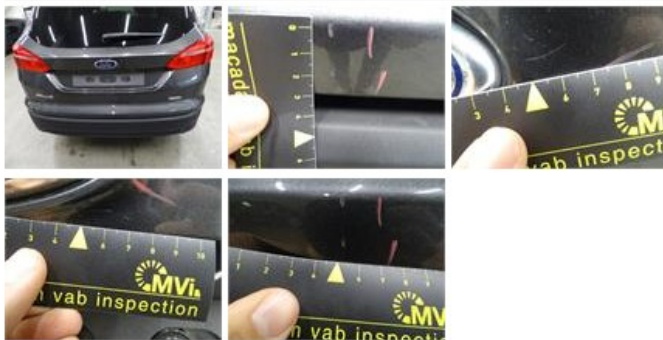
Tailgate, Scratch(es), LI - Repair and paint (complete)

301,68

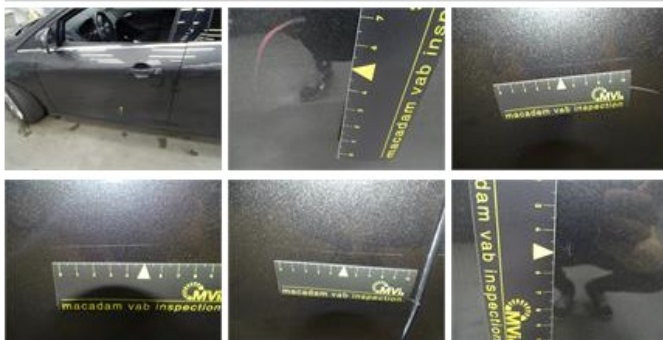
Door F L, Scratch(es), LI - Repair and paint (complete)

318,35
