PEUGEOT 308 SW: 1KDZ038

Limited Technical Inspection

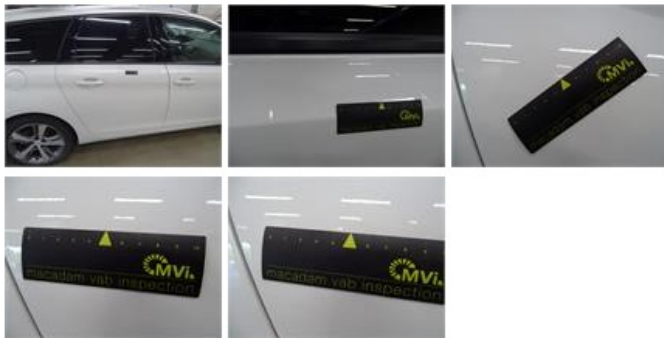
Door R R, Bad repair, Acceptable 0,00

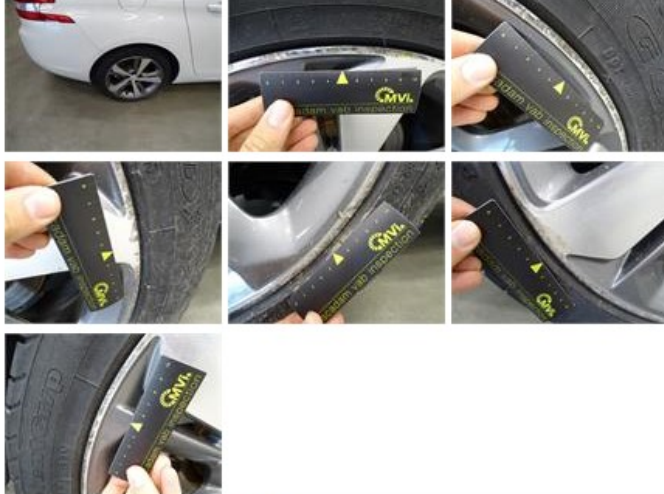
Alloy rim R R polished, Scratch(es), LI - Repair and paint (complete) 95,00

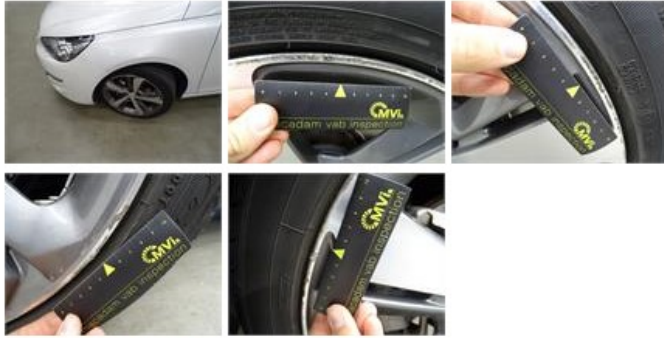
Alloy rim F L polished, Scratch(es), LI - Repair and paint (complete) 95,00

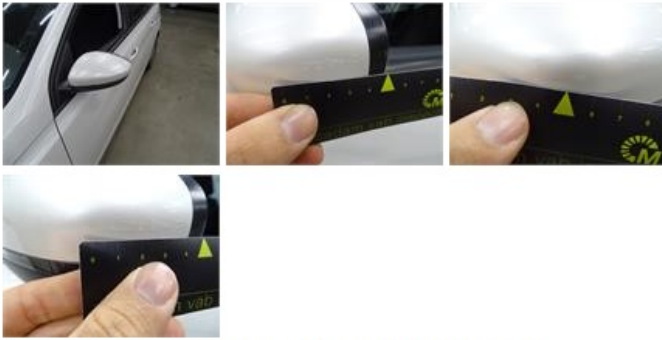
Rearview mirror housing L, Scratch(es), LI - Repair and paint (complete)

115,56

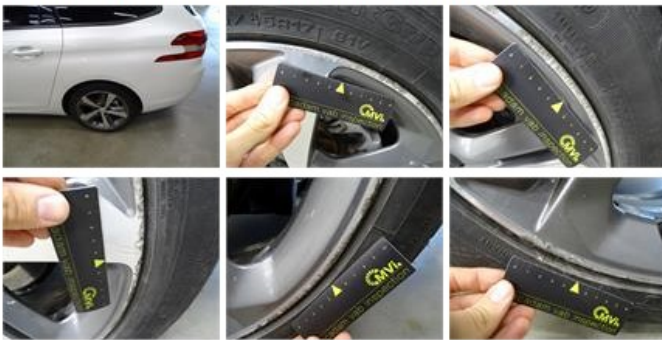
Alloy rim R L polished, Scratch(es), LI - Repair and paint (complete)

95,00

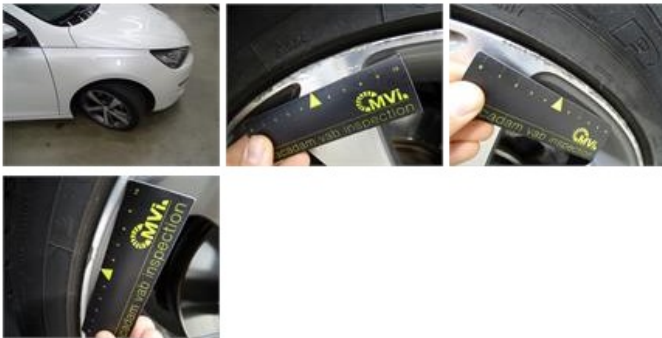
Alloy rim F R polished, Scratch(es), LI - Repair and paint (complete)

95,00
