BMW 4 Gran Coupe: 1JGP507

| Vinnumber: | WBA4D51040D424496 | Versionname: | 4 GRAN COUPE 418d 136PK |

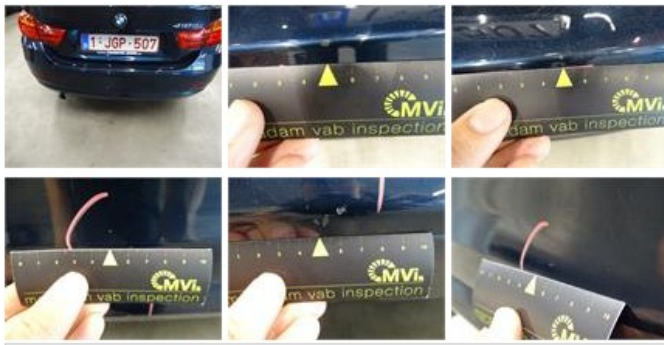
| Bumper R, Scratch(es), LI - Repair and paint (complete) | 254,16 |

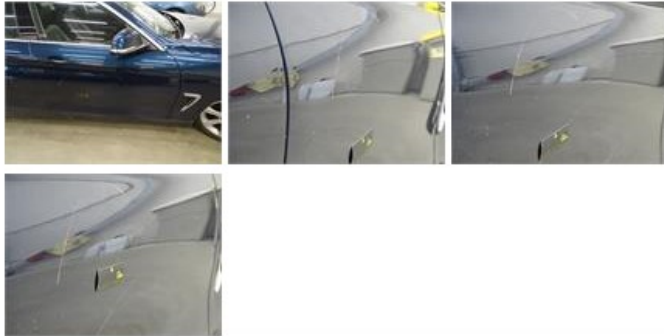
| Door F R, Bad repair, Acceptable | 0,00 |

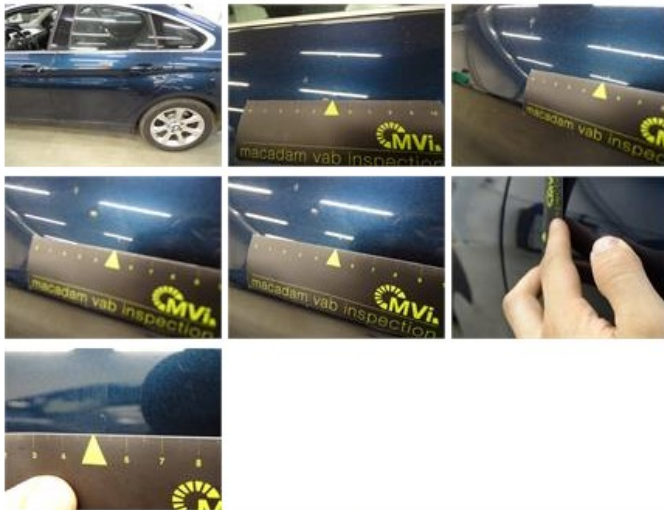
| Door R L, Bad repair, Acceptable | 0,00 |

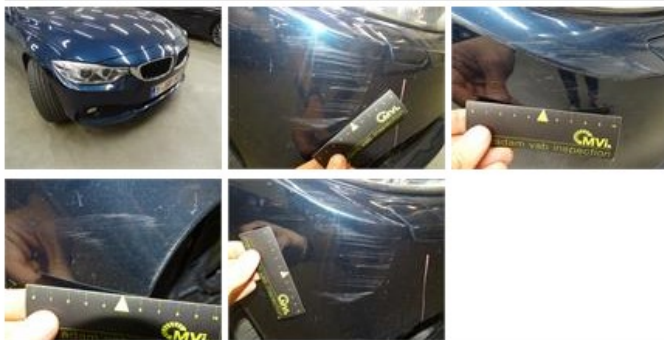
| Bumper F, Scratch(es), LI - Repair and paint (complete) | 254,16 |

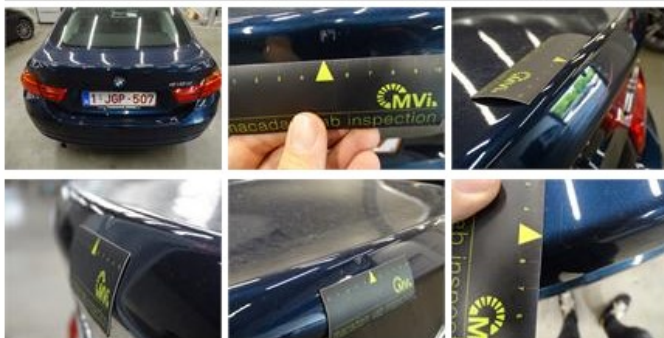
| Tailgate, Dent(s) and scratch(es), LI - Repair and paint (complete) | 362,02 |

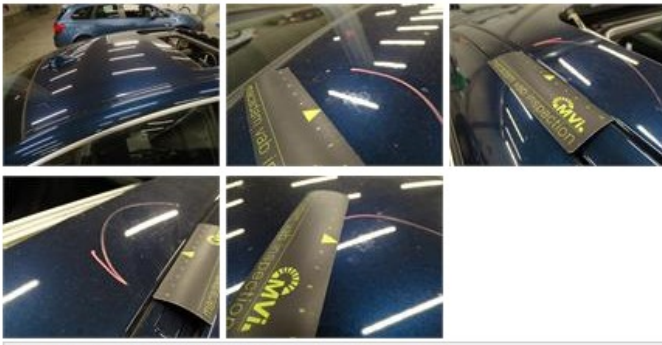
| Roof, Chemical polution, LI - Repair and paint (complete) | 577,80 |
