**OPEL Astra: 1HFS975**

**Limited Technical Inspection**

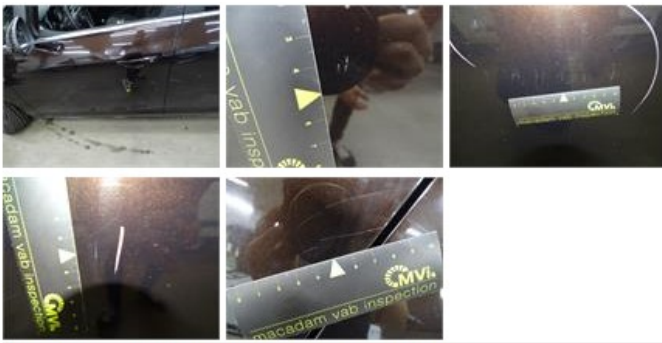
Door F L, Scratch(es), LI - Repair and paint (complete) 0,00

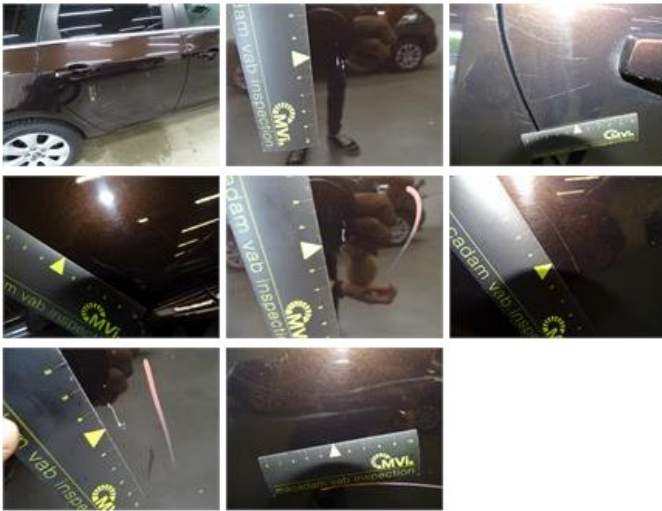
Door R R, Scratch(es), LI - Repair and paint (complete)

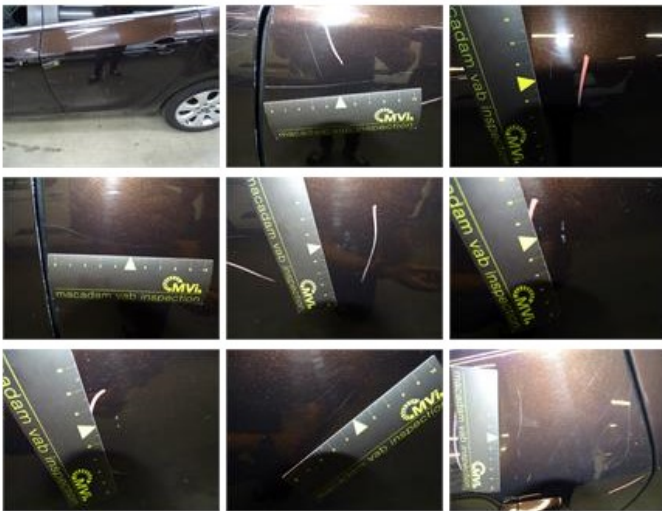
Door R L, Scratch(es), LI - Repair and paint (complete)

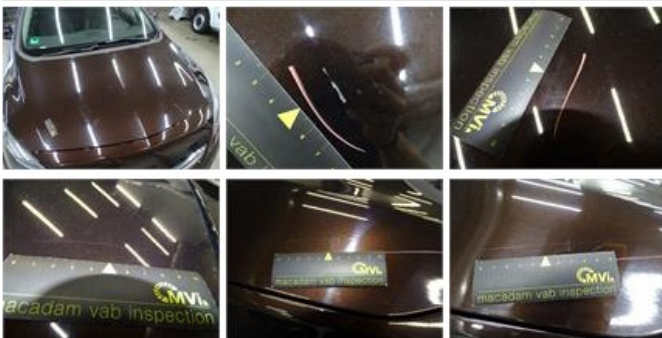
Bonnet, Scratch(es), LI - Repair and paint (complete)

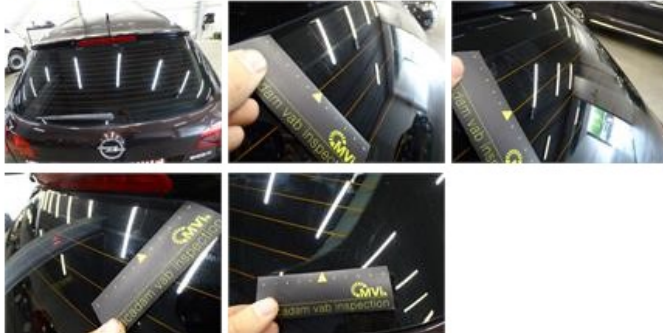
Rear window, Scratch(es), Acceptable 0,00

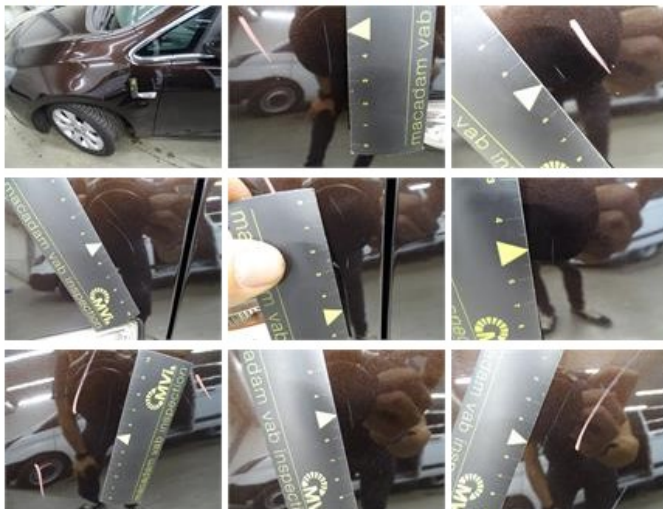
Wing F L, Scratch(es), LI - Repair and paint (complete) 0,00

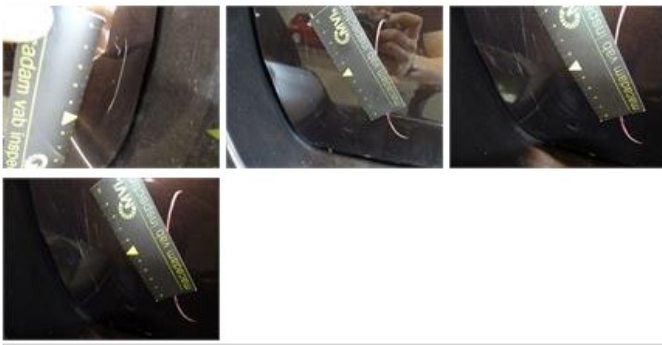
Tailgate, Scratch(es), LI - Repair and paint (complete) 301,68

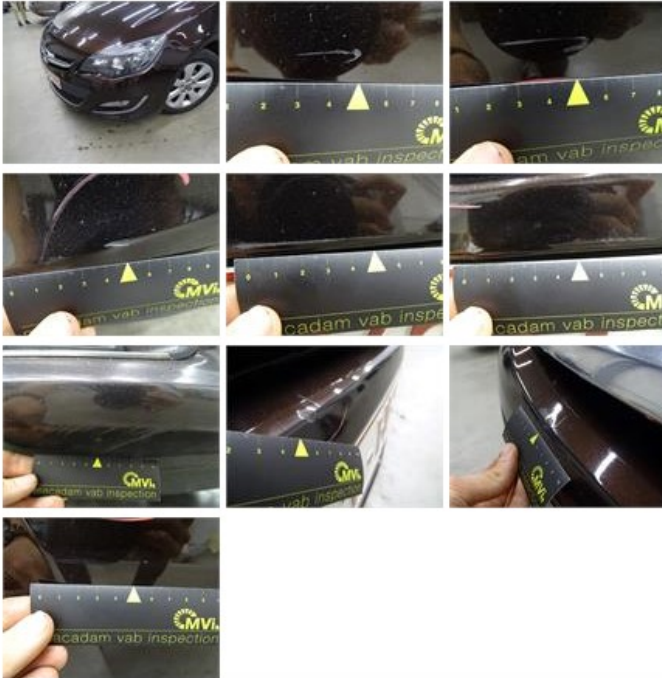
Bumper F, Dent(s) and scratch(es), LI - Repair and paint (complete) 211,80

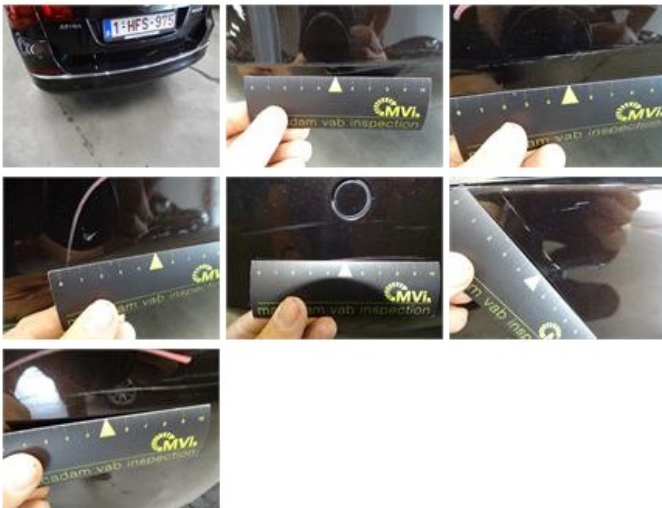
Bumper R, Scratch(es), LI - Repair and paint (complete) 211,80
