VOLKSWAGEN Golf: 1HNT250

Limited Technical Inspection

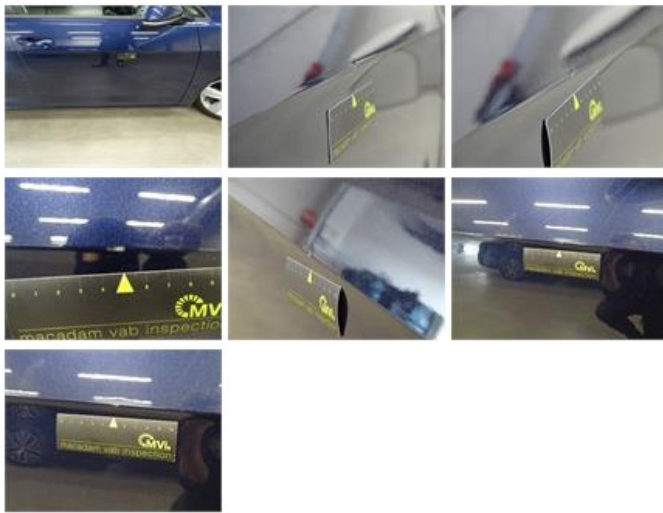
Total cost ex VAT	2431,62
Door F R, Dent(s) and scratch(es), LI - Repair and paint (complete)	318,35

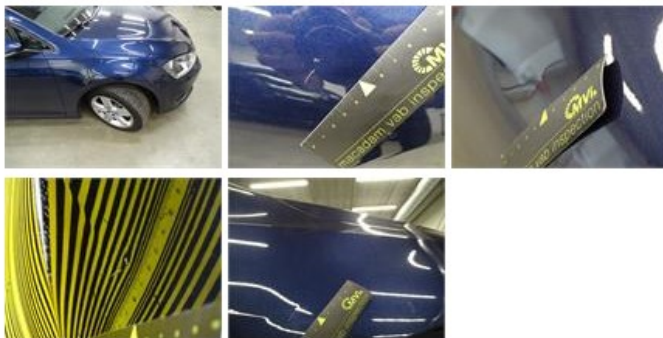
Wing F R, Dent(s) and scratch(es), LI - Repair and paint (complete) 220,18

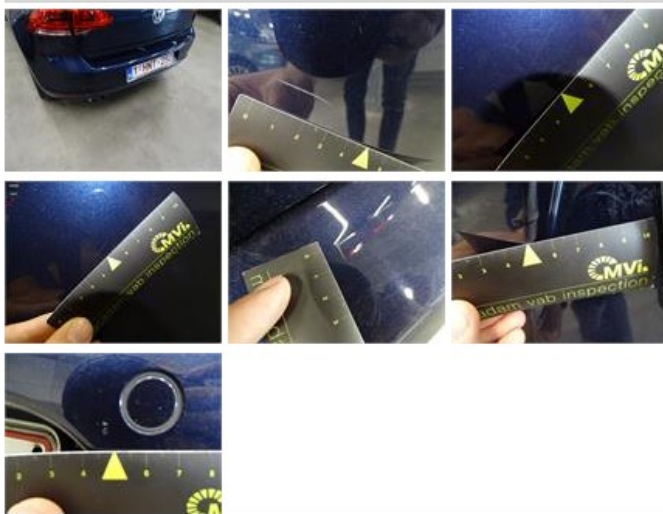
Bumper R, Scratch(es), LI - Repair and paint (complete) 211,80

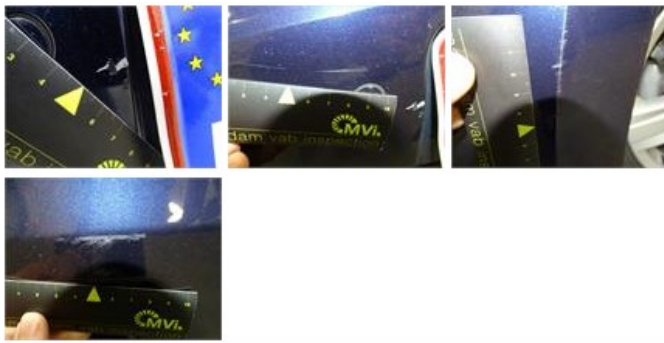
Bumper F, Scratch(es), LI - Repair and paint (complete) 211,80

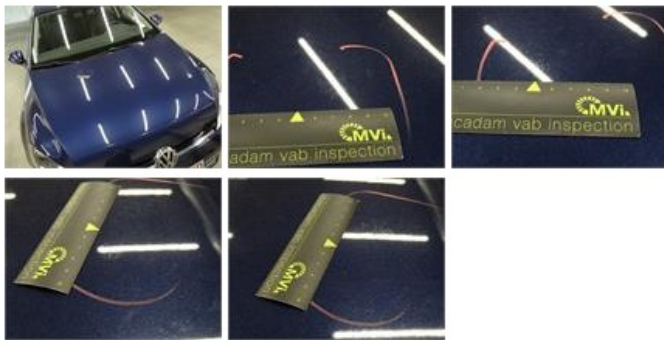
Bonnet, Chemical polution, LI - Repair and paint (complete)

290,08

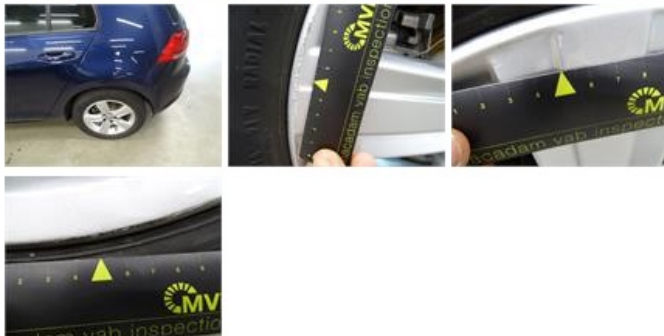
Alloy rim R L, Scratch(es), LI - Repair and paint (complete)

95,00

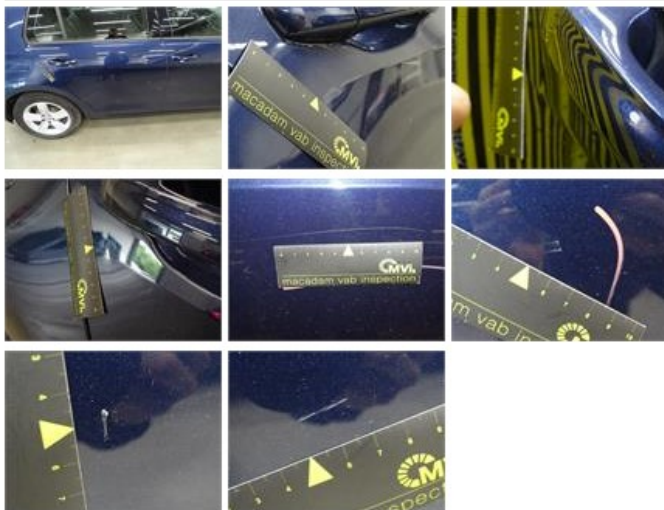
Door R R, Dent(s) and scratch(es), LI - Repair and paint (complete)

318,35

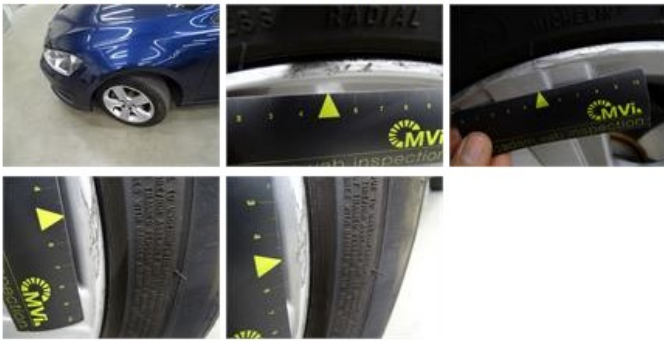
Alloy rim F L, Scratch(es), LI - Repair and paint (complete)

95,00
