VOLVO V40: 1HEH339

Limited Technical Inspection

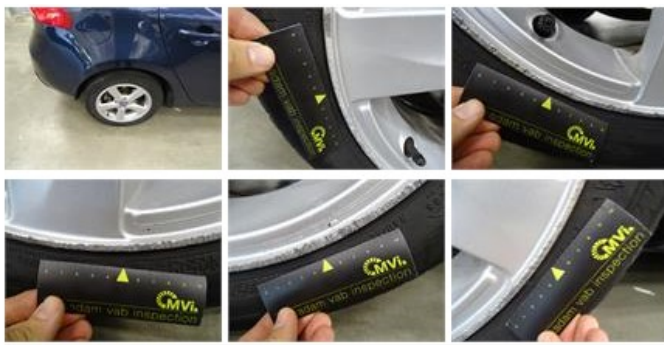
Total cost ex VAT	1986,20
Alloy rim R R, Scratch(es), LI - Repair and paint (complete)	95,00

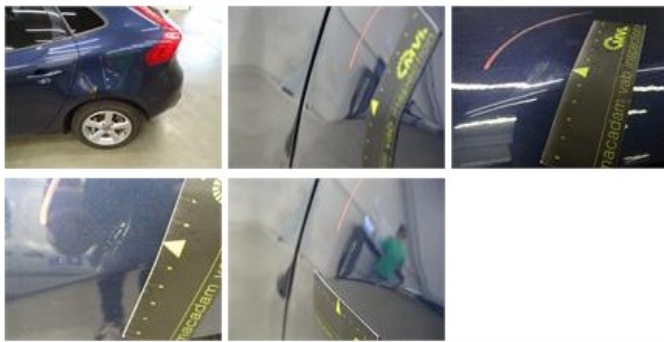
Wing R L, Dent(s) and scratch(es), LI - Repair and paint (complete) 308,20

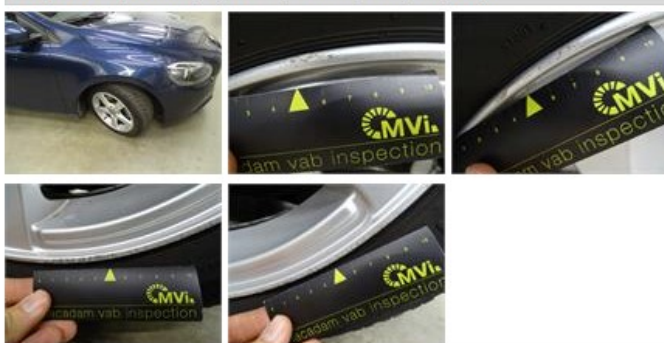
Alloy rim F R, Scratch(es), LI - Repair and paint (complete) 95,00

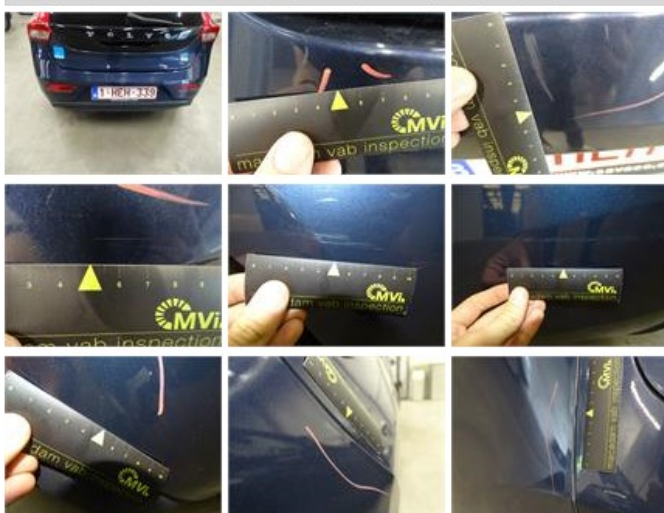
Bumper R, Dent(s) and scratch(es), LI - Repair and paint (complete) 211,80

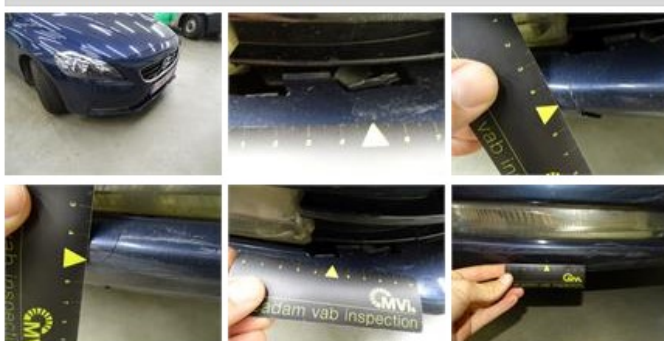
Bumper F, Crack, Le - Replace and paint 735,00

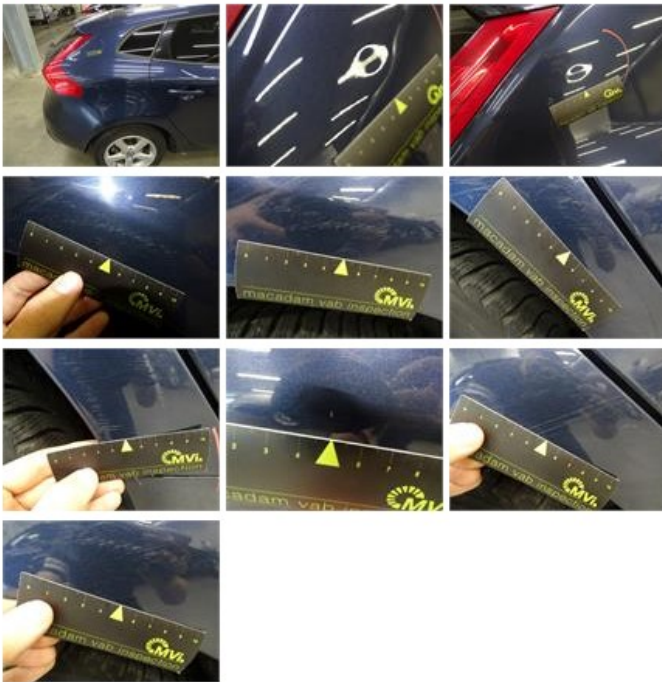
Wing R R, Scratch(es), LI - Repair and paint (complete) 308,20

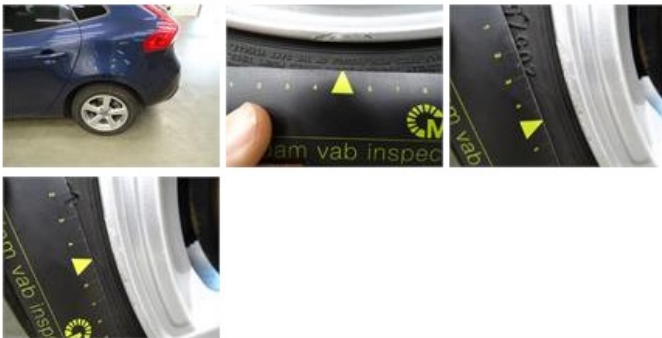
Alloy rim R L, Scratch(es), LI - Repair and paint (complete) 95,00

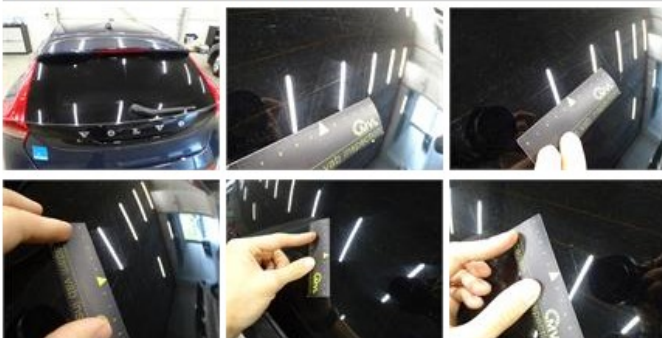
Rear window, Scratch(es), Acceptable 0,00
