**RENAULT Grand Scenic: 1GIC315**

**Limited Technical Inspection**

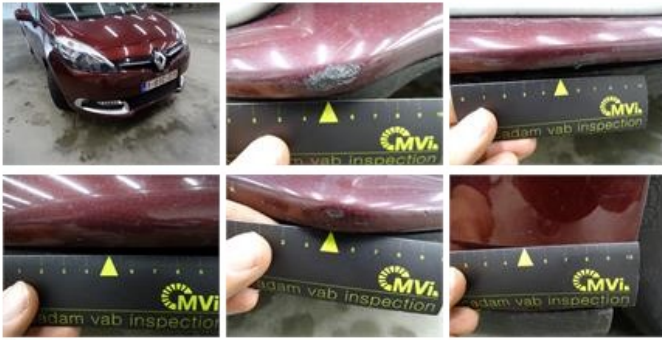
Bumper F, Scratch(es), LI - Repair and paint (complete)

211,80

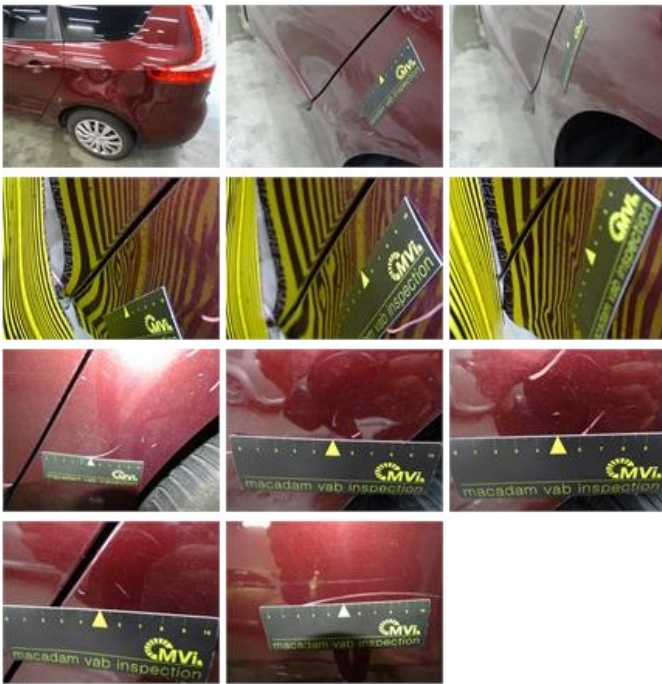
Wing R L, Dent(s) and scratch(es), LI - Repair and paint (complete)

308,20

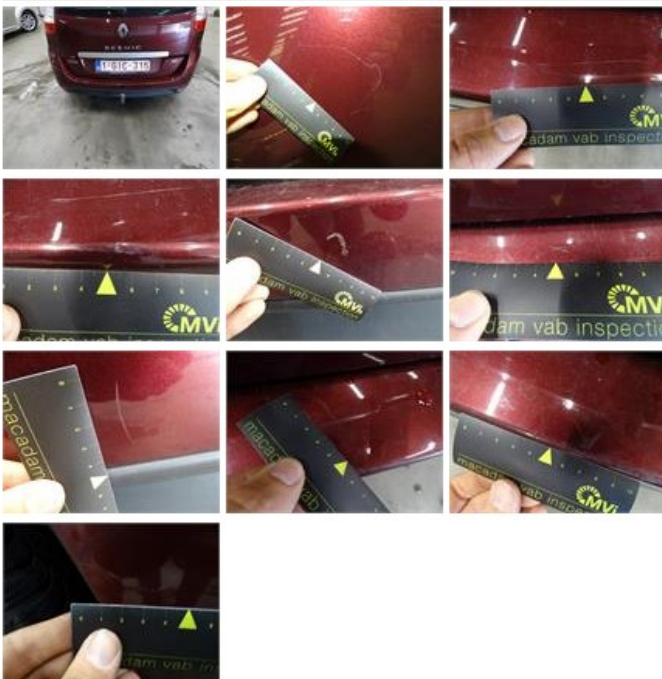
Bumper R, Scratch(es), LI - Repair and paint (complete)

211,80

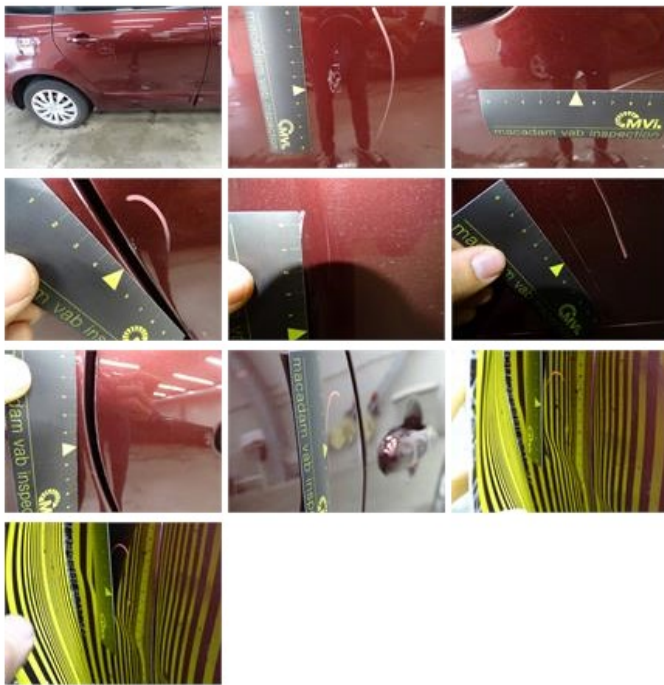
Door R R, Dent(s) and scratch(es), LI - Repair and paint (complete)

318,35

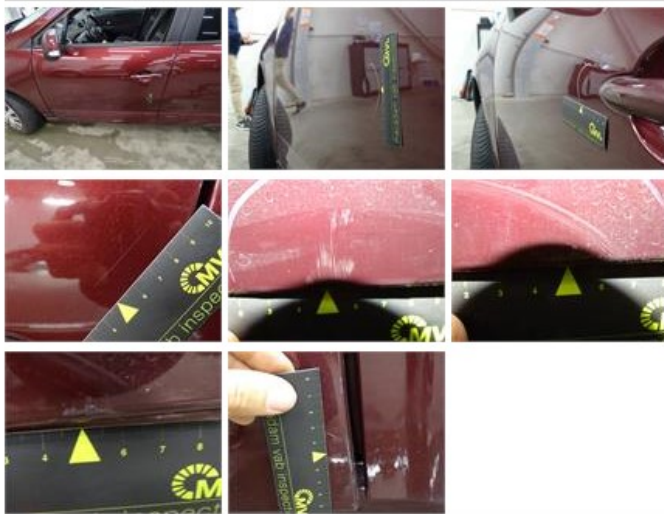
Door F L, Dent(s) and scratch(es), LI - Repair and paint (complete) 318,35

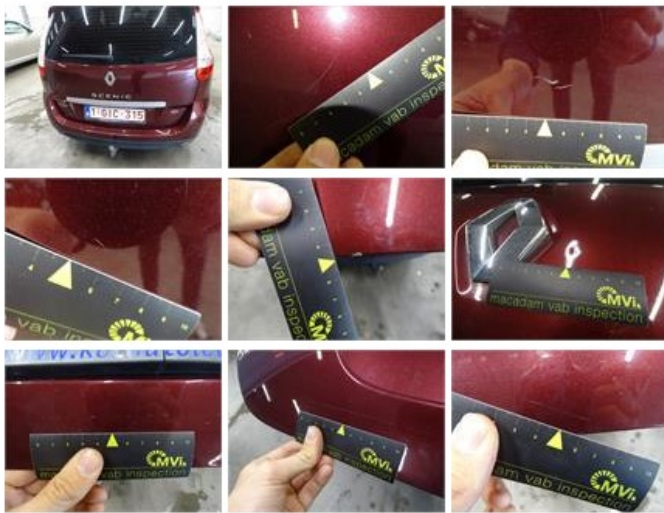
Tailgate, Dent(s) and scratch(es), LI - Repair and paint (complete) 301,68

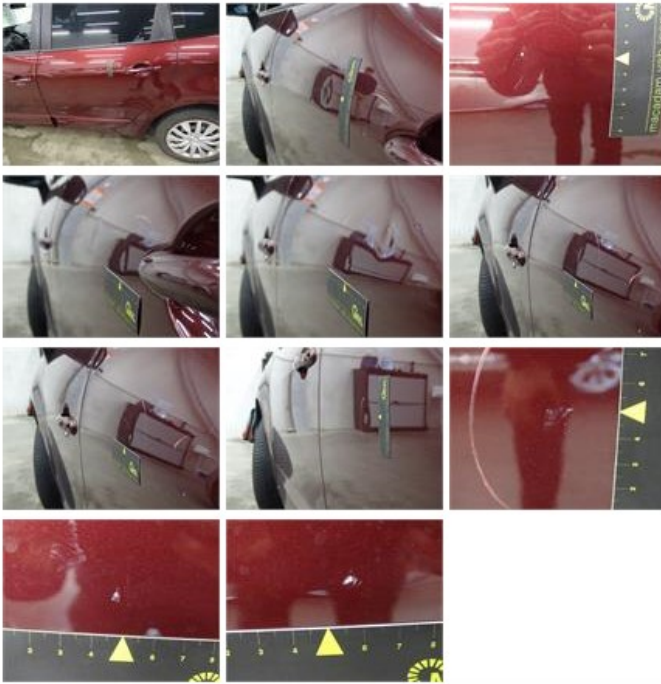
Door R L, Dent(s) and scratch(es), LI - Repair and paint (complete) 318,35

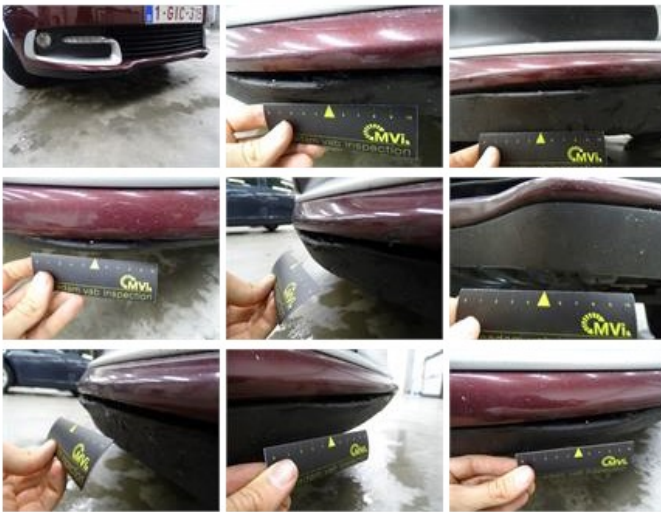
Bumper F M, Deformed / Strained, Smart repair 110,64
