VOLKSWAGEN SHARAN: 1KLD438

Limited Technical Inspection

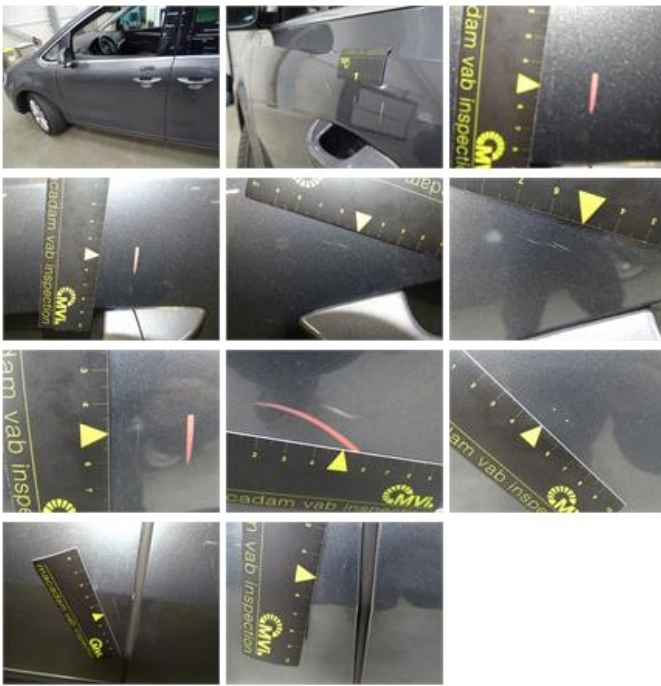
Door F L, Dent(s) and scratch(es), LI - Repair and paint (complete) 382,02

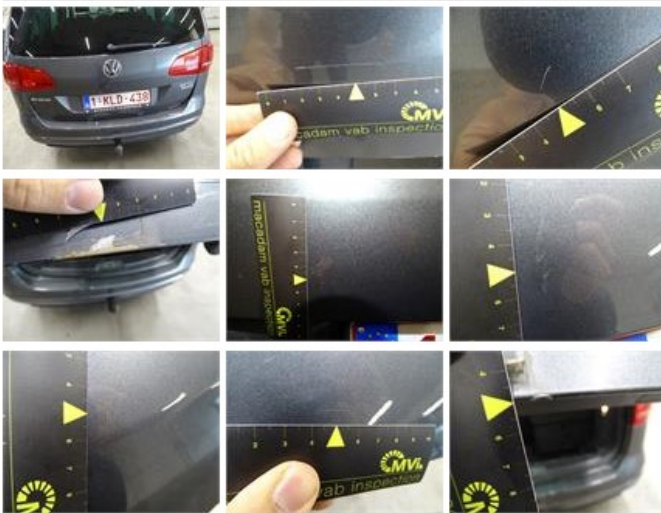
Tailgate, Scratch(es), LI - Repair and paint (complete) 362,02

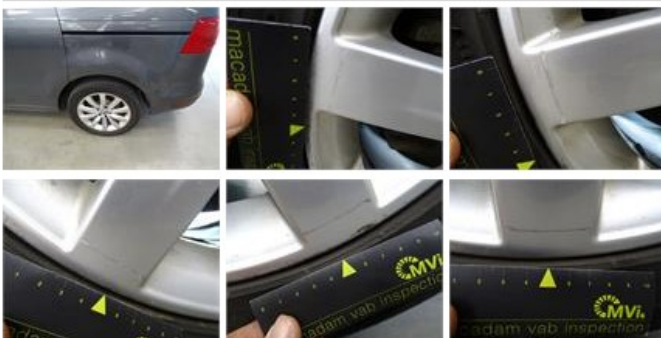
Alloy rim R L, Scratch(es), LI - Repair and paint (complete) 95,00

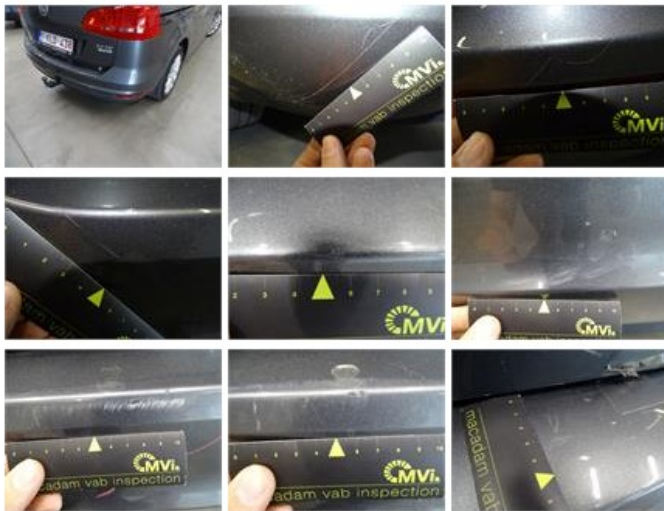
Bumper R, Scratch(es), LI - Repair and paint (complete)

254,16
