BMW 1 HATCH: 1JRD677

Limited Technical Inspection

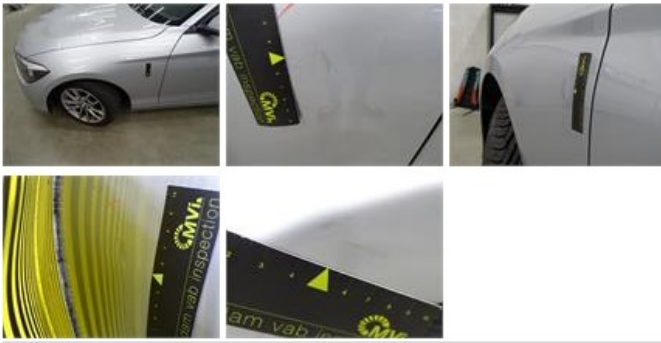
Wing F L, Dent(s) and scratch(es), LI - Repair and paint (complete) 220,18

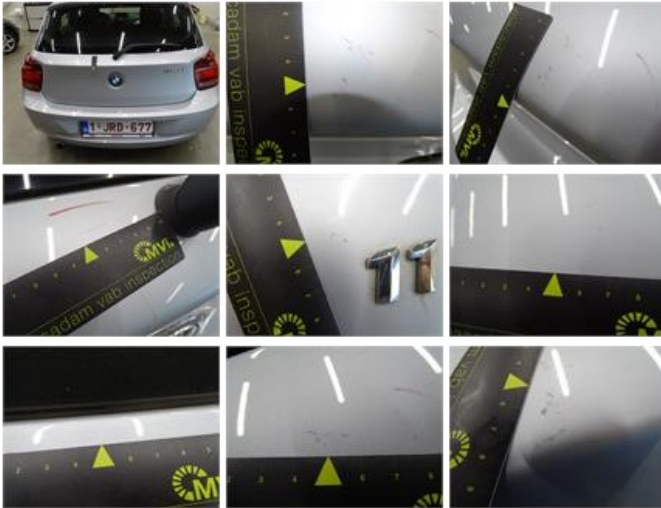
Tailgate, Scratch(es), LI - Repair and paint (complete) 301,68

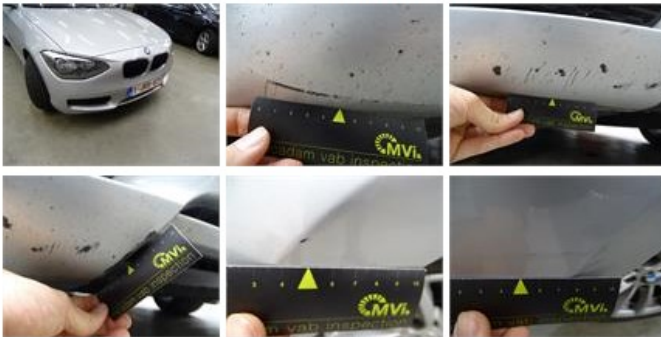
Bumper F, Scratch(es), LI - Repair and paint (complete) 211,80

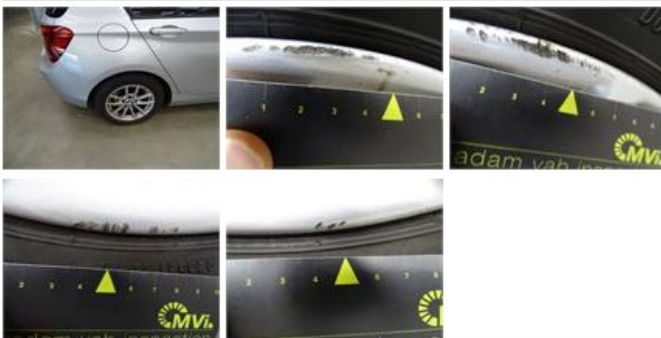
Alloy rim R R, Scratch(es), LI - Repair and paint (complete) 95,00

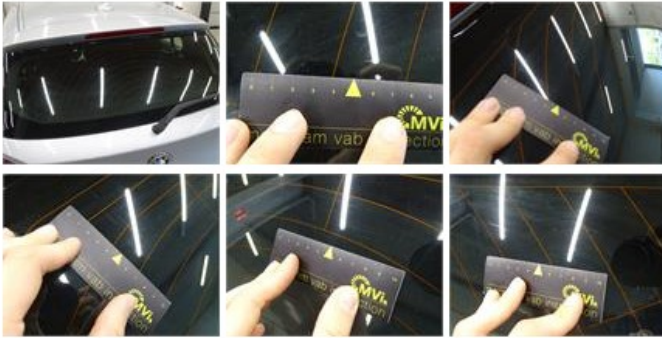
Rear window, Scratch(es), Acceptable

0,00
