VOLVO S60: 1EMA920

Limited Technical Inspection

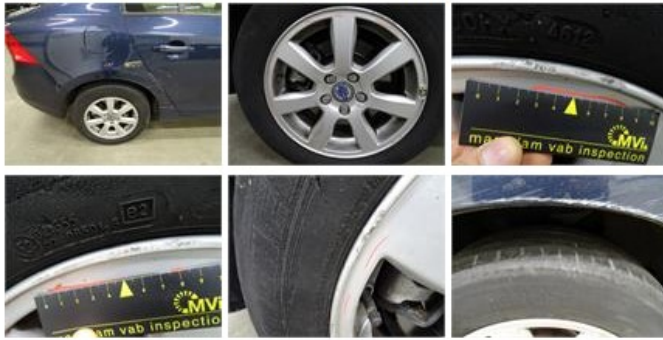
Alloy rim R R, Scratch(es), LI - Repair and paint (complete)

95,00

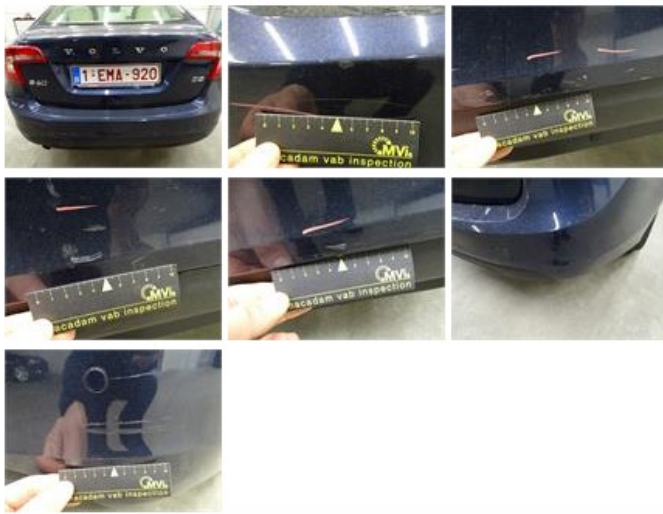
Bumper R, Scratch(es), LI - Repair and paint (complete)

211,80

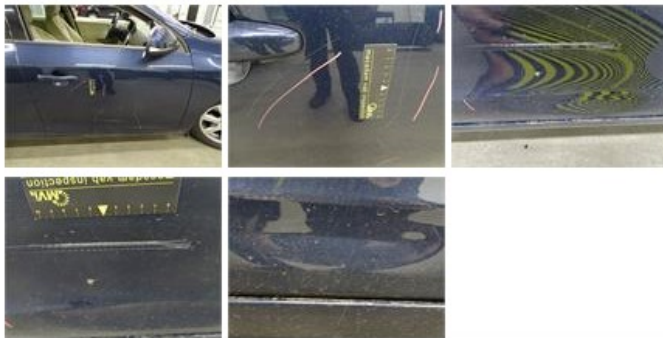
Door F R, Scratch(es), LI - Repair and paint (complete)

318,35

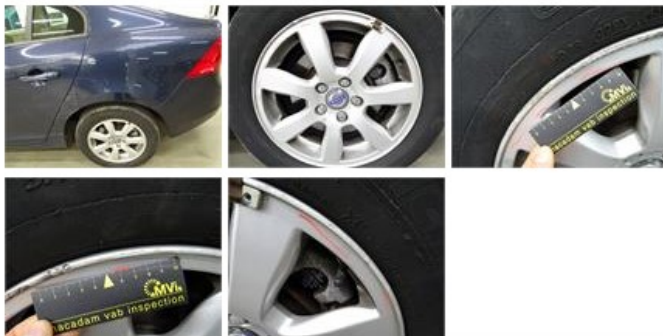
Alloy rim R L, Scratch(es), LI - Repair and paint (complete)

95,00
