VOLVO V40: 1GUH365

Limited Technical Inspection

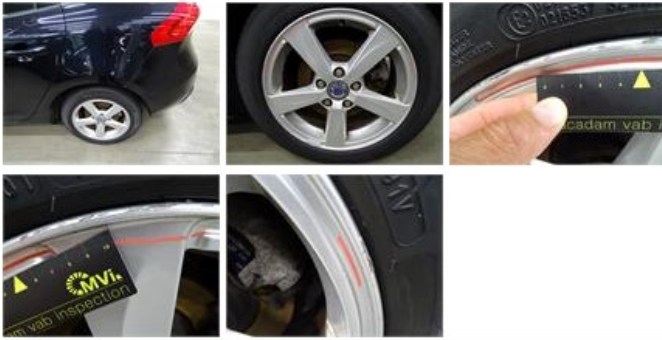
Alloy rim R L, Scratch(es), LI - Repair and paint (complete) 95,00

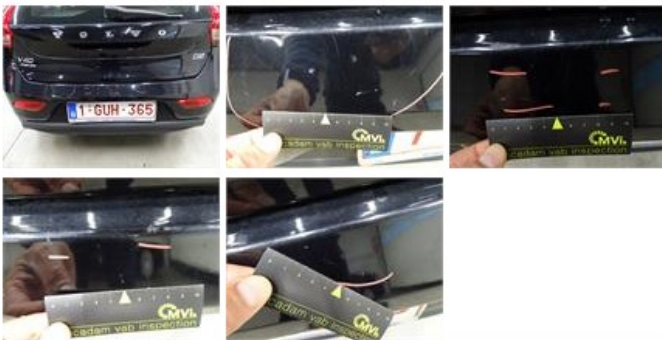
Bumper R, Scratch(es), LI - Repair and paint (complete) 211,80

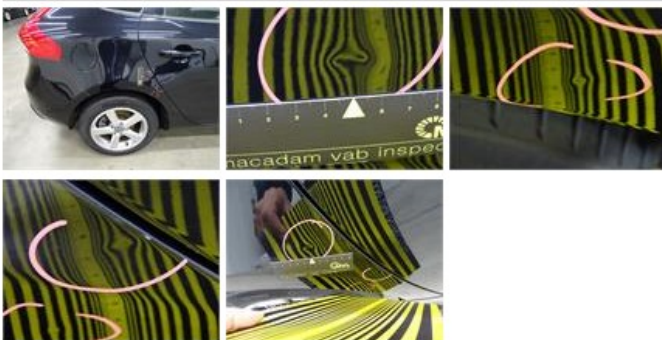
Wing R R, Dent(s), PDR - Paintless dent repair 102,60

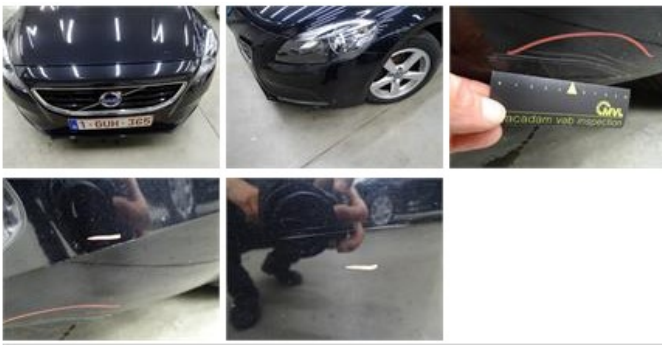
Bumper F, Scratch(es), LI - Repair and paint (complete) 211,80

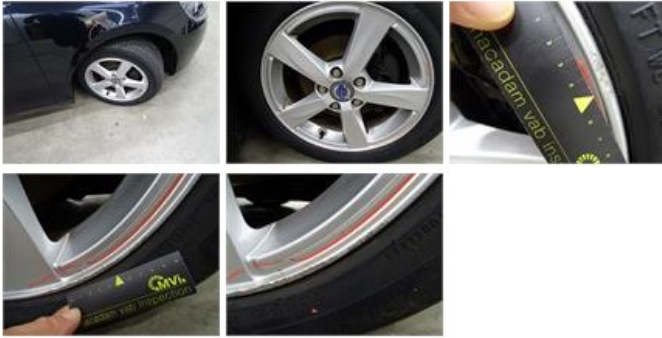
Alloy rim F R, Scratch(es), LI - Repair and paint (complete) 95,00

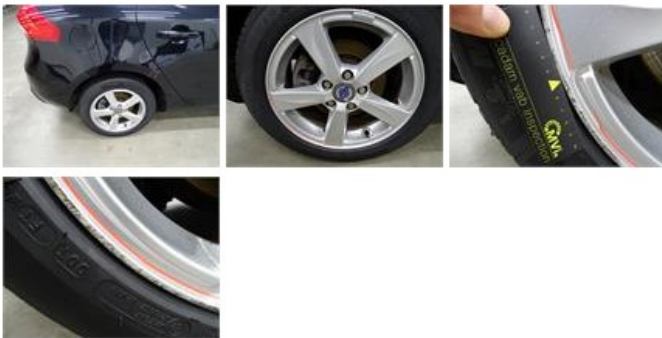
Alloy rim R R, Scratch(es), LI - Repair and paint (complete) 95,00

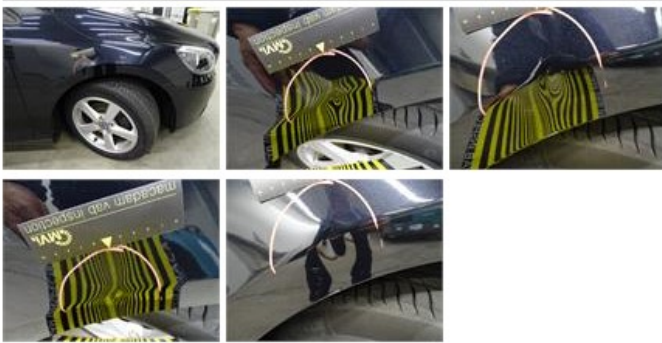
Wing F R, Dent(s) and scratch(es), LI - Repair and paint (complete) 220,18
