**VOLVO V40: 1G1C232**

**Limited Technical Inspection**

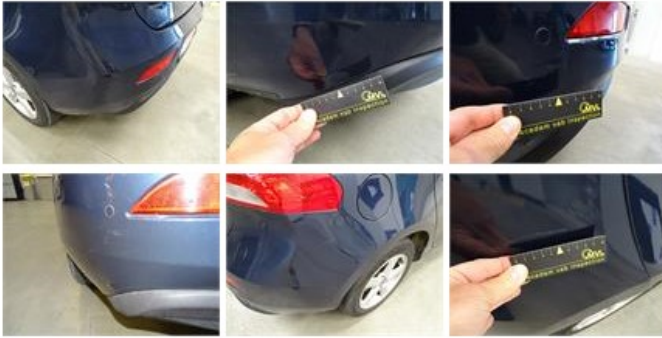
Bumper R, Dent(s) and scratch(es), LI - Repair and paint (complete) 259,80

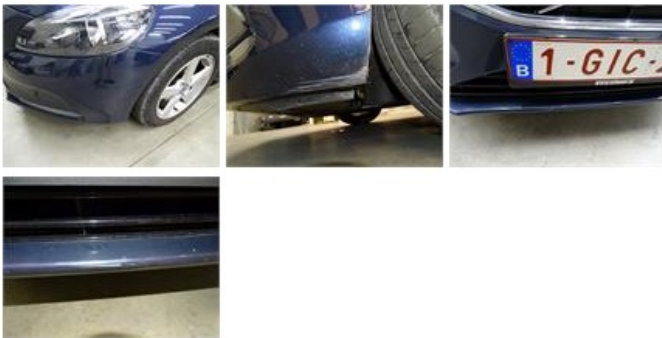
Bumper F, Scratch(es), LI - Repair and paint (complete) 211,80
