VOLKSWAGEN GOLF VARIANT: 1JJG789

Limited Technical Inspection

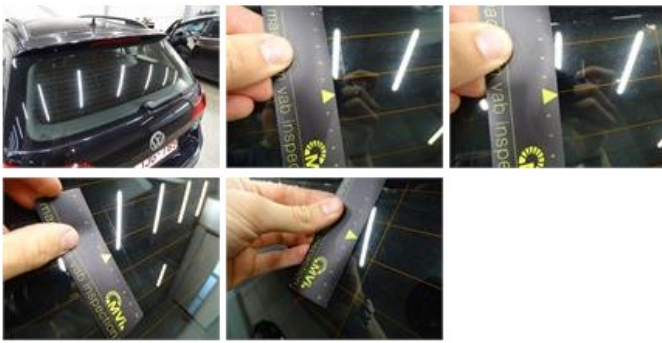
Total cost ex VAT	1531,65
Rear window, Scratch(es), Acceptable	0,00

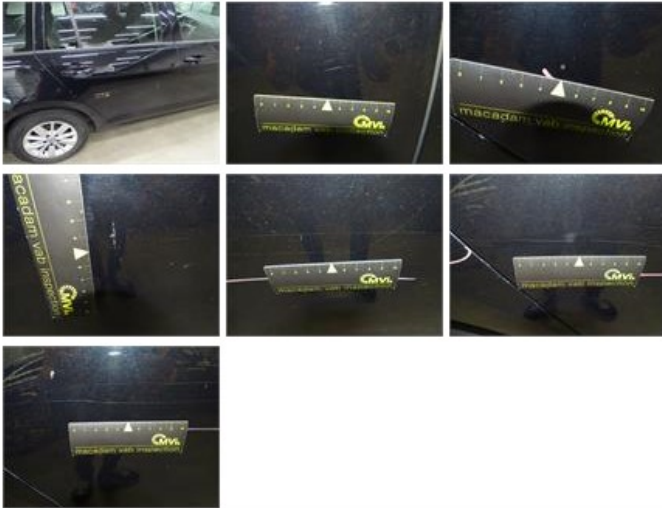
Door R R, Scratch(es), LI - Repair and paint (complete) 318,35

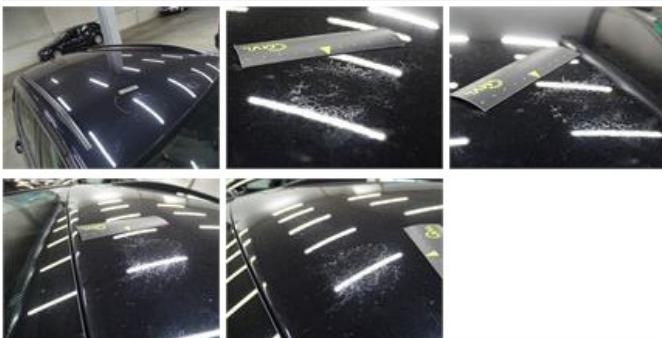
Roof, Chemical polution, LI - Repair and paint (complete) 481,50

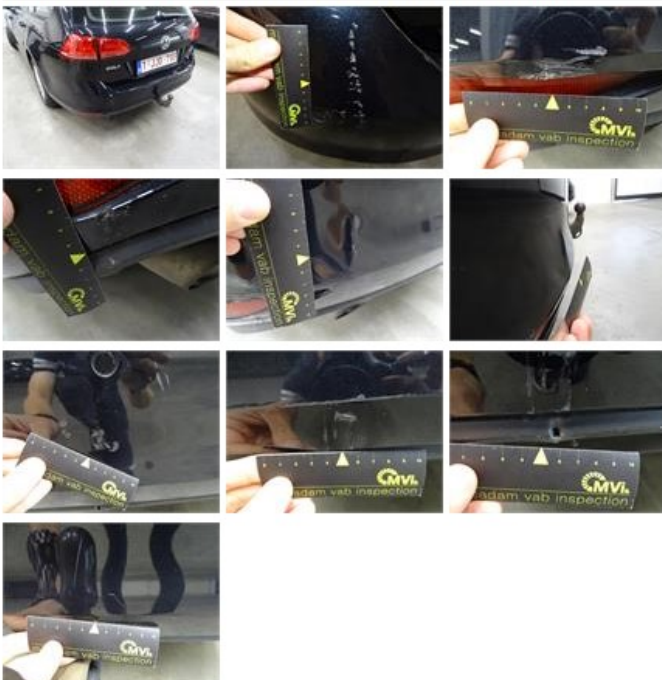
Bumper R, Dent(s) and scratch(es), LI - Repair and paint (complete) 211,80
