SKODA OCTAVIA COMBI: 1JUF870

Limited Technical Inspection

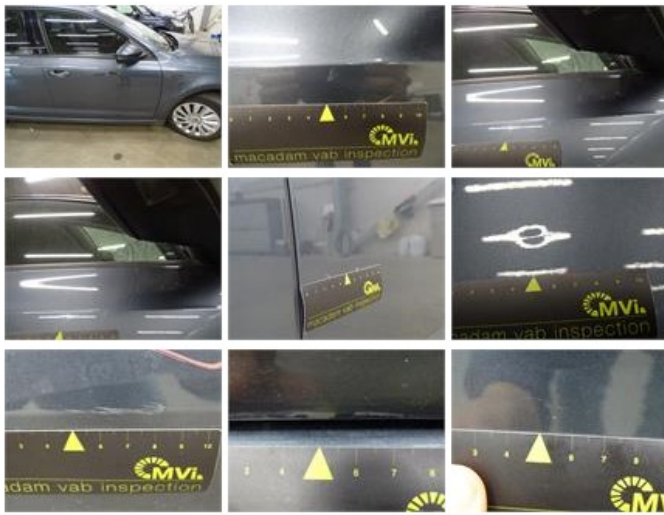
Total cost ex VAT	1819,35
Door F R, Dent(s) and scratch(es), LI - Repair and paint (complete)	318,35

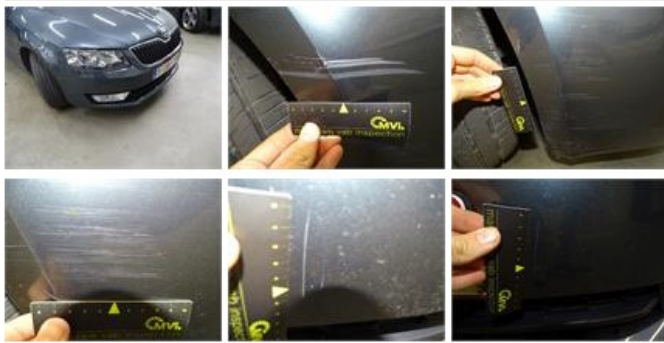
Bumper F, Scratch(es), LI - Repair and paint (complete) 211,80

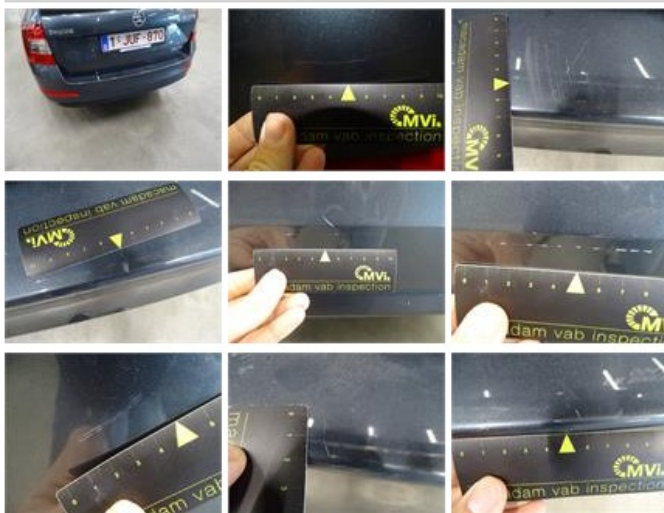
Bumper R, Scratch(es), LI - Repair and paint (complete) 211,80

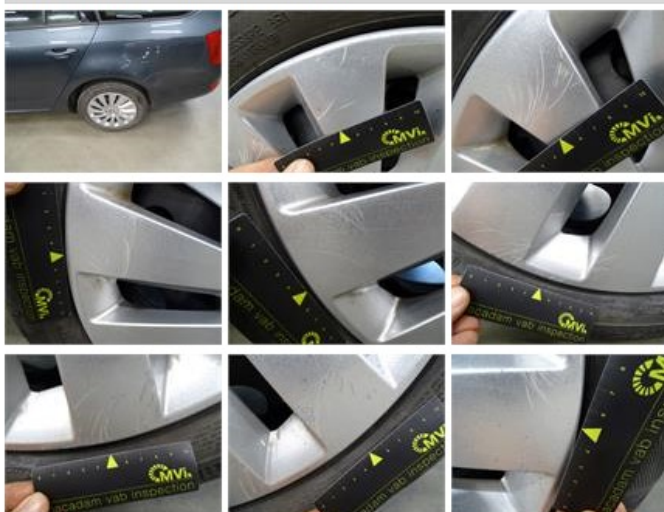
Wheel cover R L, Scratch(es), E - Replace 30,00

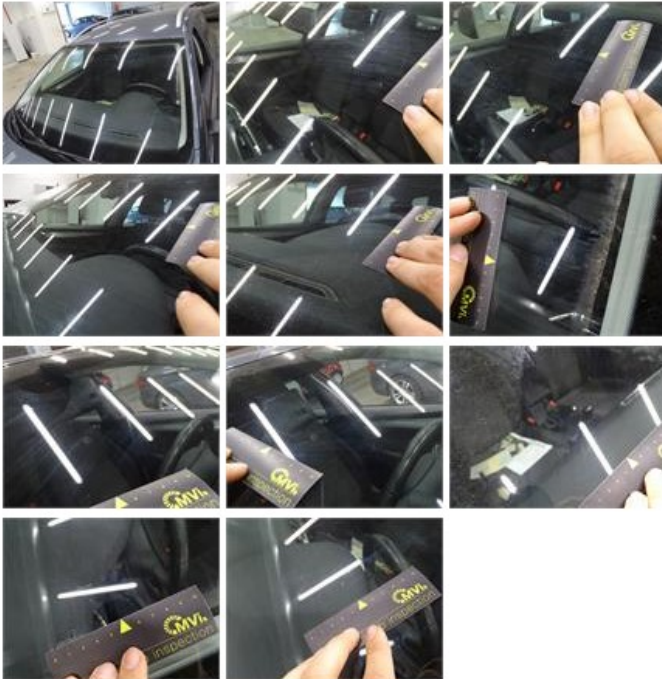
Windscreen, Scratch(es), E - Replace	487,20
--------------------------------------	--------

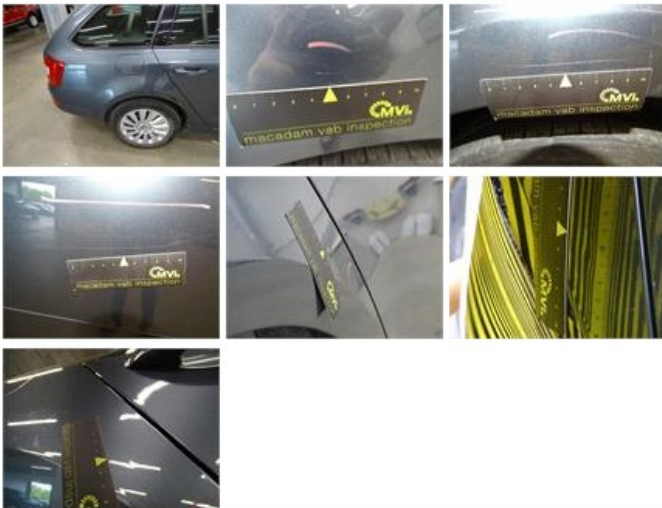
Wing R R, Dent(s) and scratch(es), LI - Repair and paint (complete)	308,20
---	--------

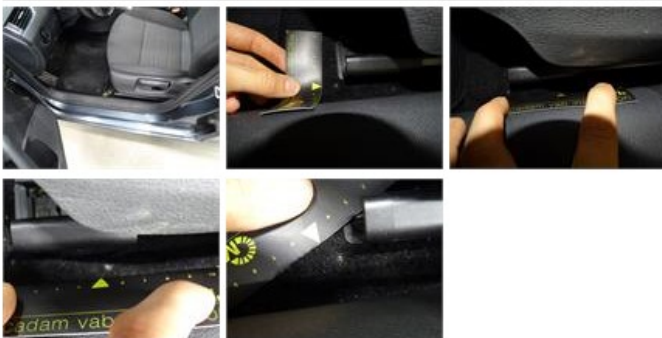
Floor covering F L, Burned, E - Replace	252,00
---	--------
