VOLVO V60: 1JJL765

Limited Technical Inspection

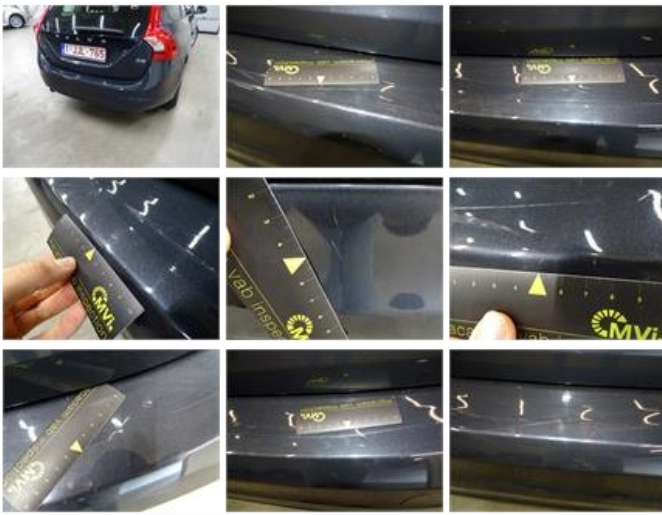
Total cost ex VAT	2146,88
Bumper R, Scratch(es), LI - Repair and paint (complete)	211,80

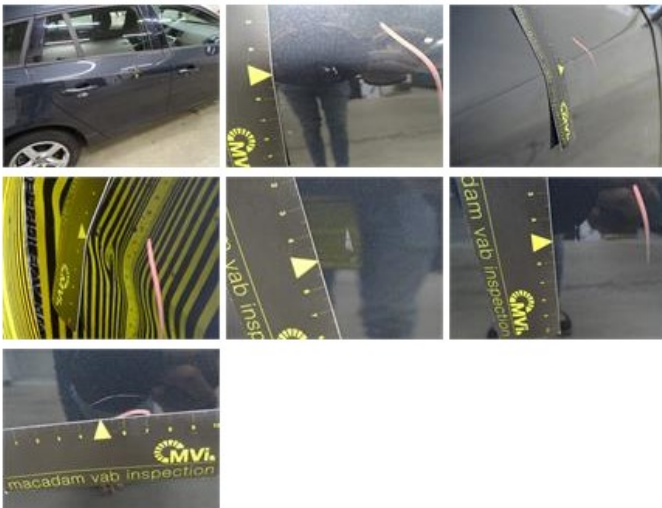
Door R R, Dent(s) and scratch(es), LI - Repair and paint (complete)

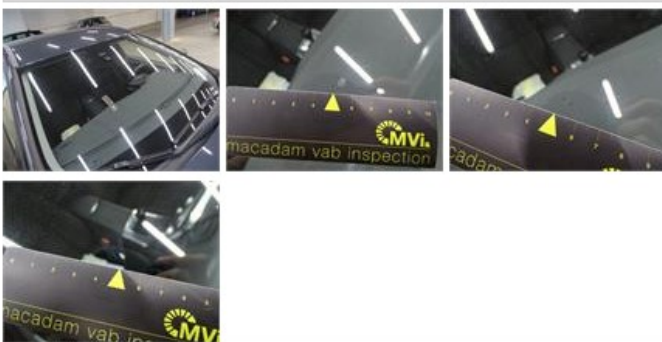
Windscreen, Stone chip(s), Acceptable

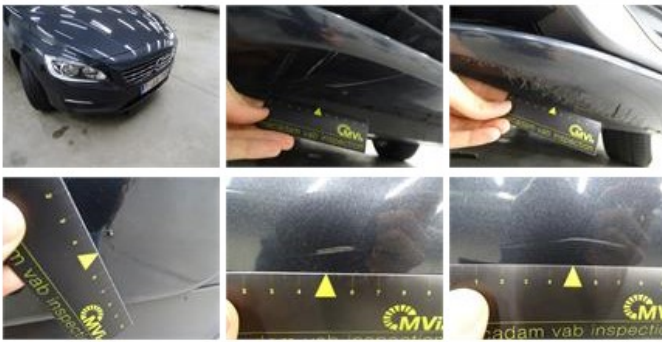
Bumper F, Scratch(es), LI - Repair and paint (complete) 211,80

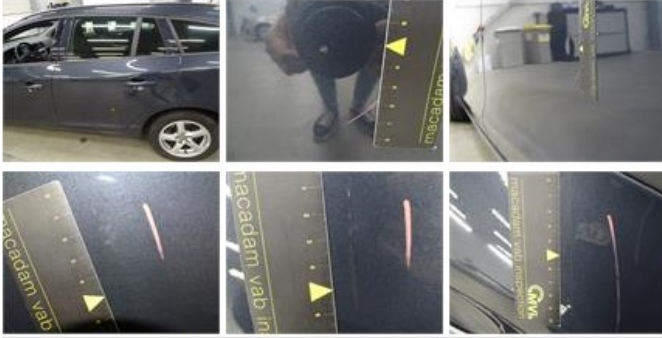
Door R L, Dent(s) and scratch(es), LI - Repair and paint (complete) 318,35

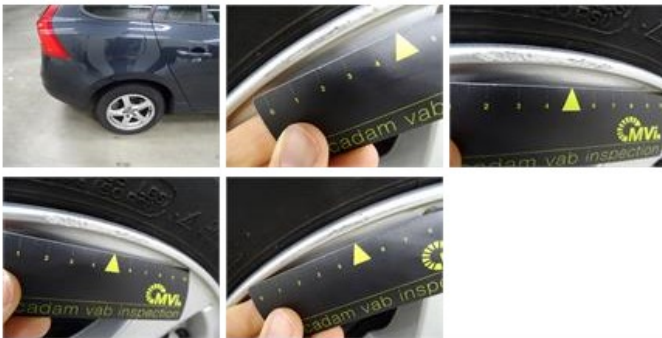
Alloy rim R R, Scratch(es), LI - Repair and paint (complete) 95,00

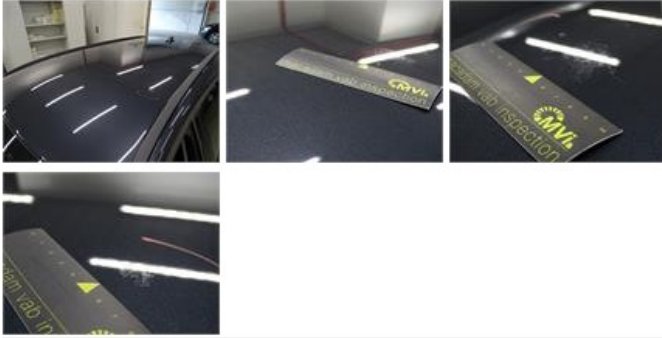
Roof, Chemical polution, LI - Repair and paint (complete) 481,50

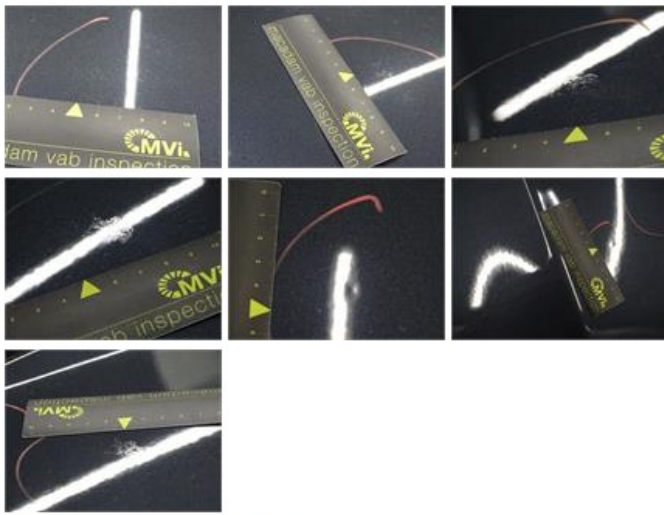
Bonnet, Chemical polution, LI - Repair and paint (complete) 290,08

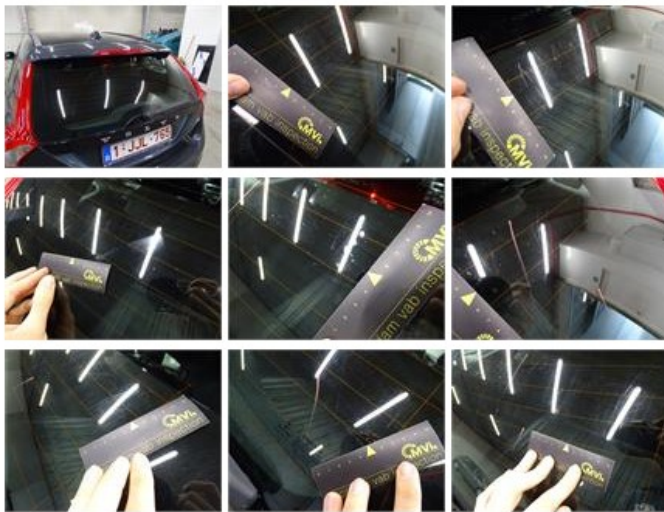
Rear window, Scratch(es), E - Replace 0,00

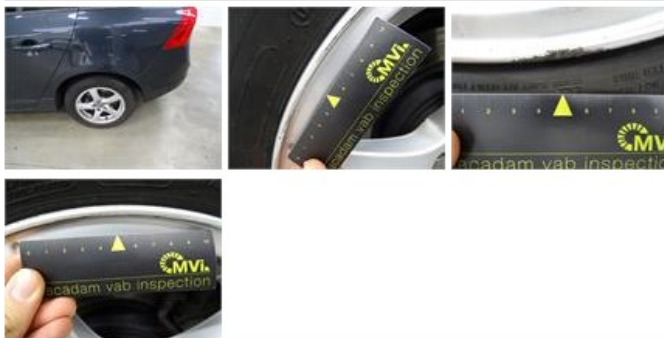
Alloy rim R L, Scratch(es), LI - Repair and paint (complete) 95,00
