VOLVO V40: PK8179

Limited Technical Inspection

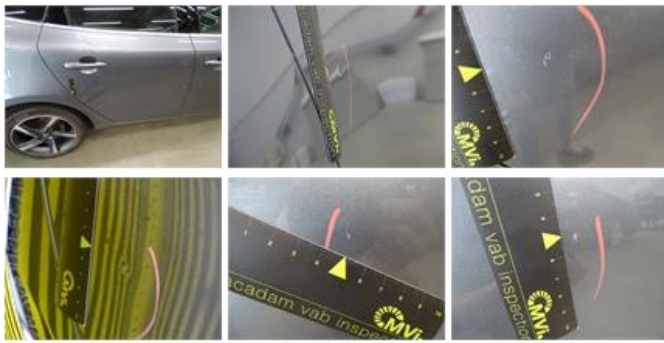
Total cost ex VAT	1915,41
Door R R, Dent(s) and scratch(es), LI - Repair and paint (complete)	318,35

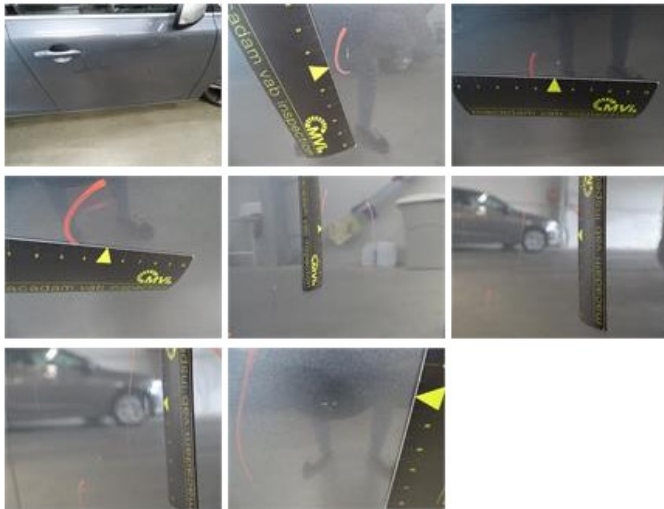
Door F R, Dent(s) and scratch(es), LI - Repair and paint (complete)

318,35

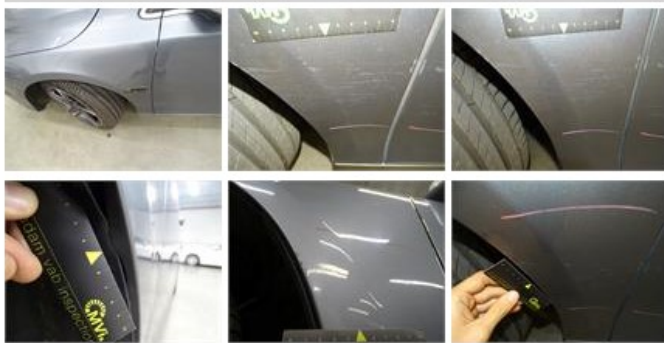
Wing F L, Dent(s) and scratch(es), LI - Repair and paint (complete)

220,18

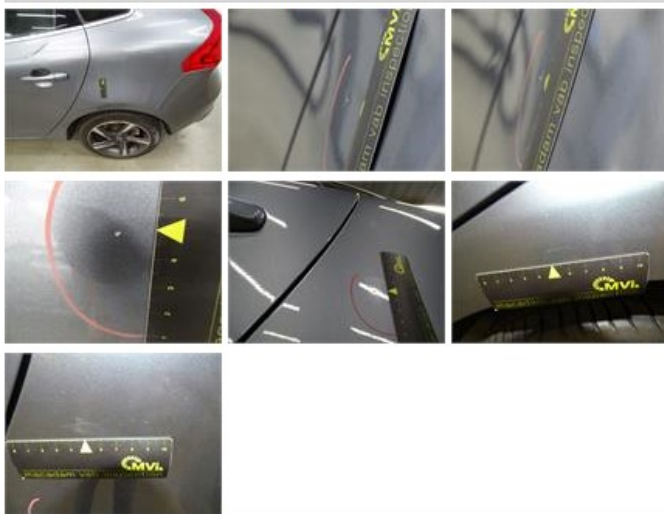
Wing R L, Dent(s) and scratch(es), LI - Repair and paint (complete)

308,20

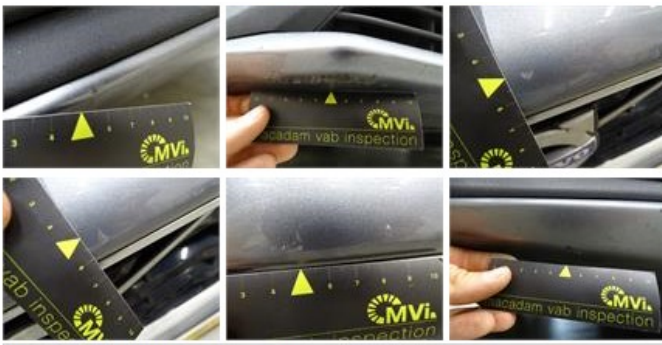
Bumper F, Scratch(es), LI - Repair and paint (complete)

211,80

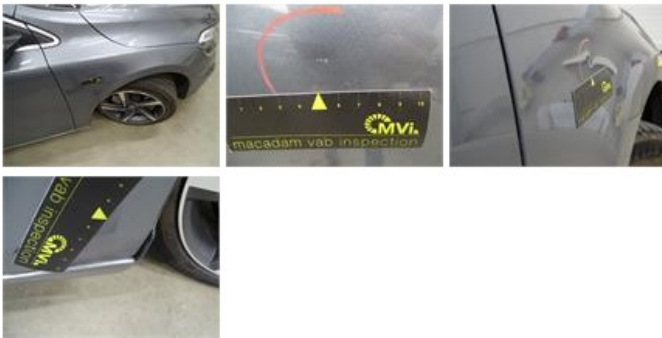
Wing F R, Dent(s) and scratch(es), LI - Repair and paint (complete) 220,18

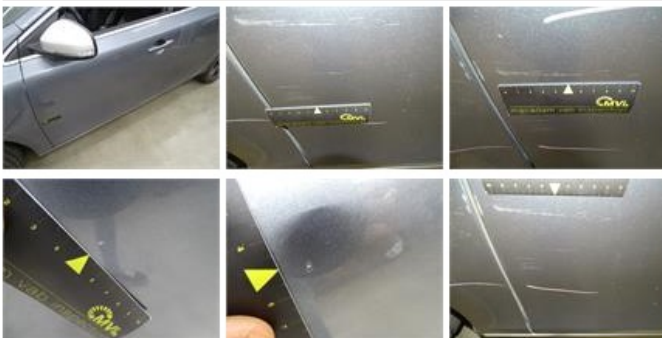
Door F L, Scratch(es), LI - Repair and paint (complete) 318,35
