VOLVO V60: 1GSM16

Limited Technical Inspection

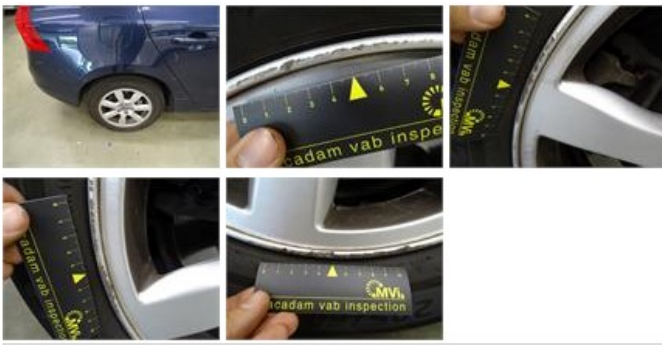
Total cost ex VAT		1760,05
Wing R R, Scratch(es), Acceptable		0,00
<i>No pictures to display</i>		
Alloy rim R R, Scratch(es), LI - Repair and paint (complete)		95,00

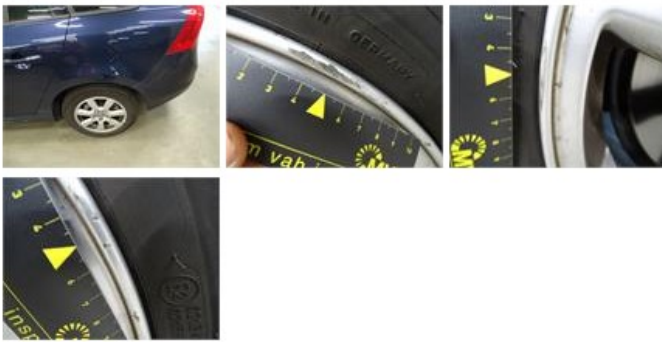
Alloy rim R L, Scratch(es), LI - Repair and paint (complete) 95,00

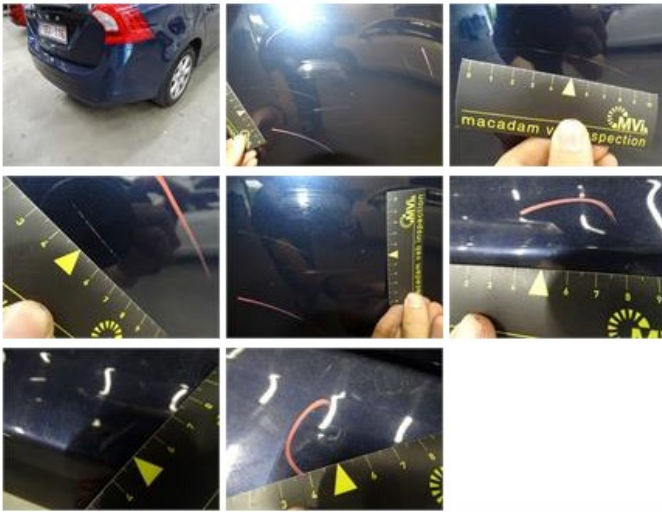
Bumper R, Scratch(es), LI - Repair and paint (complete) 211,80

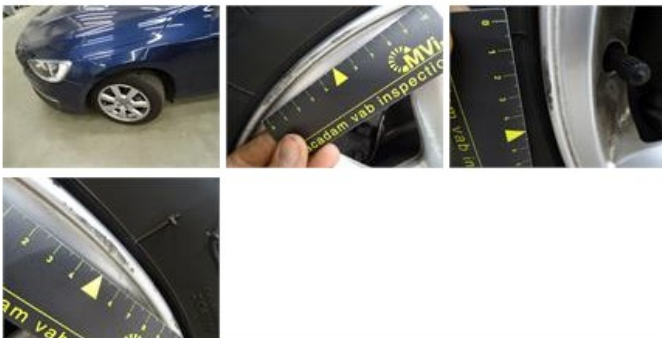
Alloy rim F L, Scratch(es), LI - Repair and paint (complete) 95,00

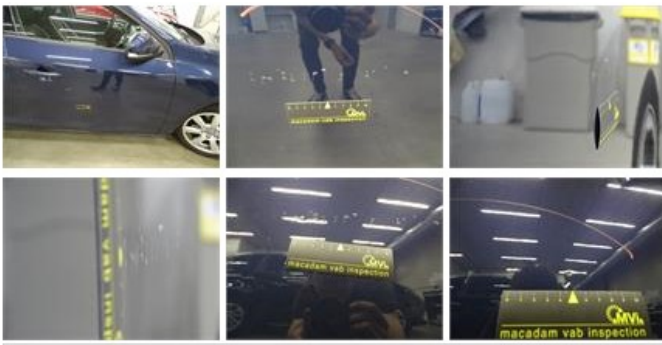
No pictures to display Door F R, Dent(s) and scratch(es), LI - Repair and paint (complete) 318,35

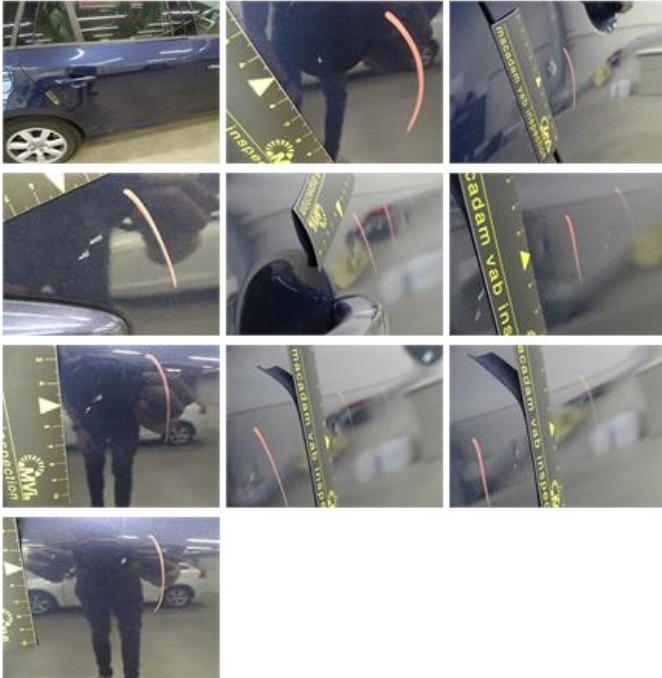
Door R R, Dent(s) and scratch(es), LI - Repair and paint (complete) 318,35

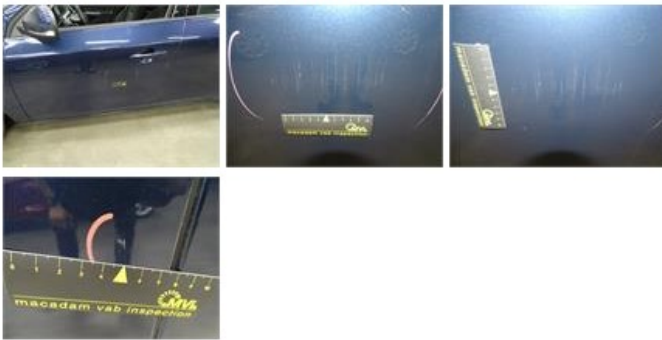
Door F L, Scratch(es), LI - Repair and paint (complete) 318,35

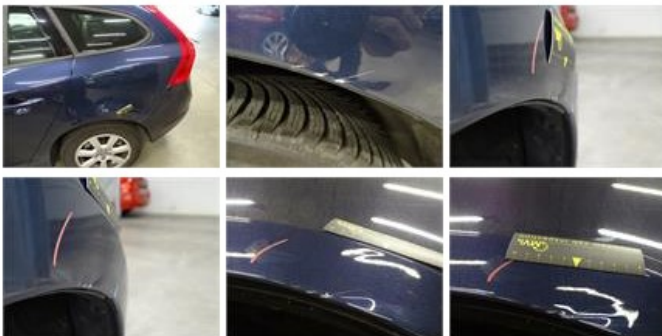
Wing R L, Dent(s) and scratch(es), LI - Repair and paint (complete) 308,20
