VOLVO V60: 1NKL333

Limited Technical Inspection

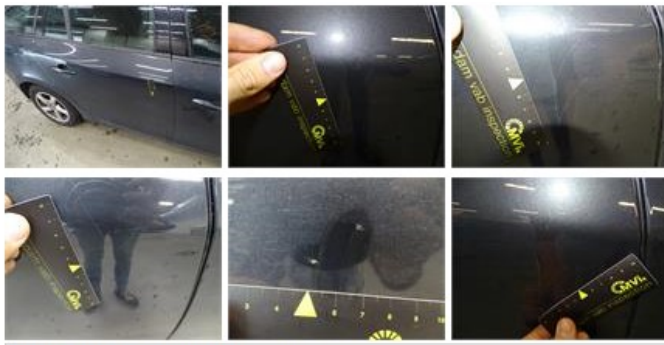
Total cost ex VAT	1438,45
Door R R, Scratch(es), LI - Repair and paint (complete)	318,35

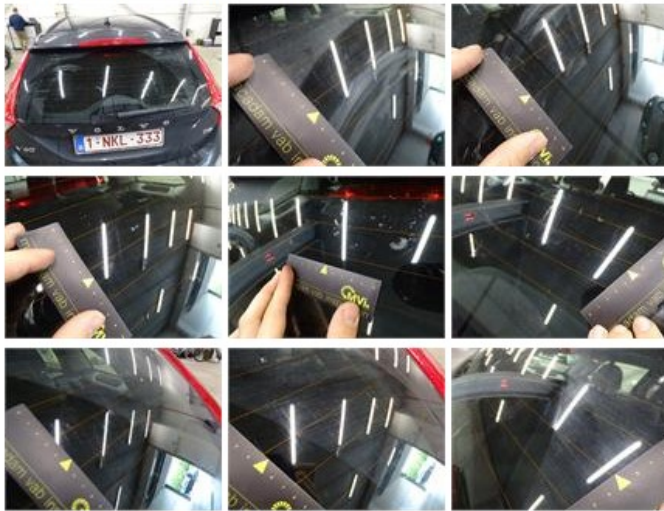
Rear window, Scratch(es), E - Replace

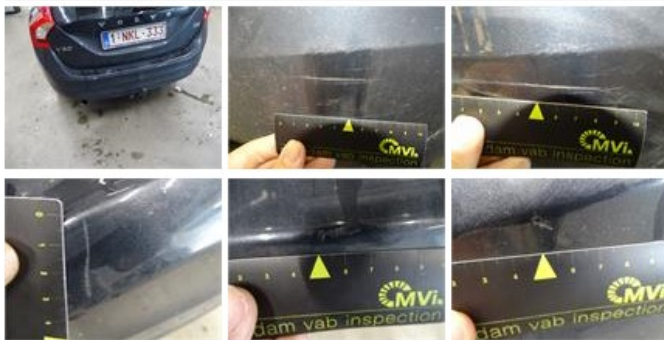
Bumper R, Scratch(es), LI - Repair and paint (complete)

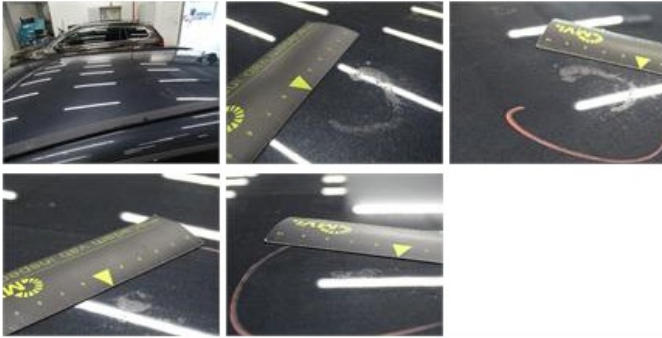
Roof, Chemical pollution, LI - Repair and paint (complete) 481,50
