VOLVO V40: 1NHH920

Limited Technical Inspection

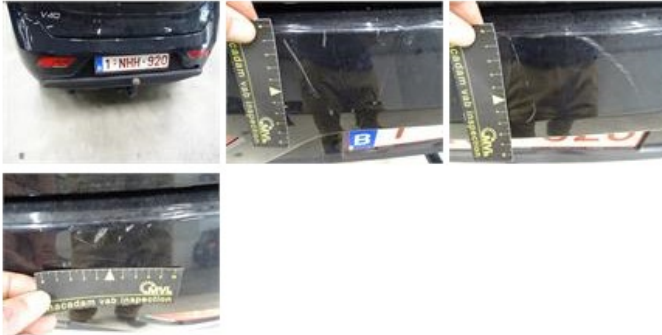
Bumper R, Scratch(es), LI - Repair and paint (complete) 211,80

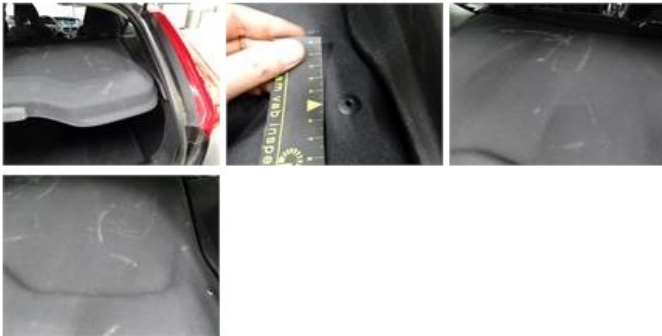
Luggage space cover, Incomplete, E - Replace 60,00

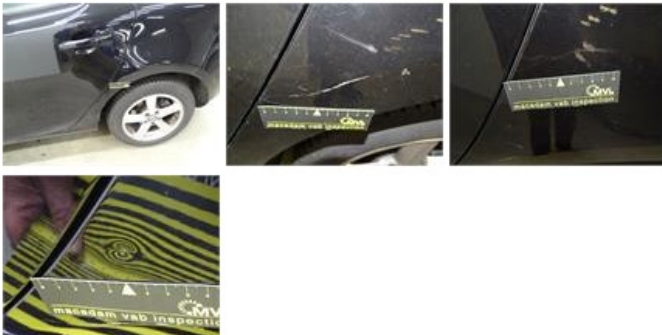
Wing R L, Dent(s) and scratch(es), LI - Repair and paint (complete) 308,20
