AUDI A3: 1HYF063

Limited Technical Inspection

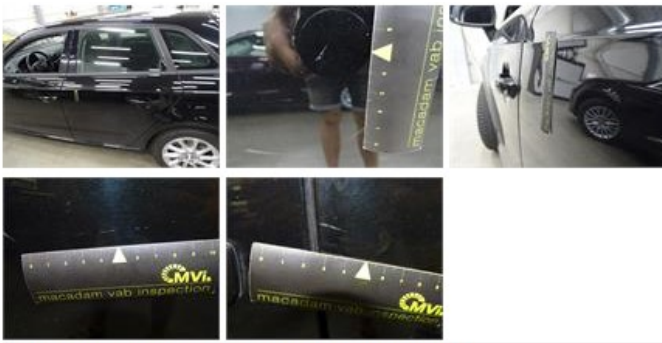
Total cost ex VAT	1916,73
Door R L, Dent(s) and scratch(es), LI - Repair and paint (complete)	318,35

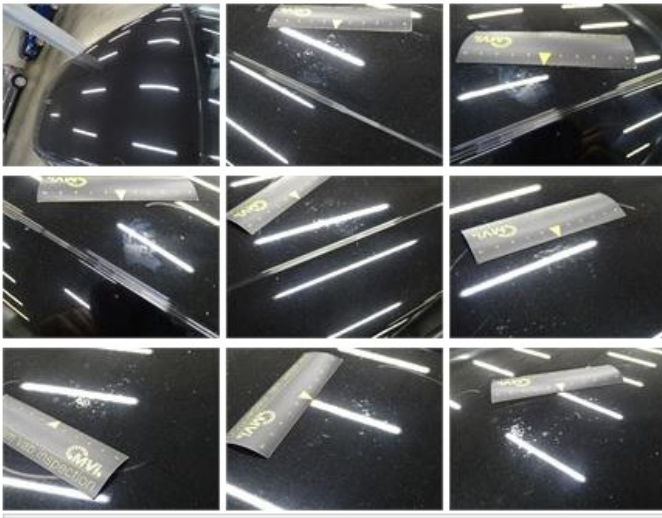
Roof, Chemical polution, LI - Repair and paint (complete) 481,50

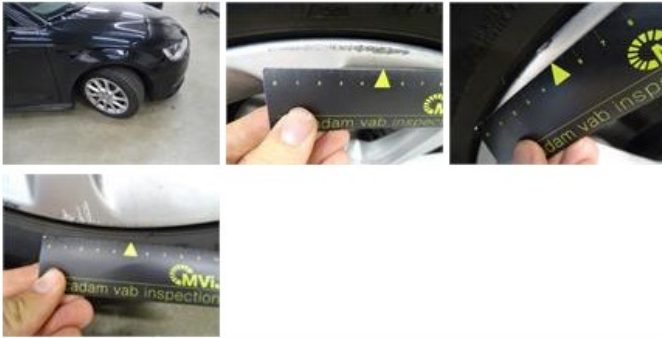
Alloy rim F R, Scratch(es), LI - Repair and paint (complete) 95,00

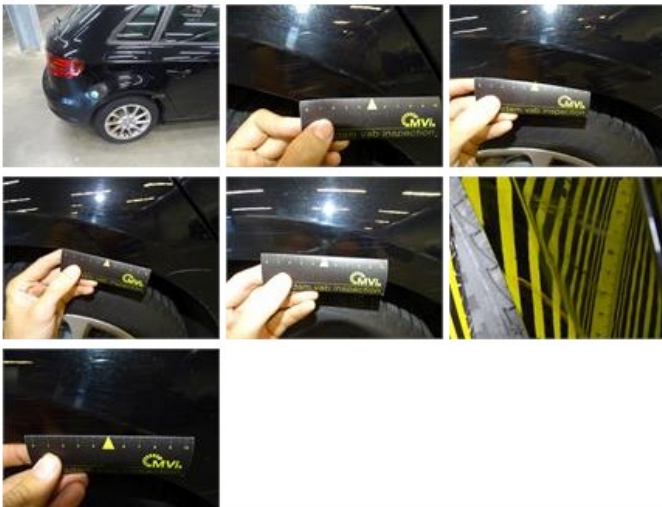
Wing R R, Dent(s) and scratch(es), LI - Repair and paint (complete) 308,20

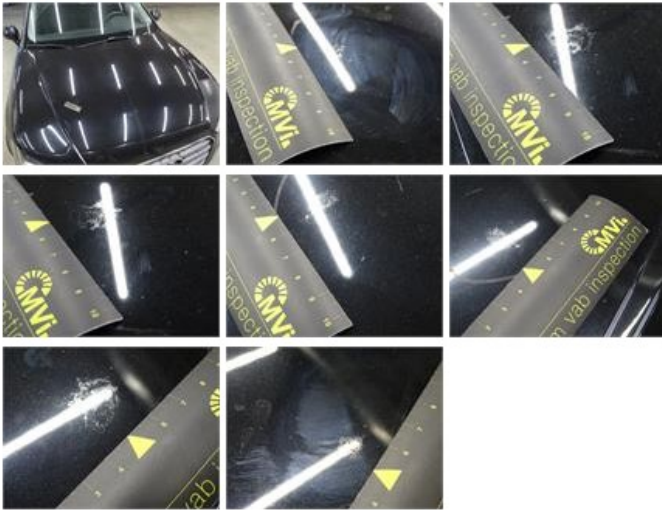
Bonnet, Chemical polution, LI - Repair and paint (complete)

290,08

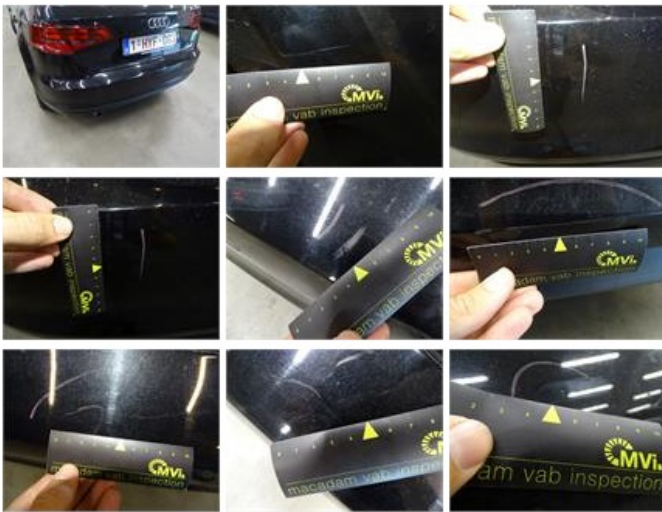
Bumper R, Scratch(es), LI - Repair and paint (complete)

211,80
