MERCEDES B: 1HTU596

Vinnumber:	WDD2462121J289289	Versionname:	B 180CDI BE Edition 109PK
First Registrationdate:	1/10/2014	Fiscalpower:	
Expertise Mileage:	193133	Power Kw:	80
Bodytype:		Body color:	Black
Gearbox:	MAN 6 VIT	Paint type:	Metalic
Transmission:	Front	Rims summer:	Aluminium
Fueltype:	Diesel	Oil level:	OK
Battery functioning:	Yes	Parking lot:	2709
Number of doors:	5		
Number of seats:	5		
Number head rests:	5		
Rims summer:	Aluminium		
Category:	Passenger Car		
Oil level:	OK		
Registration Certificate Car (BE):	Yes

Limited Technical Inspection

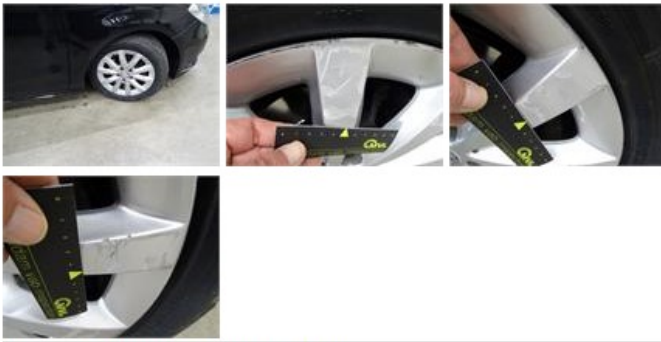
Alloy rim F R, Scratch(es), LI - repair and paint (complete)

95,00

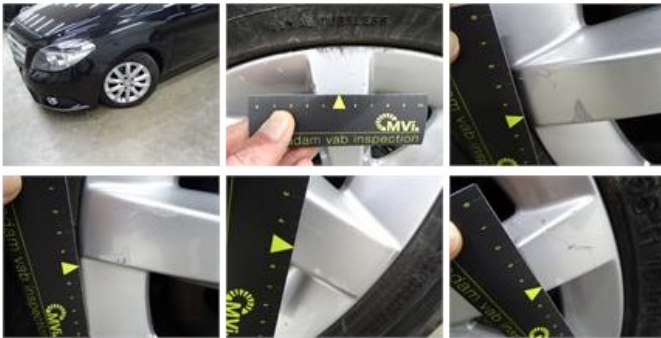
Alloy rim F L, Scratch(es), LI - Repair and paint (complete)

95,00
