FORD KUGA: 1KLX341

Limited Technical Inspection

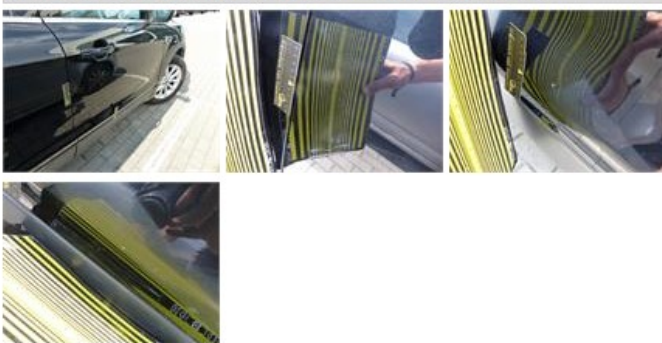
Door F R, Dent(s) and scratch(es), LI - Repair and paint (complete) 366,35

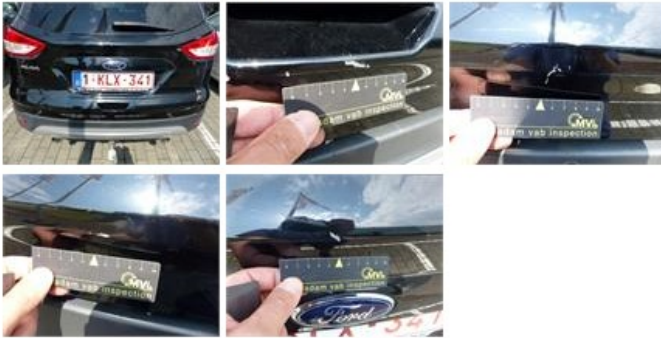
Tailgate, Scratch(es), It - Spot repair

115,56
