**BMW 5 TOURING: 1KLP311**

**Limited Technical Inspection**

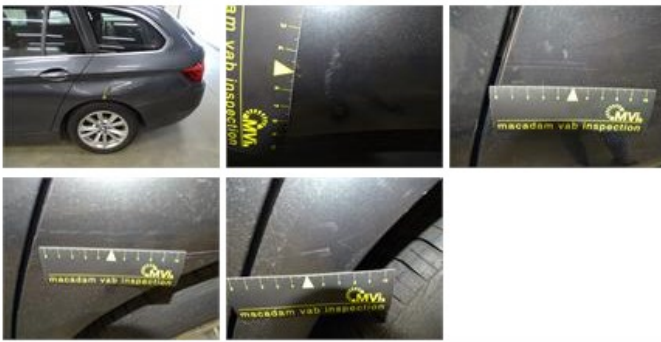
Wing R L, Scratch(es), LI - Repair and paint (complete)

369,84

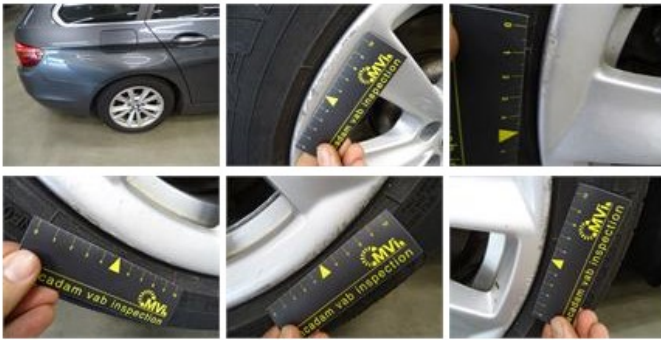
Alloy rim R R, Scratch(es), LI - Repair and paint (complete)

95,00

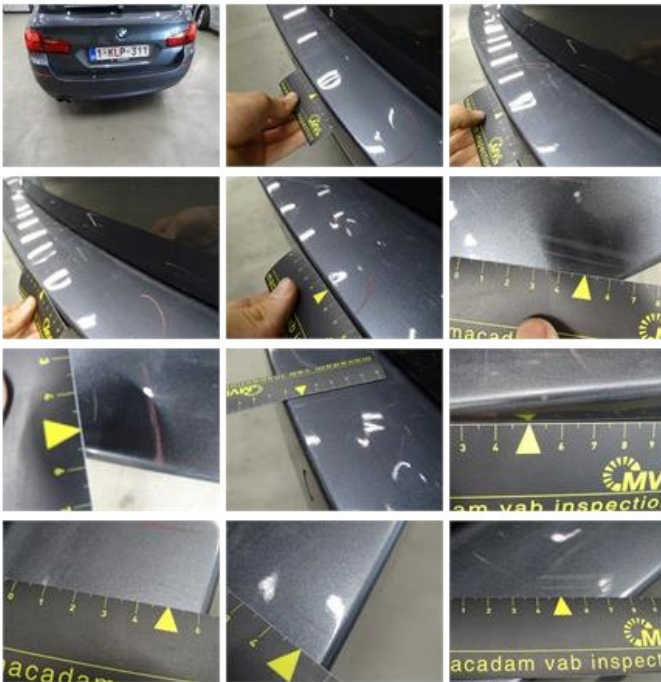
Bumper R, Dent(s) and scratch(es), LI - Repair and paint (complete)

254,16

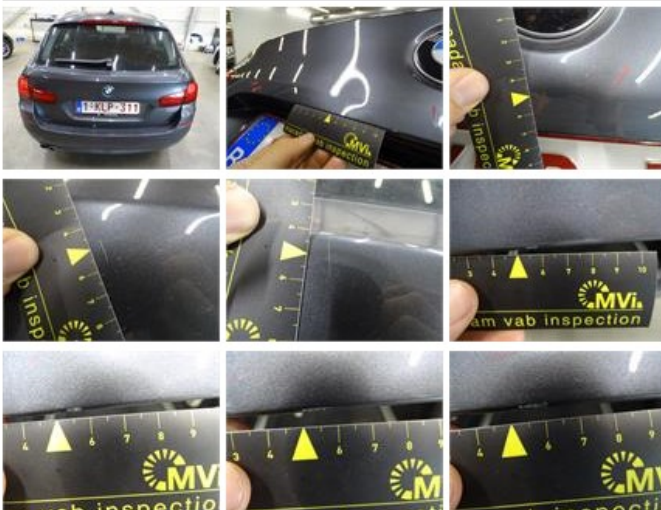
Tailgate, Dent(s) and scratch(es), LI - Repair and paint (complete)

362,02

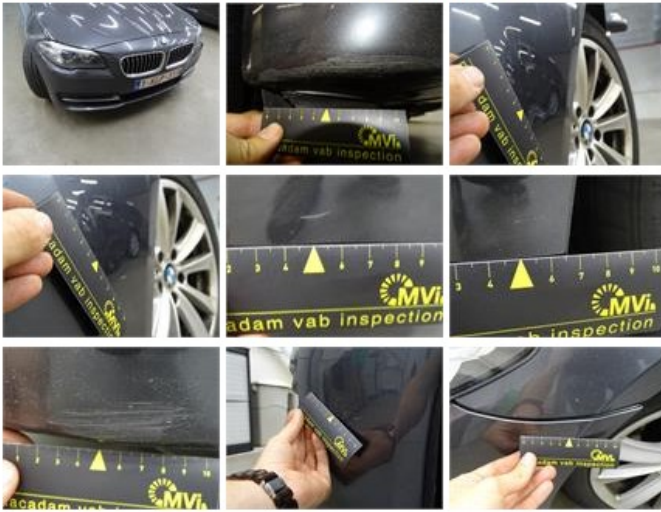
Bumper F, Dent(s) and scratch(es), LI - Repair and paint (complete)

254,16

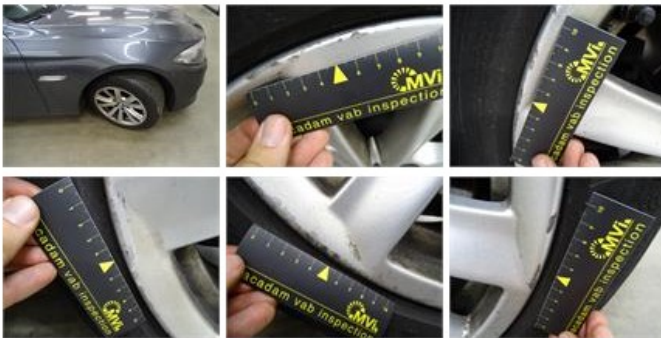
Alloy rim F R, Scratch(es), LI - Repair and paint (complete)

95,00

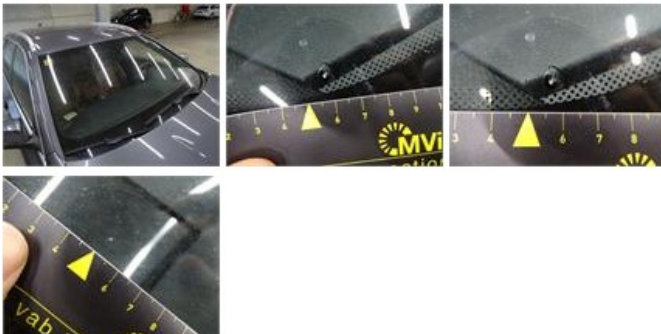
Windscreen, Stone chip(s), Acceptable
