BMW X5: 1HCG148

Limited Technical Inspection

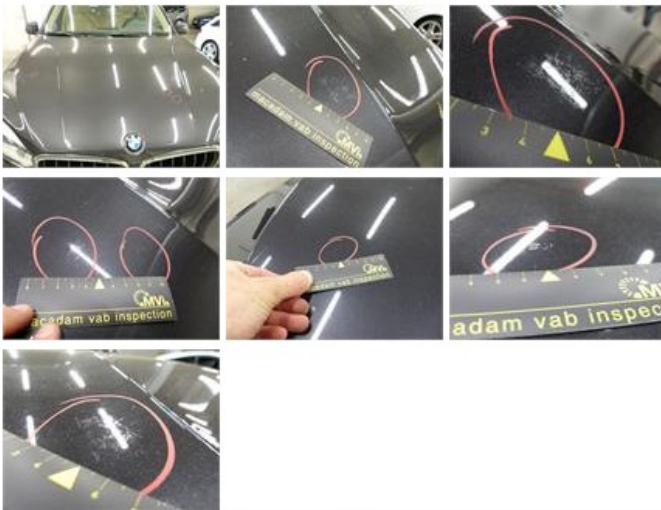
Bonnet, Chemical polution, LI - Repair and paint (complete) 348,09
