**MERCEDES B: 1HAB023**

**Limited Technical Inspection**

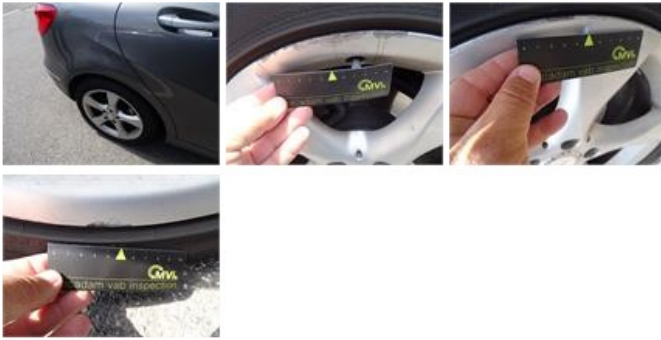
Alloy rim R R, Scratch(es), LI - Repair and paint (complete) 95,00

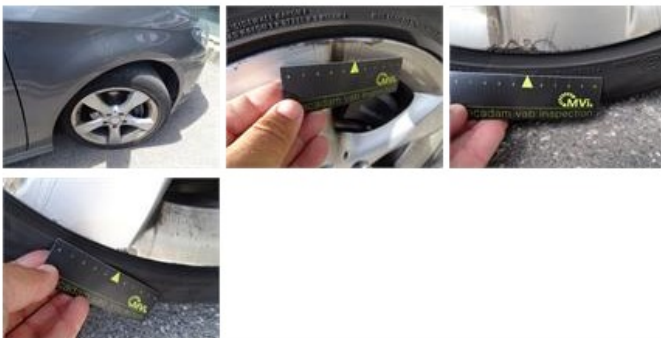
Alloy rim F R, Scratch(es), LI - Repair and paint (complete) 95,00
