**MERCEDES CLA: 1HCS809**

**Limited Technical Inspection**

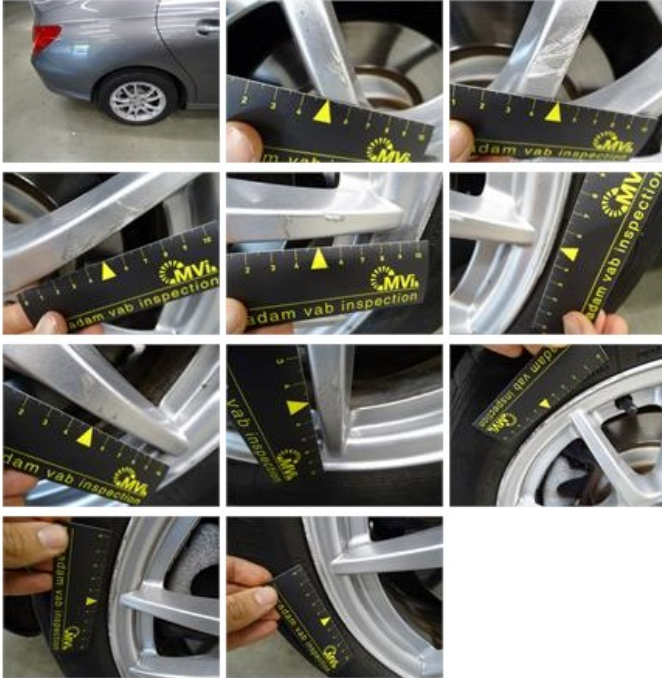
Alloy rim R R, Scratch(es), LI - Repair and paint (complete) 95,00

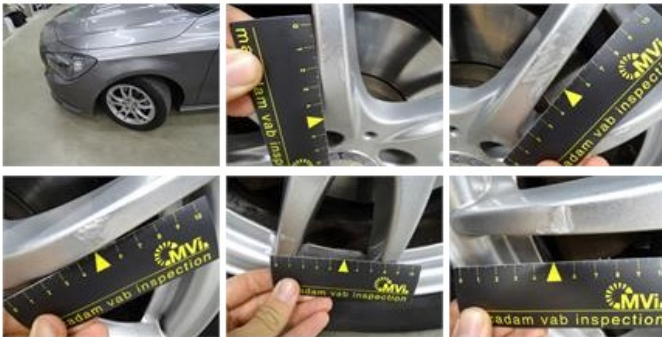
Alloy rim F L, Scratch(es), LI - Repair and paint (complete) 95,00

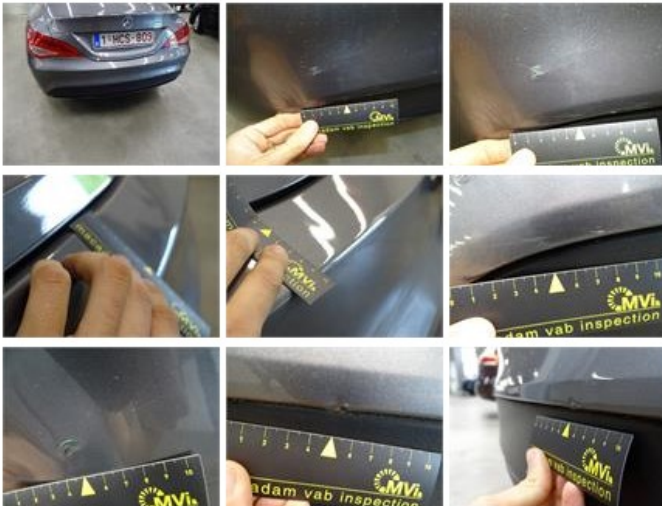
Bumper R, Dent(s) and scratch(es), LI - Repair and paint (complete) 211,80

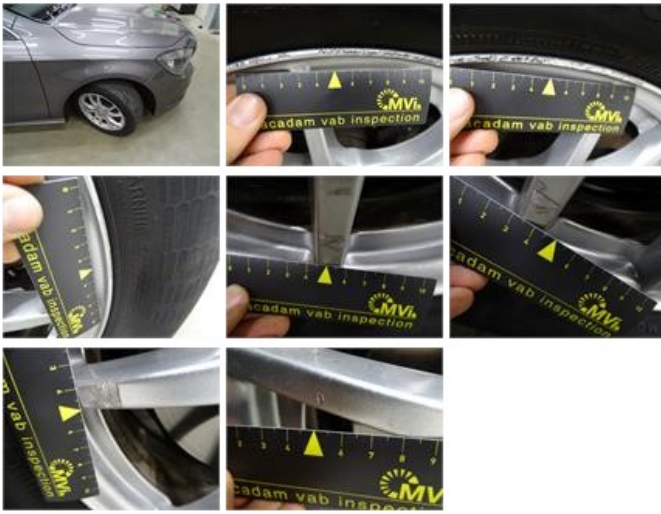
Alloy rim F R, Scratch(es), LI - Repair and paint (complete)

95,00
