**OPEL Insignia: 1HBB728**

**Limited Technical Inspection**

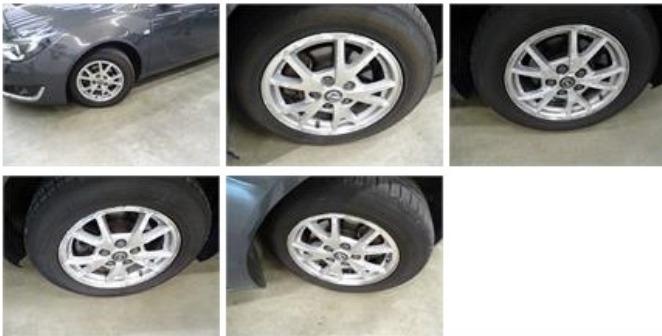
Alloy Rims (all), Rust, Acceptable 0,00

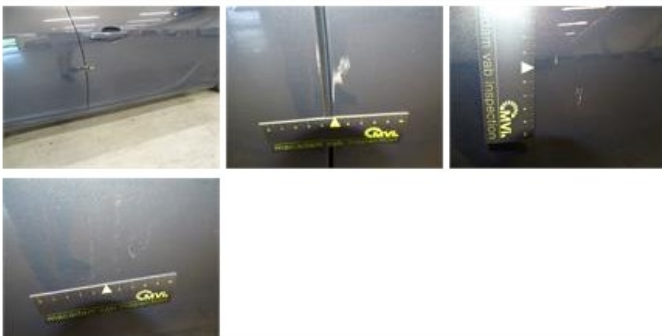
Door F R, Scratch(es), LI - Repair and paint (complete) 318,35

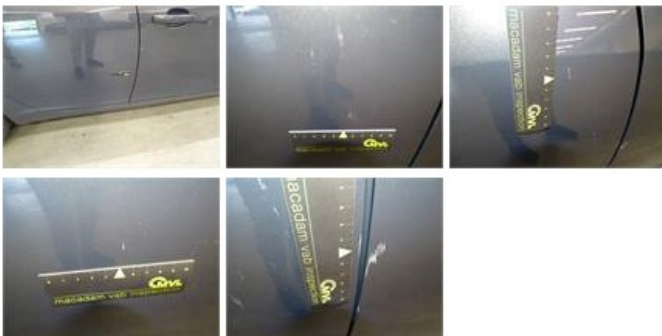
Door R R, Scratch(es), LI - Repair and paint (complete) 318,35
