OPEL Astra: 1GHM382

Limited Technical Inspection

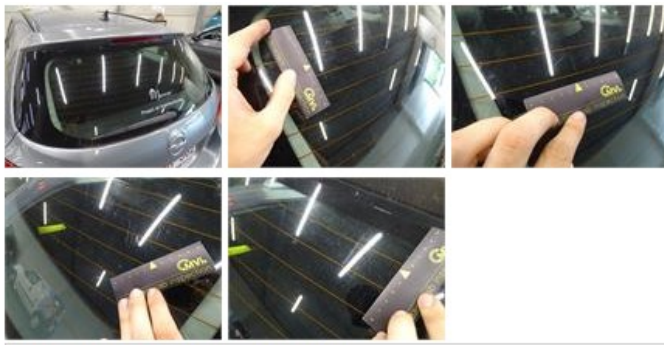
Rear window, Scratch(es), Acceptable 0,00

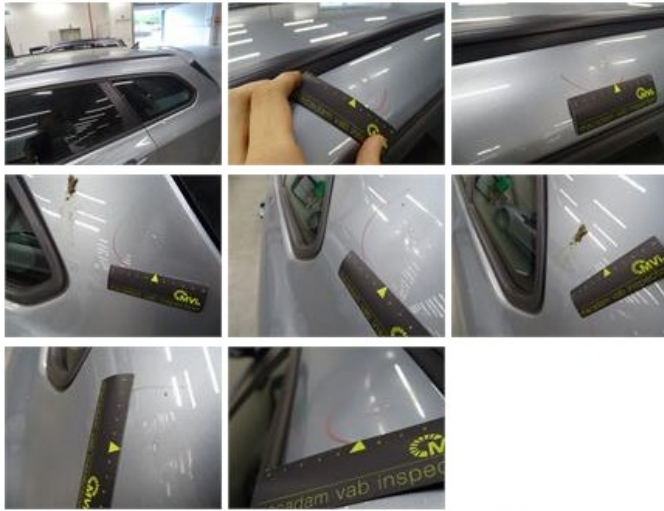
Roof pillar L, Chemical polution, LI - Repair and paint (complete) 220,18

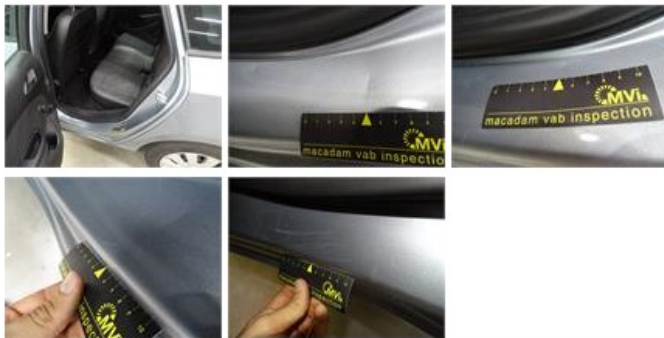
Rocker panel inner R L, Dent(s), LI - Repair and paint (complete) 115,56

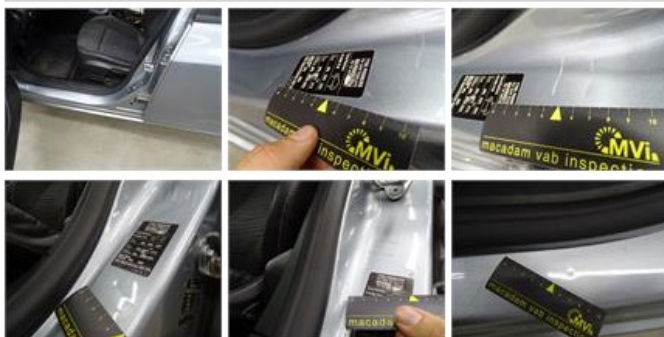
Rocker panel inner F L, Dent(s), LI - Repair and paint (complete) 115,56

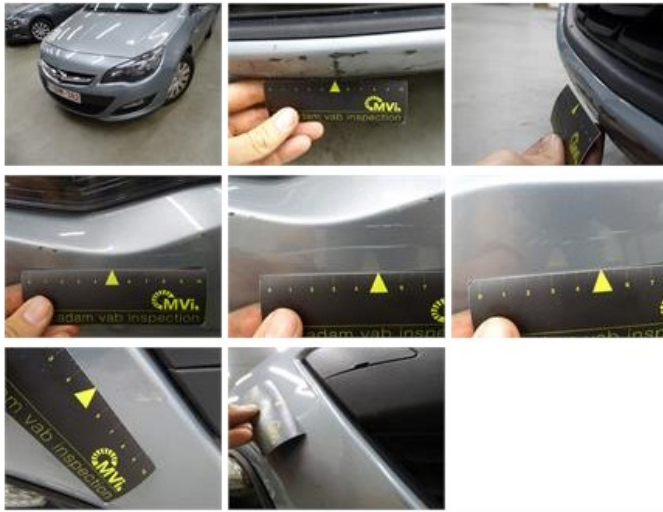
Bumper F, Dent(s) and scratch(es), LI - Repair and paint (complete)

211,80

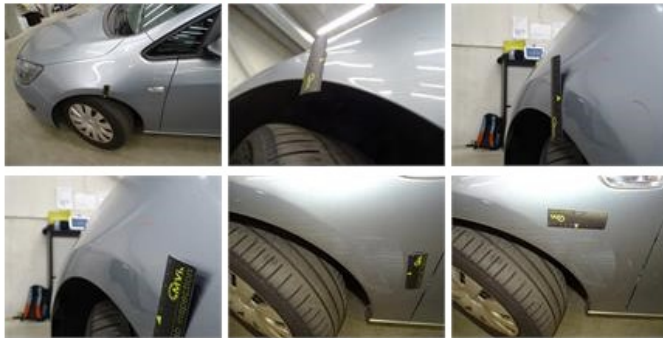
Wing F L, Dent(s) and scratch(es), LI - Repair and paint (complete)

220,18

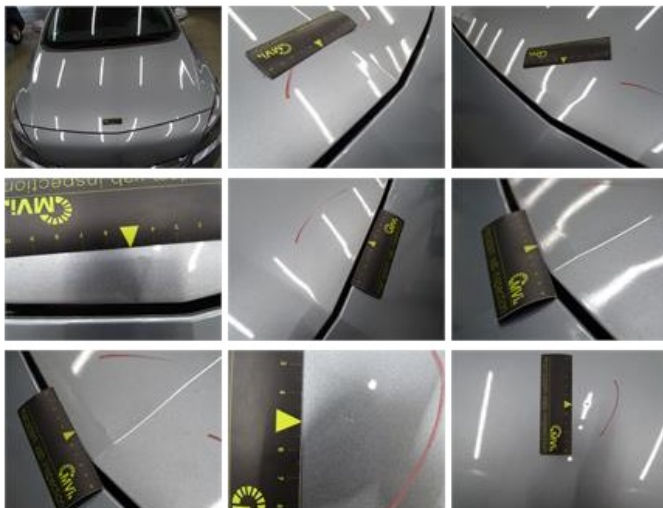
Bonnet, Dent(s) and scratch(es), LI - Repair and paint (complete)

290,08

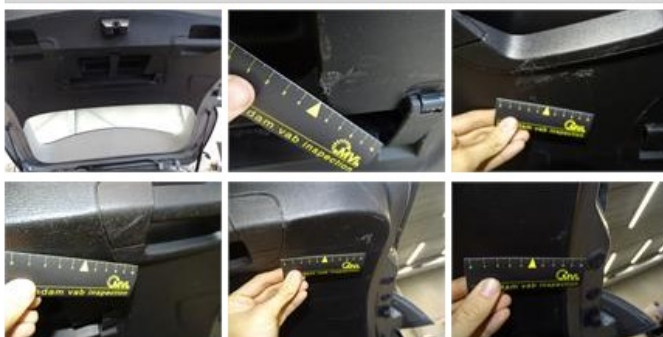
Trunk lid covering R, Scratch(es), Smart repair

110,64

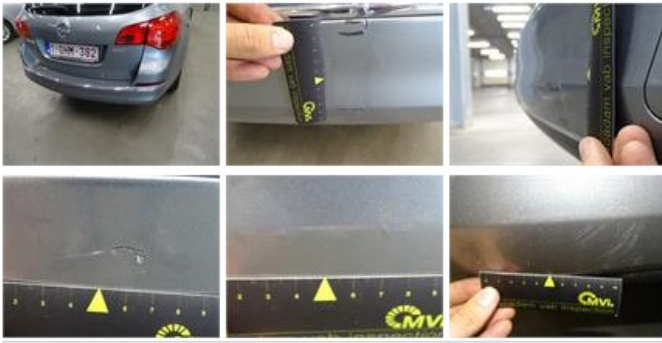
Bumper R, Dent(s) and scratch(es), LI - Repair and paint (complete)

211,80

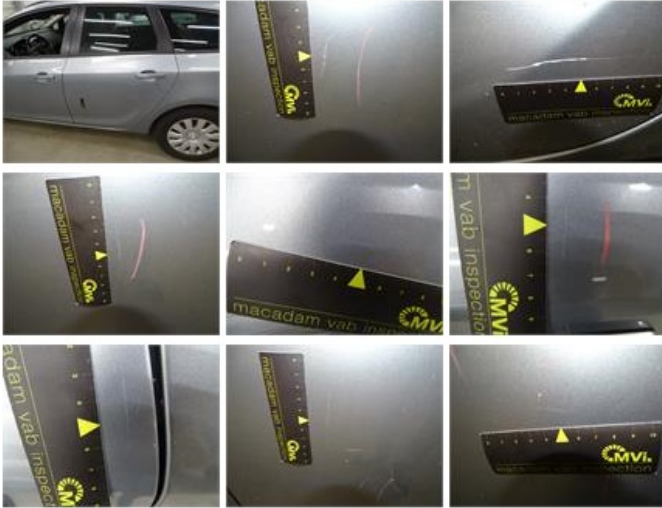
Door R L, Scratch(es), LI - Repair and paint (complete)
