AUDI A5: 1ECZ010			
Vinnumber:	WAUZZZ8T1DA032971	Versionname:	A5 SB TDie DPF 136PK
First Registrationdate:	24/10/2012	Fiscalpower:	
Expertise Mileage:	201480	Power Kw:	100
Bodytype:		Body color:	Dark Blue
Gearbox:	MAN 6 VIT	Paint type:	Metalic
Transmission:		Rims summer:	Aluminium
Fueltype:	Diesel	Oil level:	OK
Battery functioning:	Yes	Parking lot:	2729
Number of doors:	5		
Number of seats:	5		
Number head rests:	5		
Rims summer:	Aluminium		
Category:	Passenger Car		
Oil level:	OK

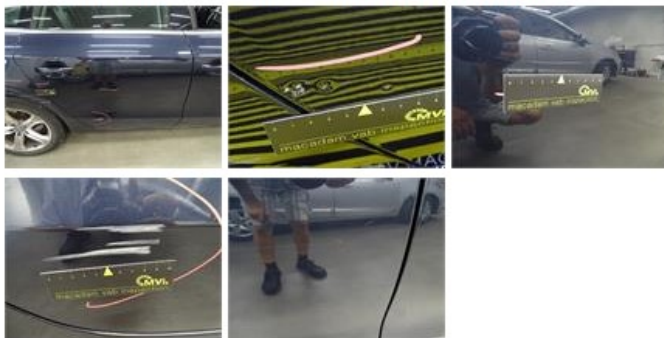
Door R R, Dent(s) and scratch(es), LI - Repair and paint (complete)

382,02

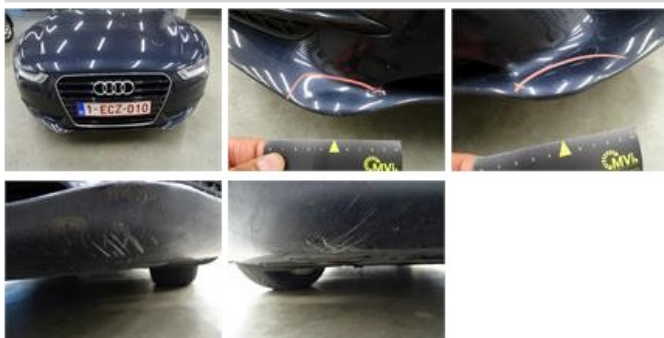
Bumper F, Dent(s) and scratch(es), LI - Repair and paint (complete)

254,16

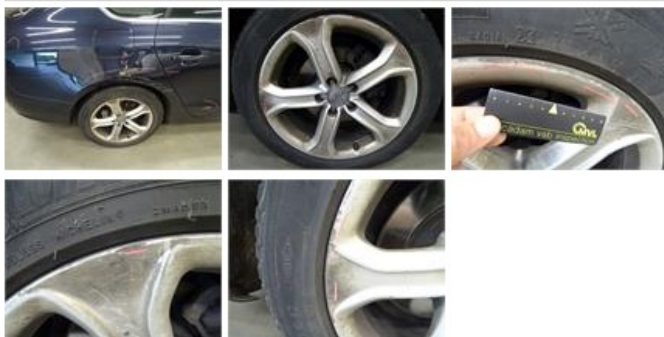
Alloy rim R R, Scratch(es), LI - Repair and paint (complete)

95,00

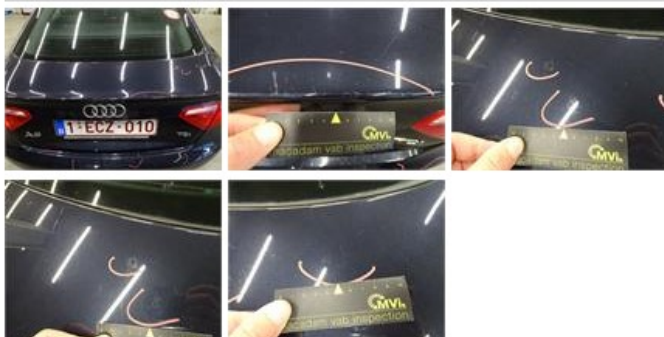
Tailgate, Scratch(es), LI - Repair and paint (complete)

362,02

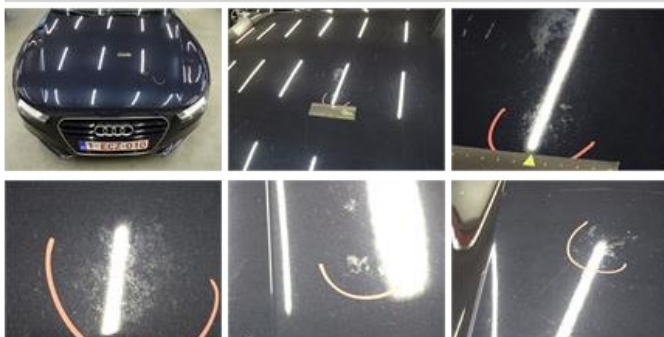
Bonnet, Chemical pollution, LI - Repair and paint (complete)

348,09

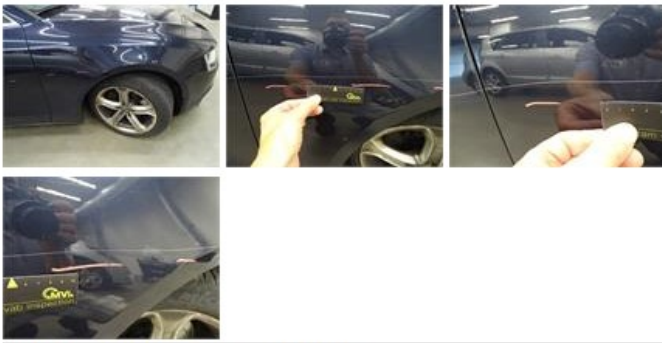
Wing F R, Scratch(es), LI - Repair and paint (complete)

264,21

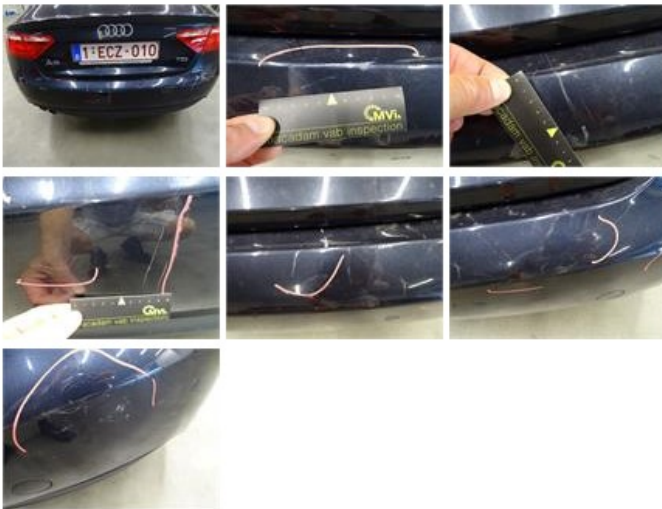
Bumper R, Scratch(es), LI - Repair and paint (complete)

254,16

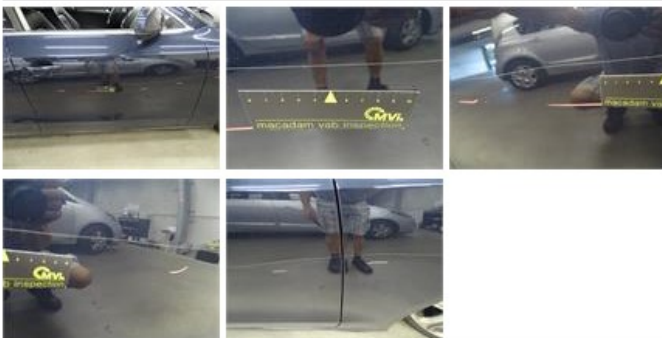
Door F R, Scratch(es), LI - Repair and paint (complete)

382,02
