**BMW 1: 1GTU763**

**Limited Technical Inspection**

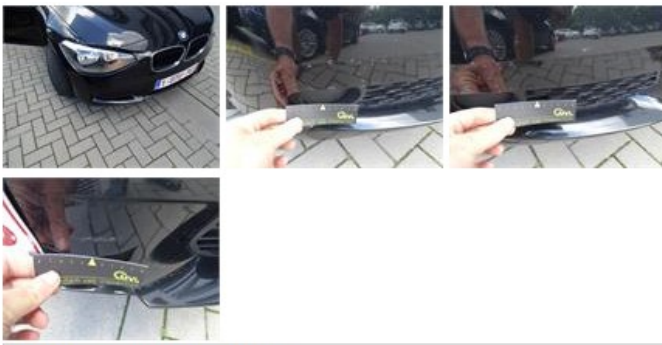
Total cost ex VAT	<b>1636,06</b>
Bumper F, Scratch(es), LI - Repair and paint (complete)	<b>211,80</b>

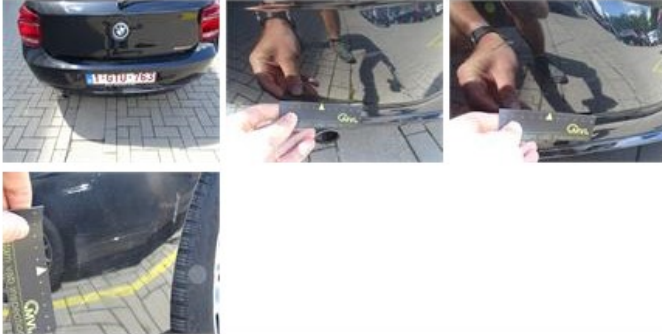
Bumper R, Scratch(es), LI - Repair and paint (complete) 211,80

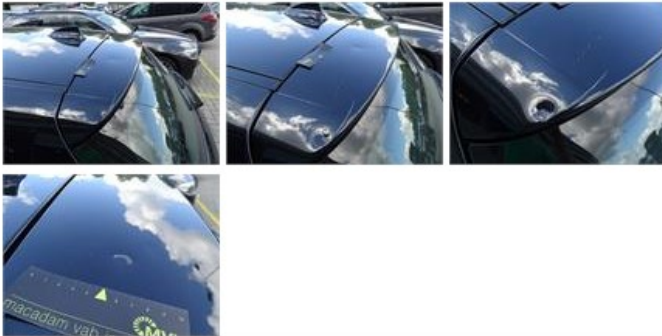
Rear spoiler, Dent(s) and scratch(es), LI - Repair and paint (complete) 115,56
