BMW 3 BERLINE: 1JUF470

| Vinnumber: | WBA3J31050F813905 | Versionname: | 2.0 318D (105KW) XDRIVE 4WD BERLINE |

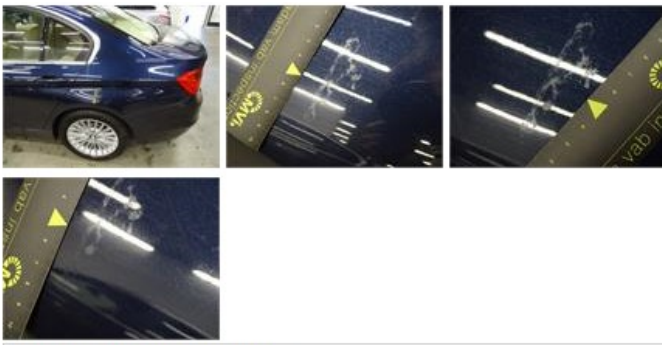
| Wing R L, Chemical polution, LI - Repair and paint (complete) | 308,20 |

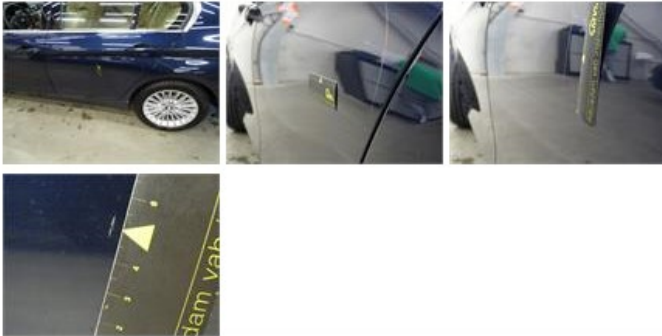
| Door R L, Bad repair, Acceptable | 0,00 |

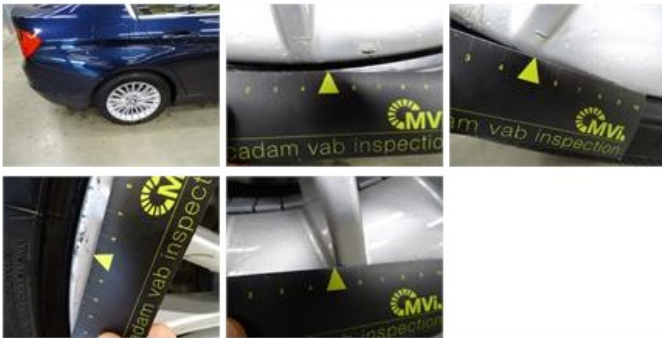
| Alloy rim R R, Scratch(es), LI - Repair and paint (complete) | 95,00 |

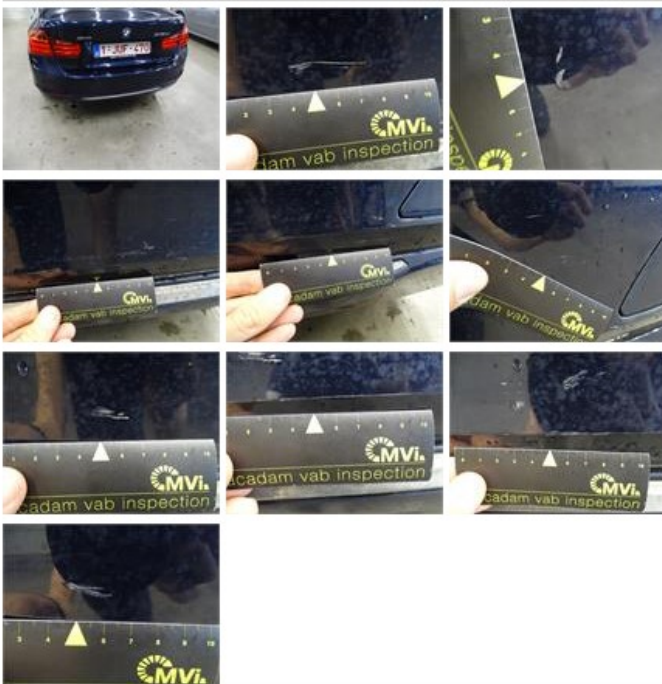
| Bumper R, Scratch(es), LI - Repair and paint (complete) | 211,80 |

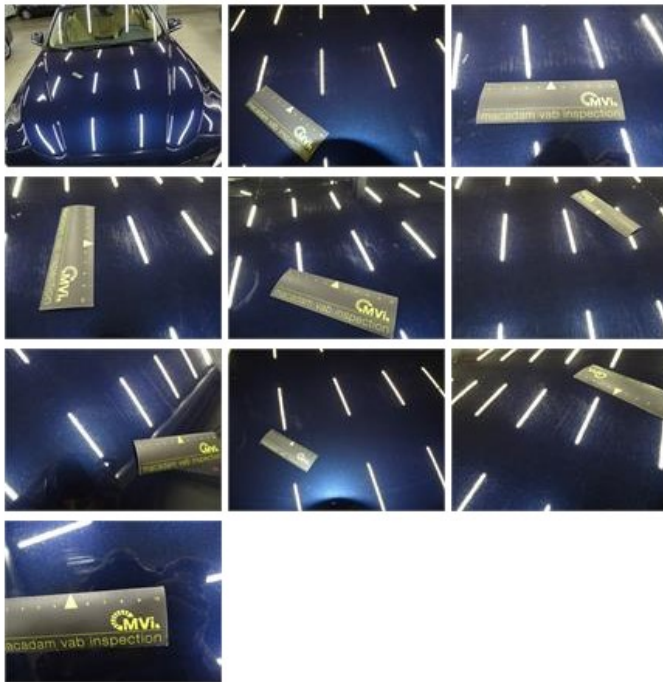
| Bonnet, Scratch(es), LI - Repair and paint (complete) | 290,08 |

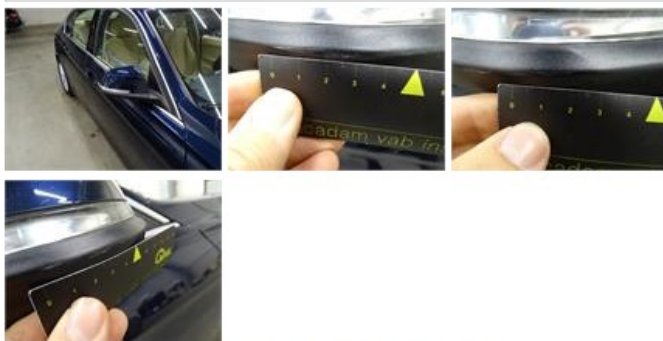
| Rearview mirror basis R, Scratch(es), Smart repair | 110,64 |

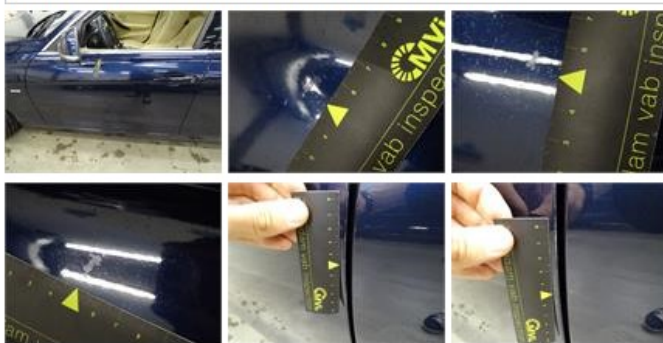
| Door F L, Chemical polution, LI - Repair and paint (complete) | 318,35 |

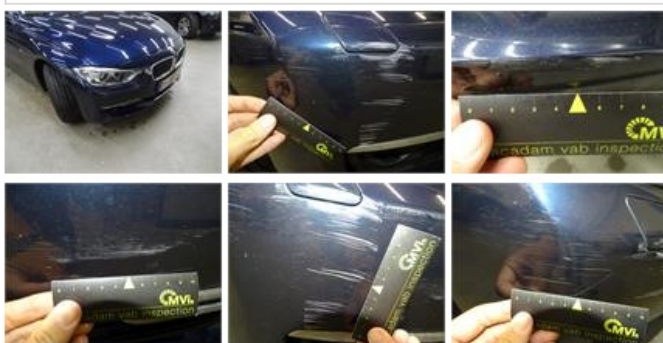
| Bumper F, Scratch(es), LI - Repair and paint (complete) | 211,80 |

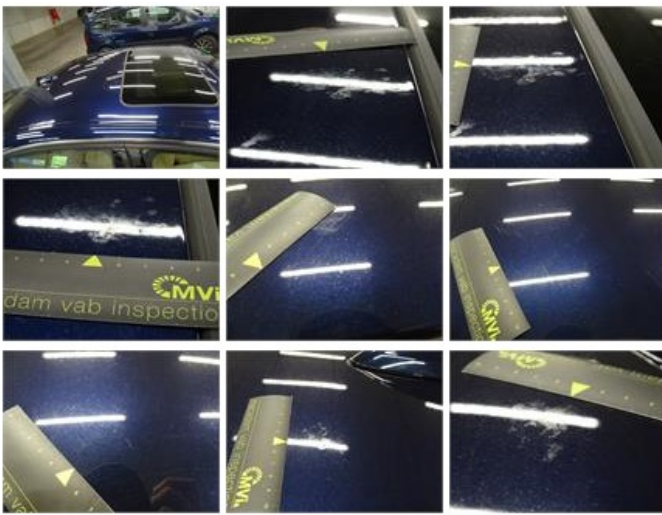
| Roof, Chemical polution, LI - Repair and paint (complete) | 481,50 |

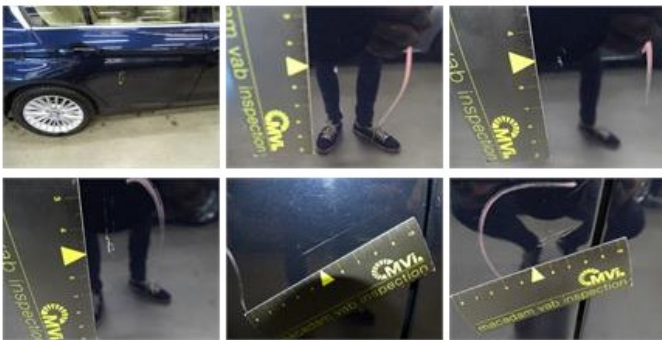
Door R R, Scratch(es), LI - Repair and paint (complete) 318,35

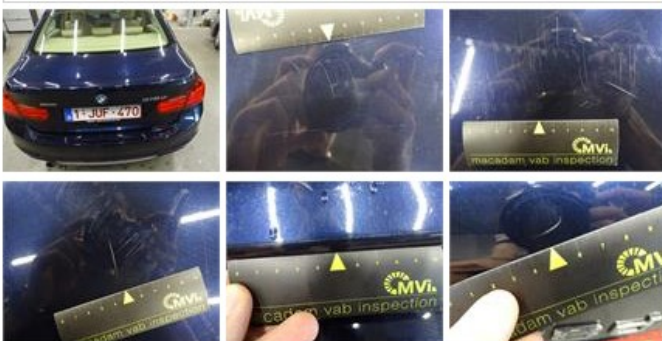
Tailgate, Scratch(es), LI - Repair and paint (complete) 301,68

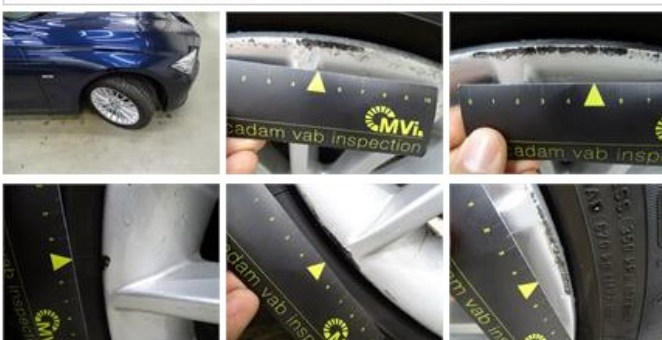
Alloy rim F R, Scratch(es), LI - Repair and paint (complete) 95,00
