BMW 2 ACTIVE TOURER: 1KRD787

Limited Technical Inspection

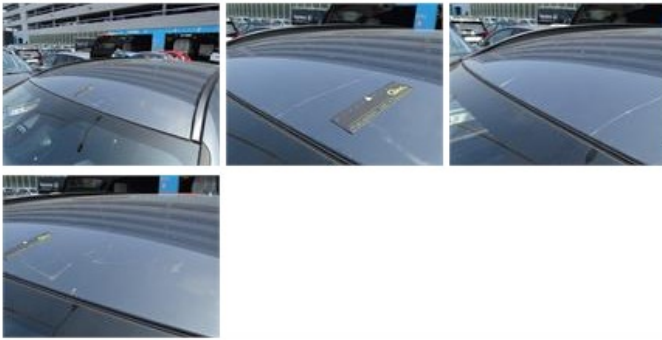
Roof, Scratch(es), LI - Repair and paint (complete) 0,00

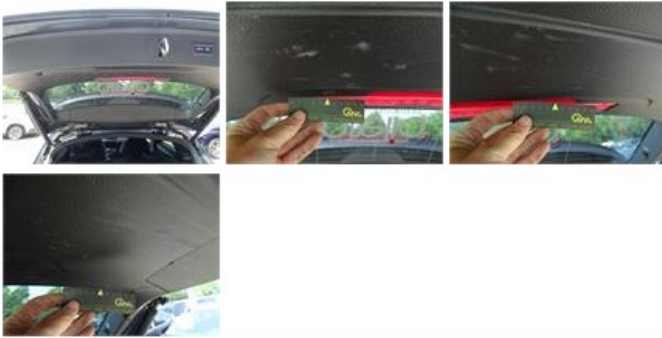
Trunk lid covering R, Scratch(es), E - Replace 200,00
