BMW 1 HATCH: 1KPH427

| Vinnumber: | WBA1V910005815919 | Versionname: | 1.5 116D EFFICIENTDYNAMICS EDIT. (85KW) |

Limited Technical Inspection

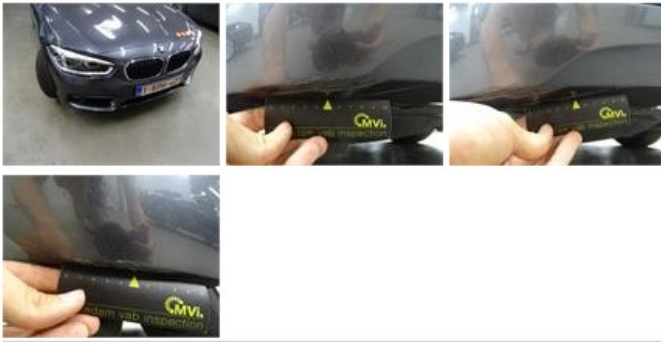
Bumper F, Scratch(es), LI - Repair and paint (complete)

211,80

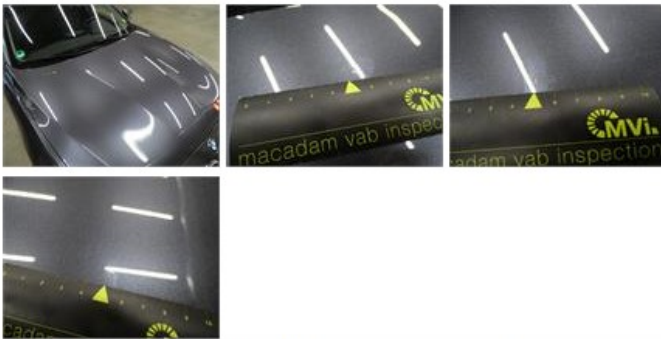
Bonnet, Bad repair, Acceptable

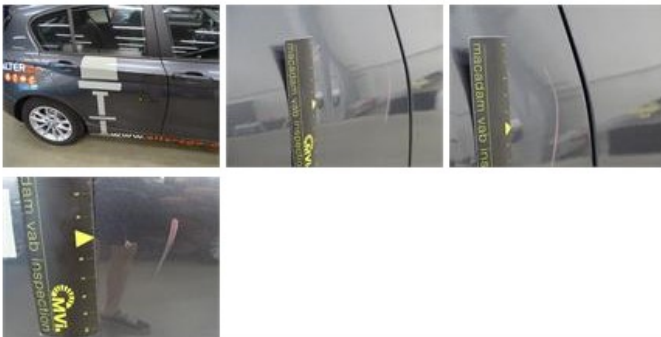
Door R R, Dent(s) and scratch(es), LI - Repair and paint (complete)

318,35

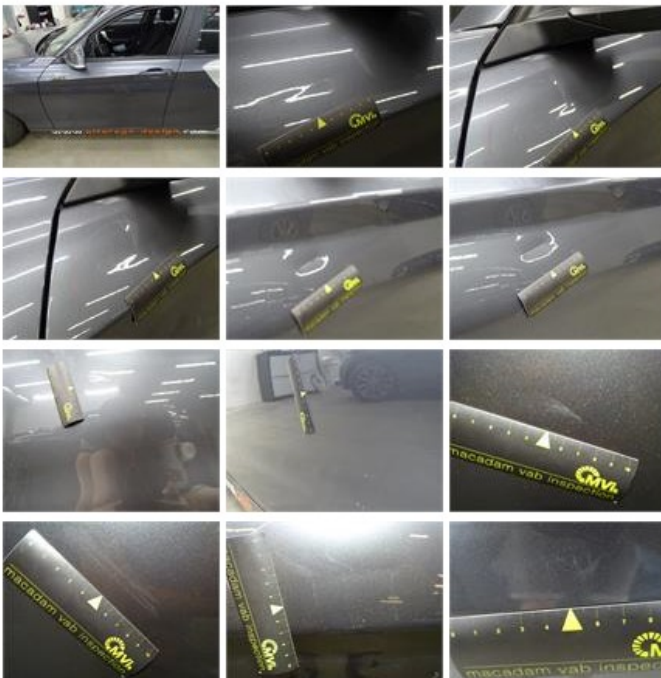
Door F L, Dent(s) and scratch(es), LI - Repair and paint (complete)

318,35

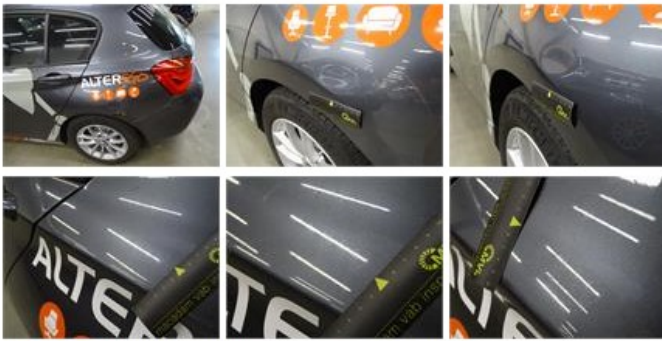
Wing R L, Dent(s), PDR - Paintless dent repair

63,00

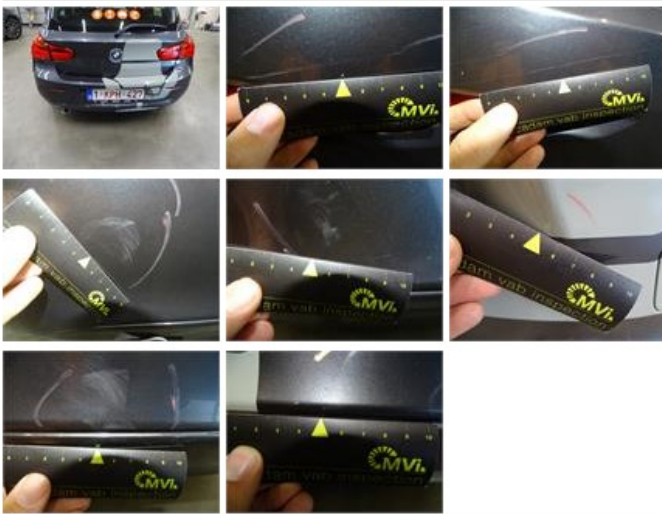
Bumper R, Scratch(es), LI - Repair and paint (partial)

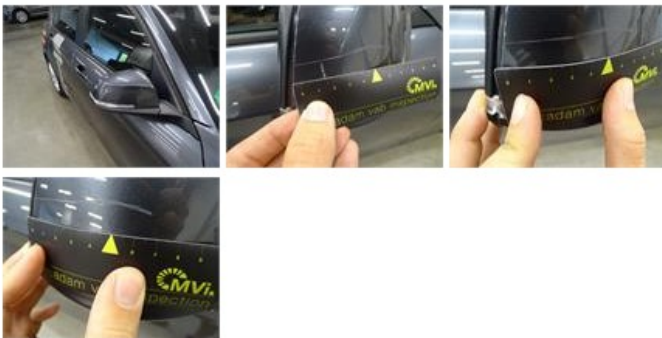
Rearview mirror housing R, Scratch(es), LI - Repair and paint (complete)

115,56
