BMW 1: 1HCS824

Limited Technical Inspection

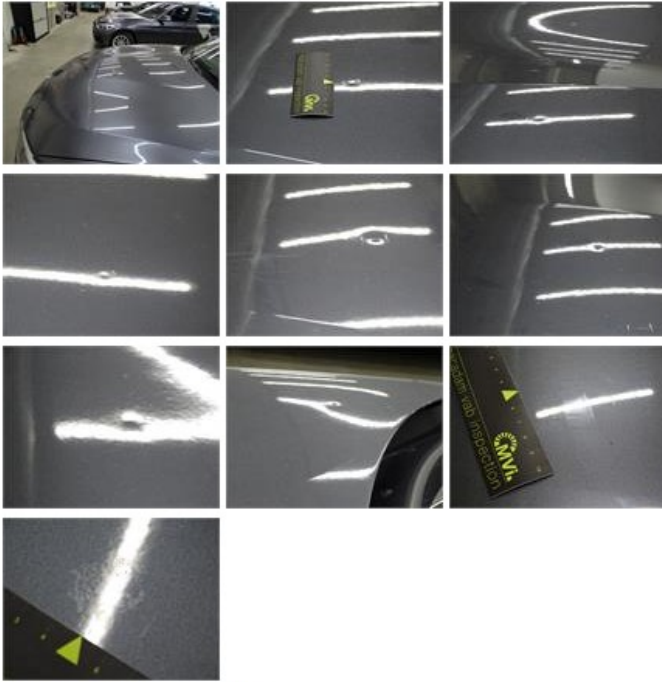
Bonnet, Hail damage, PDR - Hail 0,00

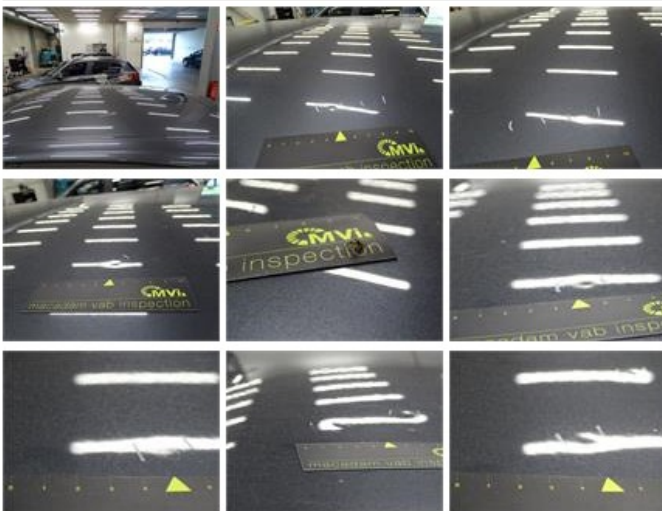
Roof, Hail damage, LI - Repair and paint (complete) 0,00
