BMW 5: 1HYP423			
Vinnumber:	WBA5E31010D786548	Versionname:	5 BER 518dA 136PK Aut.
First Registrationdate:	30/10/2014	Fiscalpower:	
Expertise Mileage:	159952	Power Kw:	100
Bodytype:	Berline	Body color:	Black
Gearbox:	Automatic	Paint type:	Metalic
Transmission:	Back	Rims summer:	Aluminium
Fueltype:	Diesel	Oil level:	OK
Battery functioning:	Yes	Parking lot:	3116
Number of doors:	4		
Number of seats:	5		
Number head rests:	5		
Rims summer:	Aluminium		
Category:	Passenger Car		
Oil level:	OK		
Registration Certificate Car (BE):	Yes

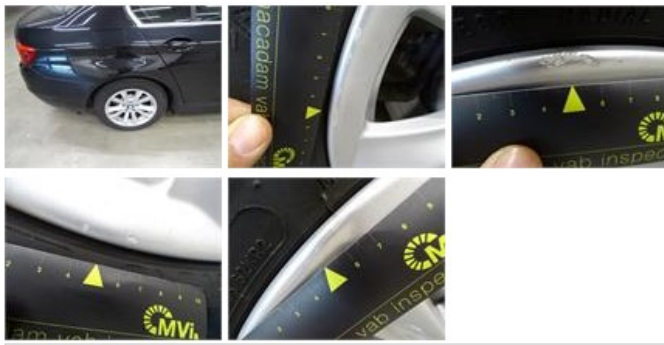
Total cost ex VAT	856,32
Alloy rim R R, Scratch(es), LI - Repair and paint (complete)	95,00

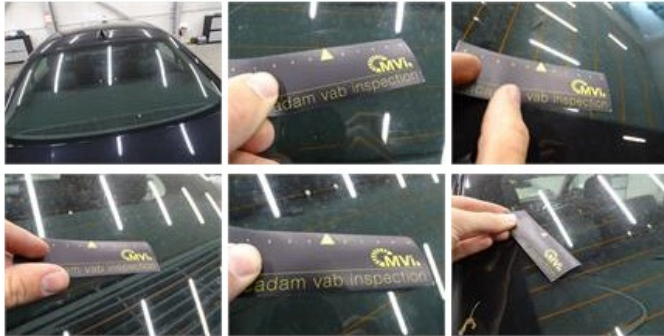
Rear window, Scratch(es), Acceptable 0,00

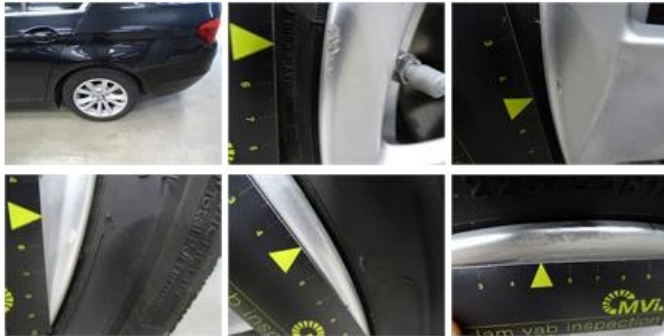
Alloy rim R L, Scratch(es), LI - Repair and paint (complete) 95,00

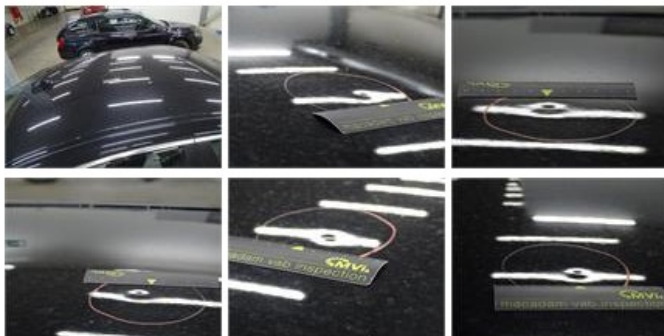
Roof, Dent(s), PDR - Paintless dent repair 63,00

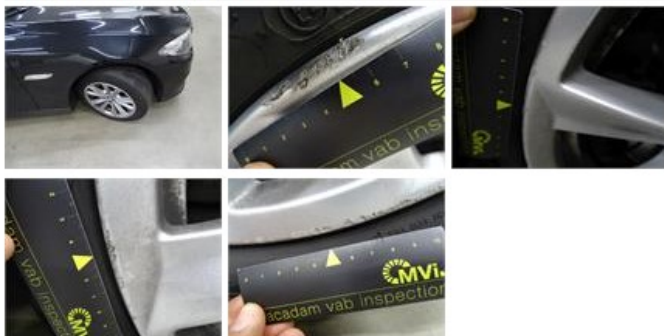
Alloy rim F R, Scratch(es), LI - Repair and paint (complete) 95,00

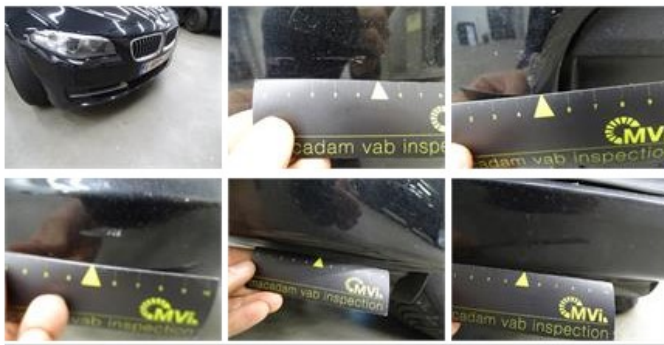
Bumper F, Scratch(es), LI - Repair and paint (complete) 254,16

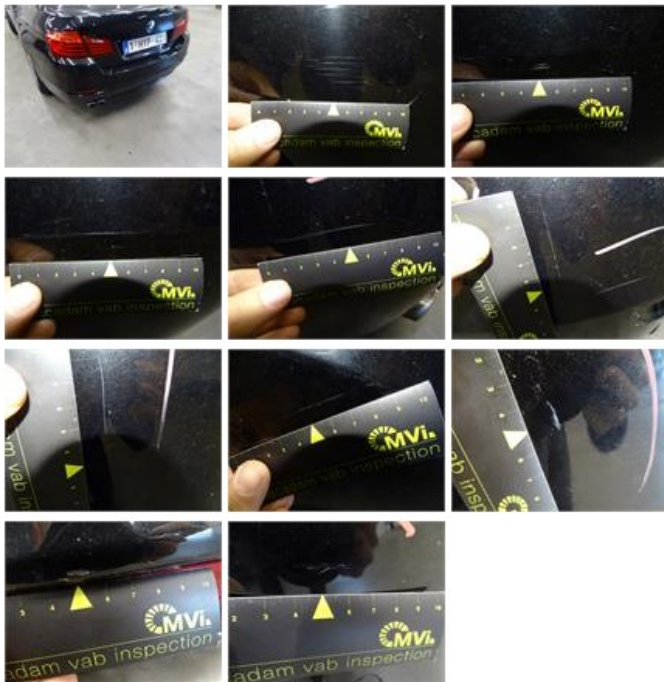
Bumper R, Scratch(es), LI - Repair and paint (complete) 254,16
