BMW 3: 1GMA634

Limited Technical Inspection

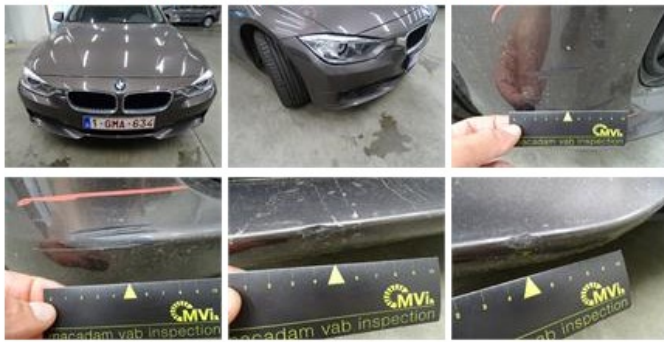
Bumper F, Dent(s) and scratch(es), LI - Repair and paint (complete)

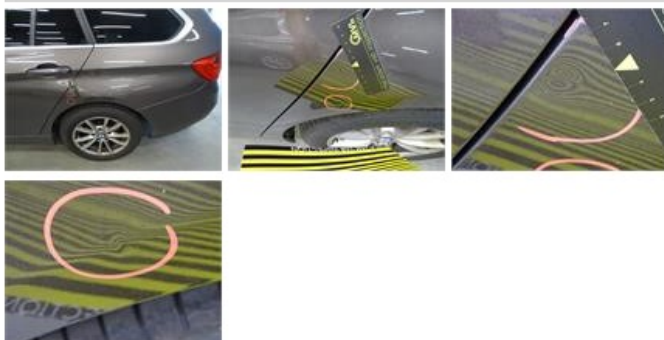
Wing R L, Dent(s), PDR - Paintless dent repair

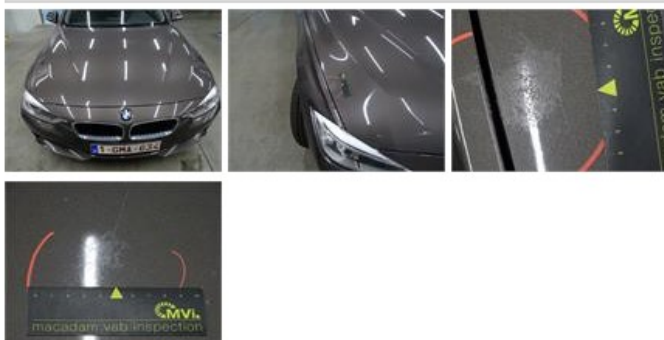
Bonnet, Chemical polution, LI - Repair and paint (complete)
