BMW 3 GT: 1DKQ805

Limited Technical Inspection

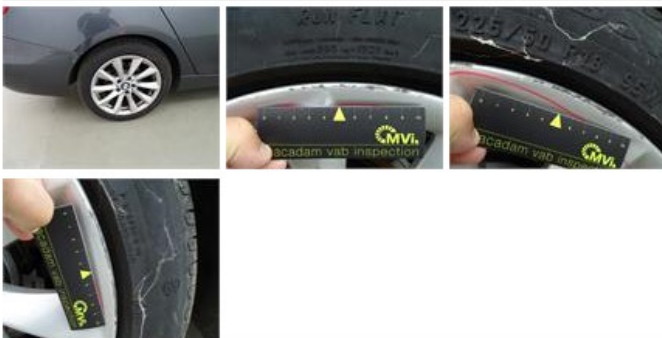
Alloy rim R R, Scratch(es), LI - Repair and paint (complete) 95,00

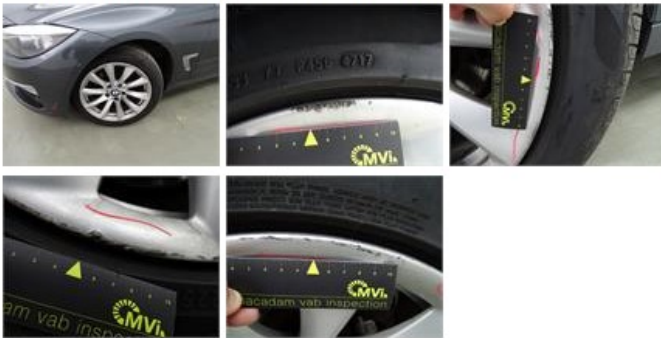
Alloy rim F L, Scratch(es), LI - Repair and paint (complete)

95,00

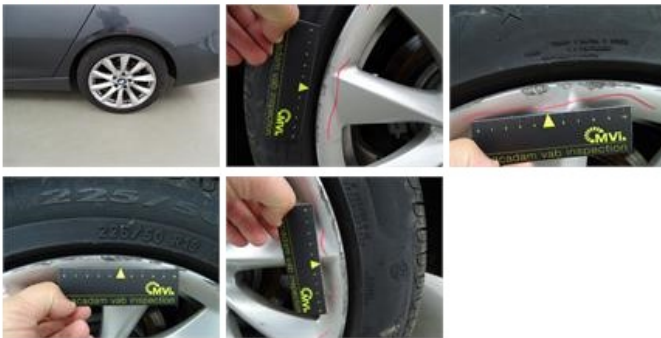
Alloy rim R L, Scratch(es), LI - Repair and paint (complete)

95,00
