BMW 3 TOURING: 1JJN569

Limited Technical Inspection

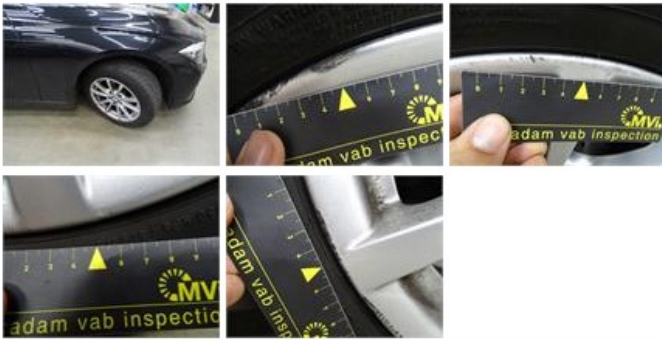
Alloy rim F R, Scratch(es), LI - Repair and paint (complete) 95,00

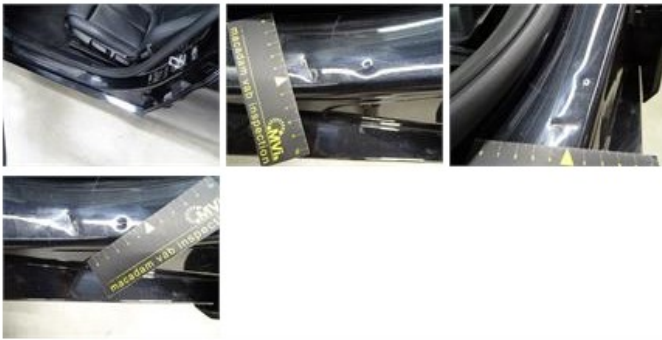
Rocker panel inner F L, Dent(s), LI - Repair and paint (complete) 115,56

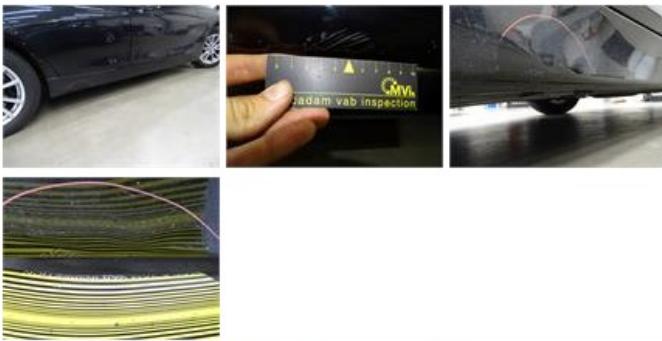
Sill outer R, Dent(s) and scratch(es), LI - Repair and paint (complete) 310,50

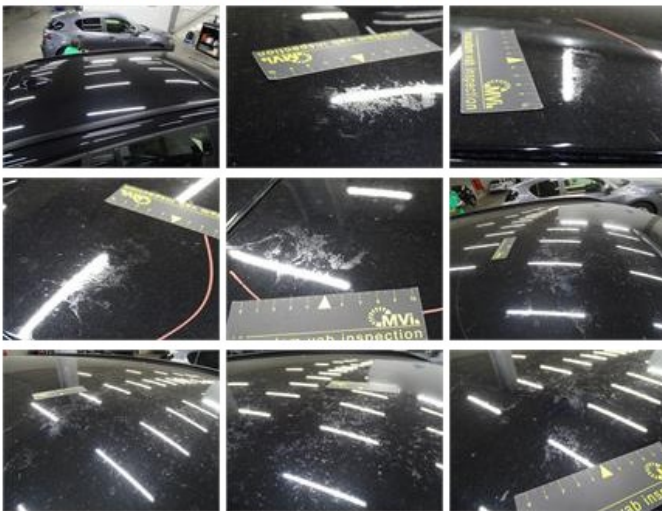
Roof, Chemical polution, LI - Repair and paint (complete) 481,50

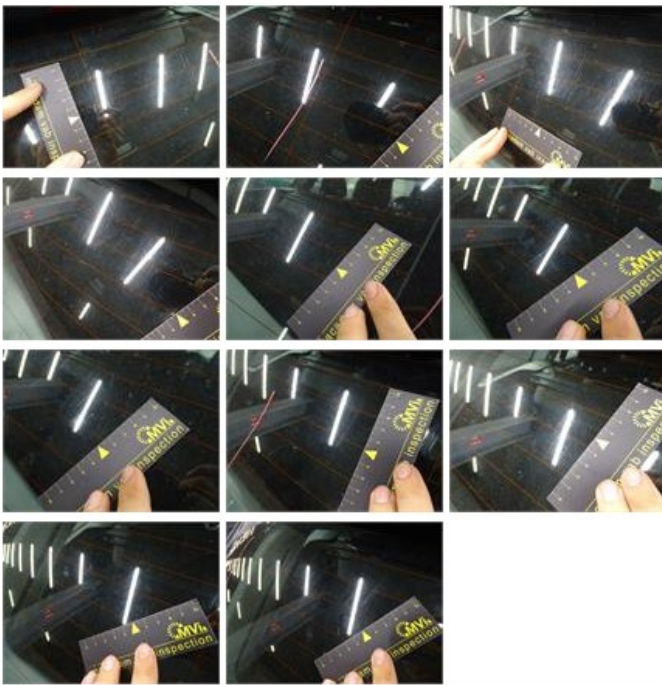
Rear window, Scratch(es), E - Replace 370,00

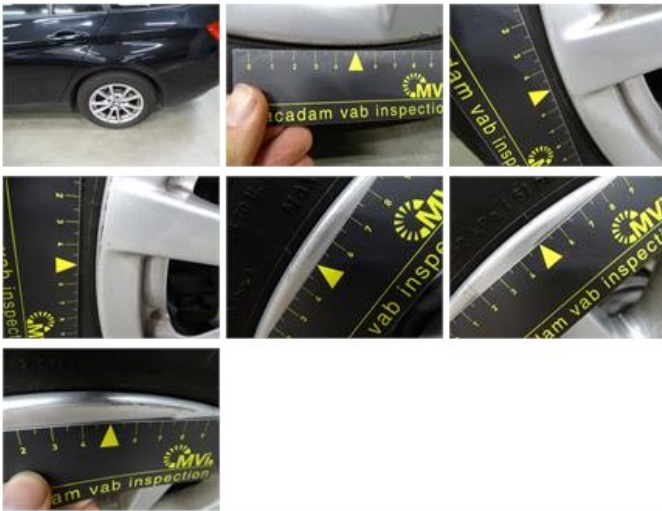
Alloy rim R L, Scratch(es), LI - Repair and paint (complete)

95,00

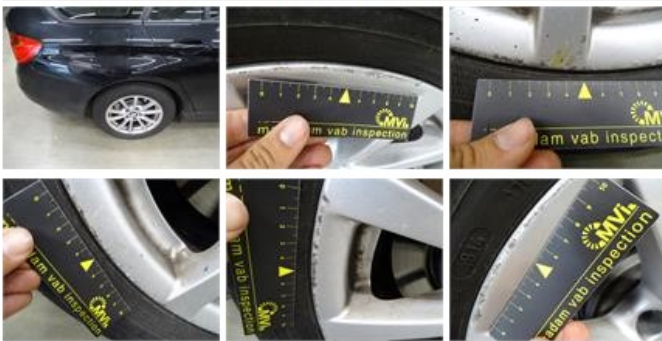
Alloy rim R R, Scratch(es), LI - Repair and paint (complete)

95,00

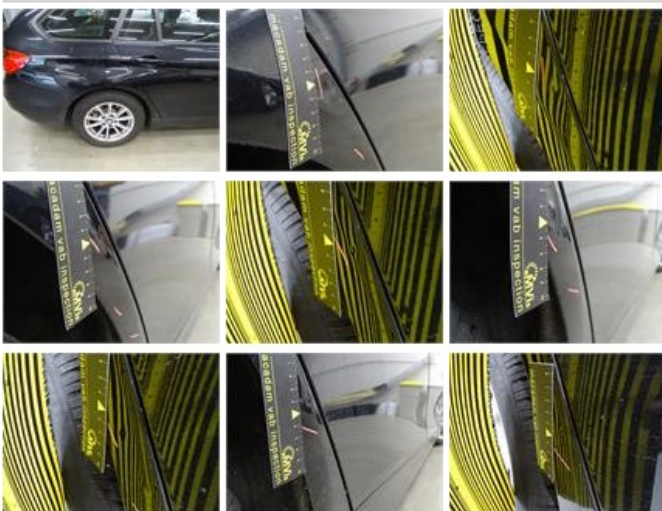
Wing R R, Dent(s), PDR - Paintless dent repair

122,40

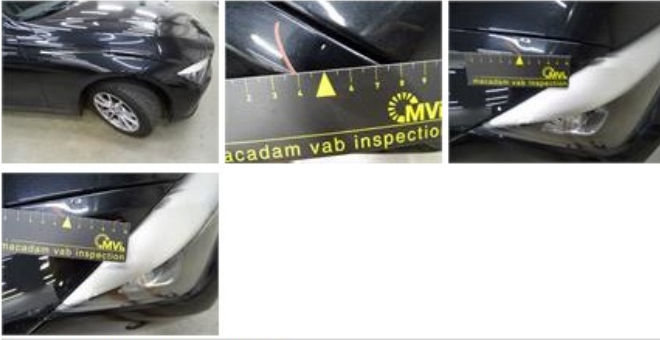
Wing F R, Dent(s) and scratch(es), LI - Repair and paint (complete) 220,18

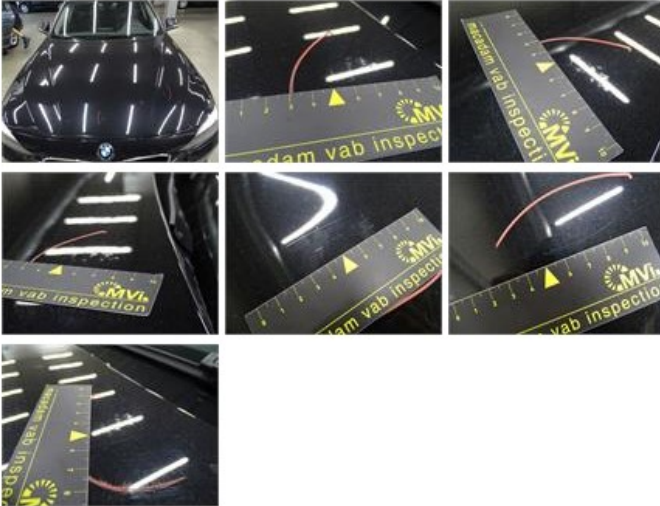
Bonnet, Chemical polution, LI - Repair and paint (complete) 290,08
