BMW 3: 1HAG032

Limited Technical Inspection

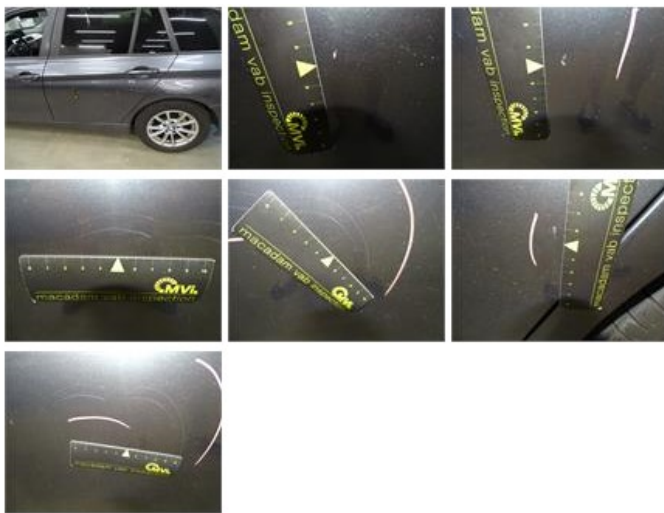
Total cost ex VAT	1405,15
Door R L, Scratch(es), LI - Repair and paint (complete)	318,35

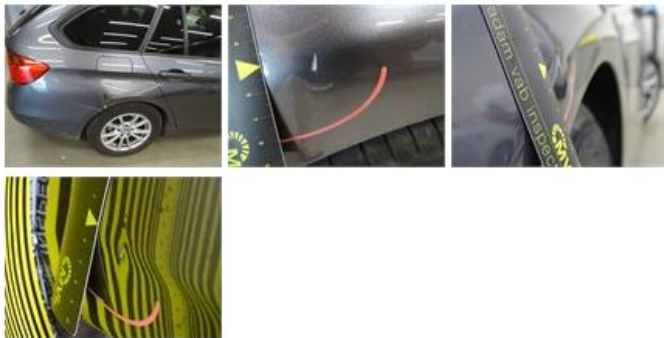
Wing R R, Dent(s) and scratch(es), LI - Repair and paint (complete)

308,20

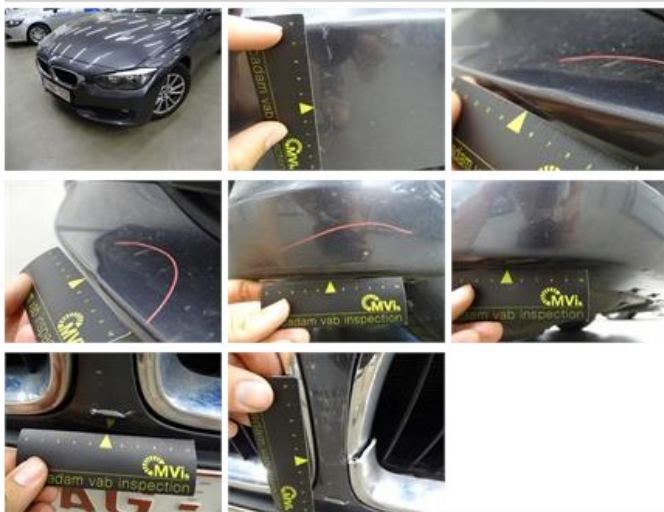
Bumper F, Dent(s) and scratch(es), LI - Repair and paint (complete)

211,80

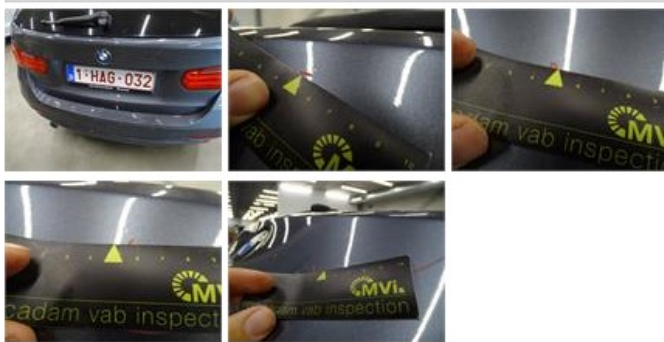
Tailgate, Bad repair, Acceptable

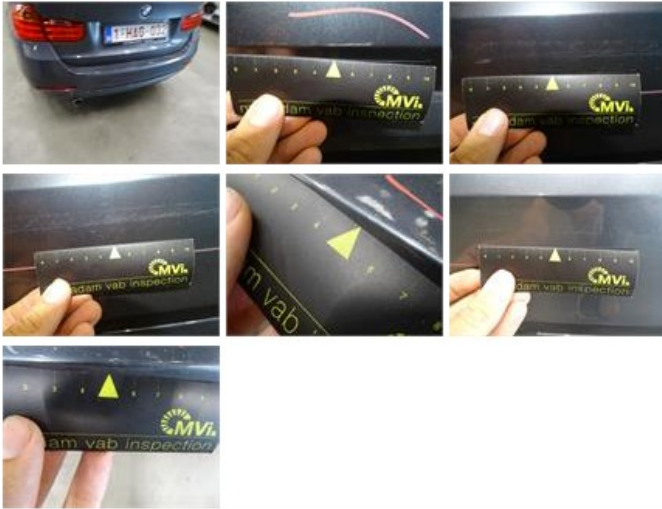
Bumper R, Scratch(es), LI - Repair and paint (complete) 211,80

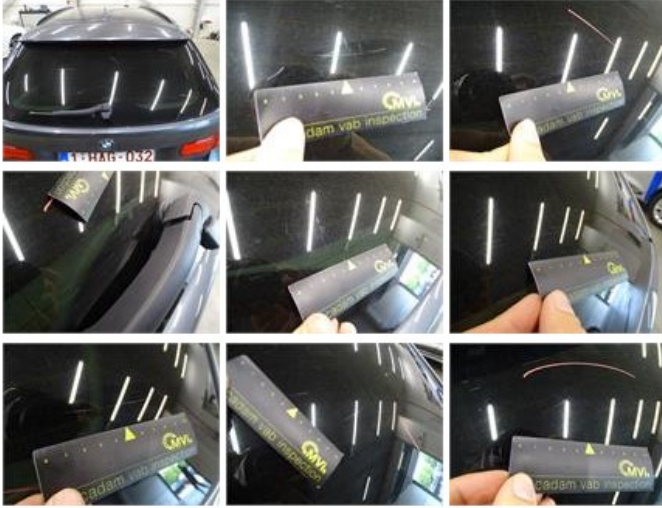
Rear window, Scratch(es), Acceptable 0,00
