**OPEL Insignia: 1HDP247**

**Limited Technical Inspection**

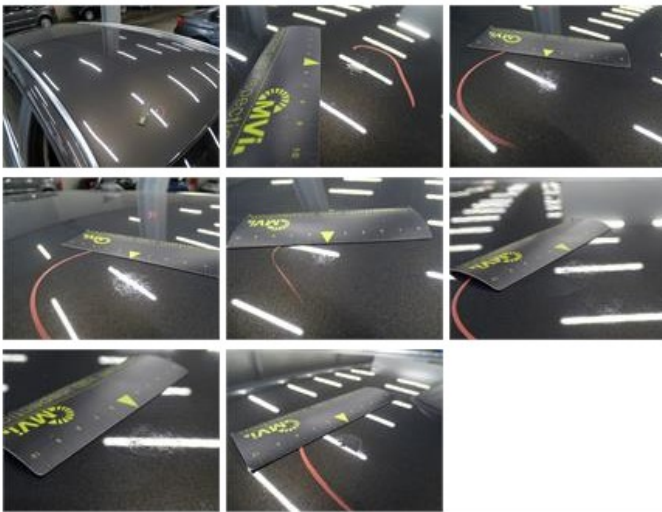
Roof. Chemical polution. LI - Repair and paint (complete)	481,50
---	--------

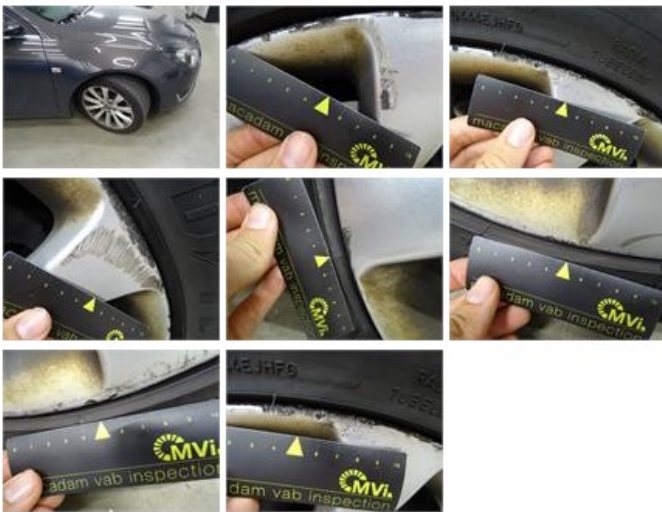
Alloy rim F R, Scratch(es), LI - Repair and paint (complete)

95,00

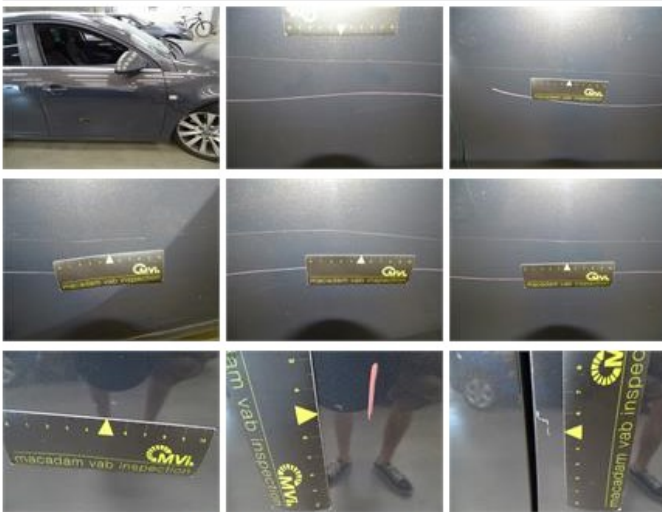
Door F R, Scratch(es), LI - Repair and paint (complete)

318,35

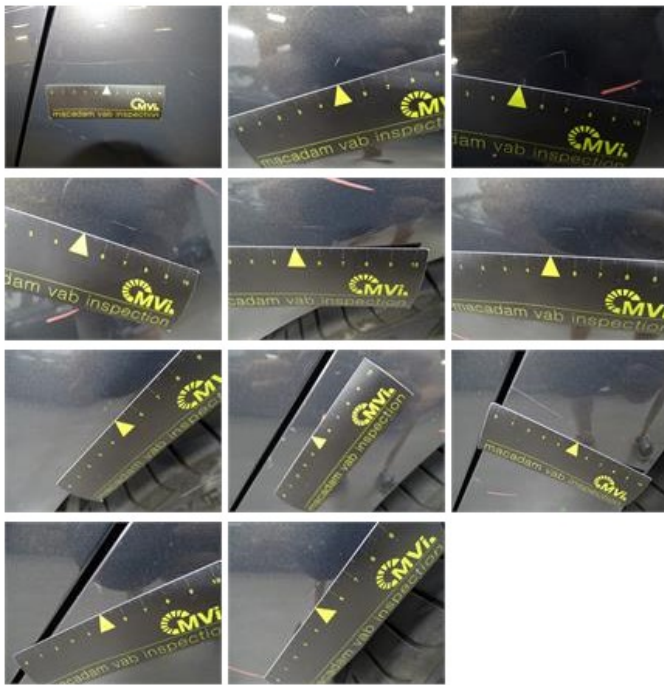
Wing R L, Scratch(es), LI - Repair and paint (complete)

308,20

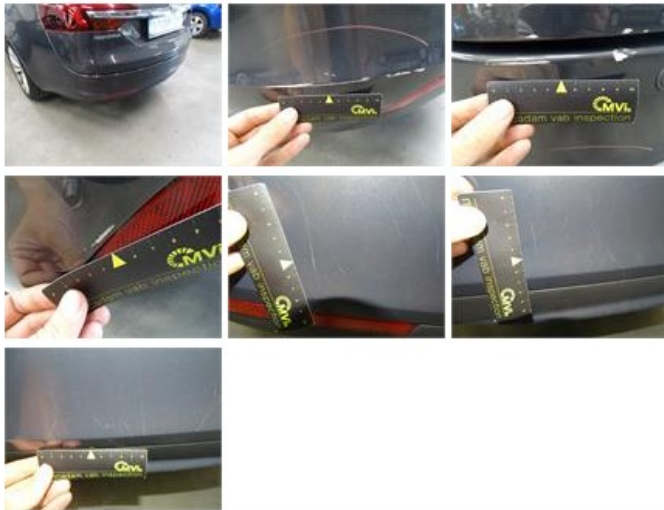
Bumper R, Scratch(es), LI - Repair and paint (complete) 211,80

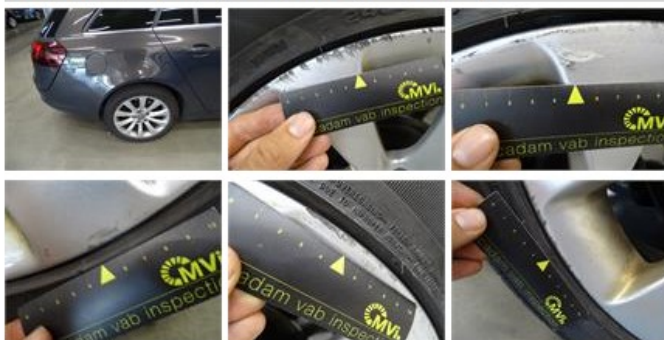
Alloy rim R R, Scratch(es), LI - Repair and paint (complete) 95,00

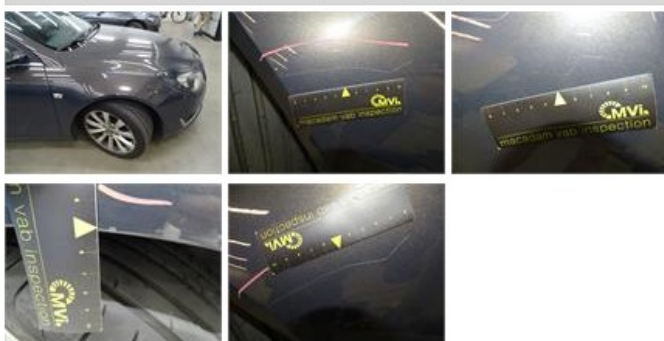
Wing F R, Scratch(es), LI - Repair and paint (complete) 220,18

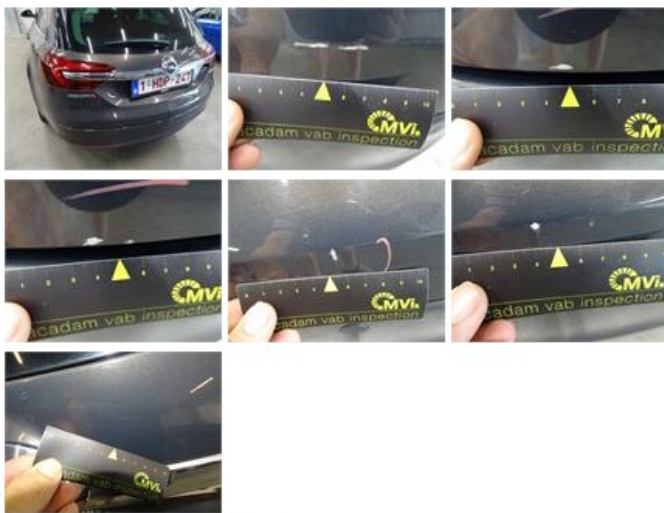
Tailgate, Scratch(es), LI - Repair and paint (complete) 301,68

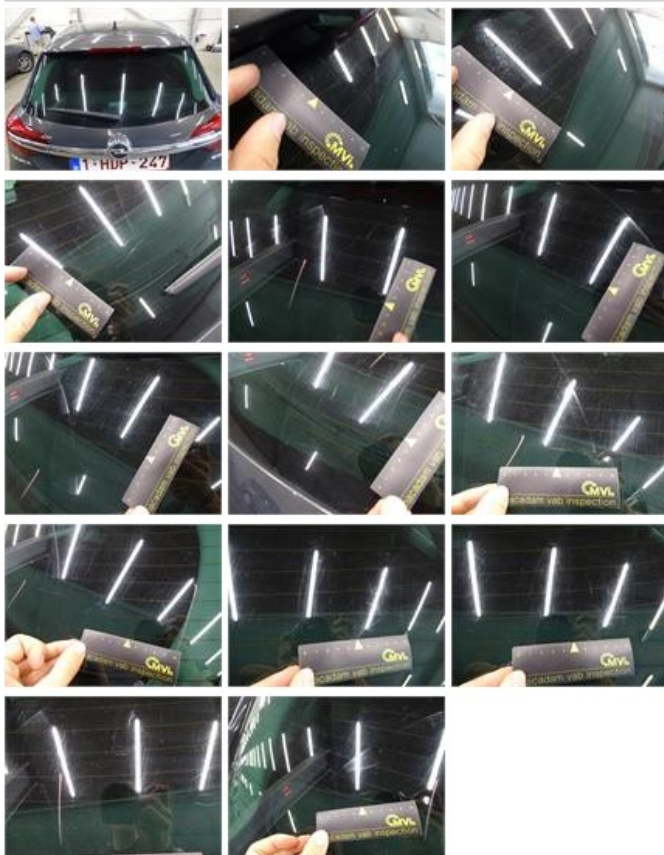
Rear window, Scratch(es), Acceptable
