VOLVO V40: 1FWY132

Limited Technical Inspection

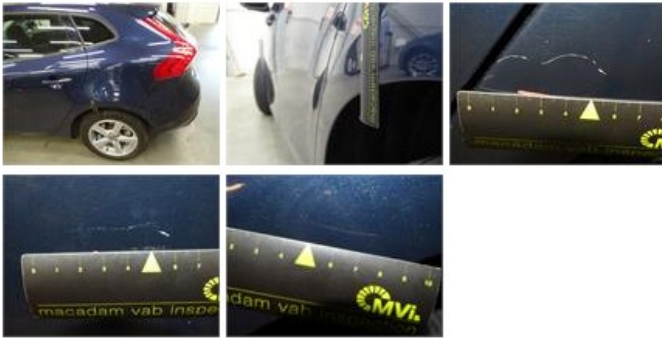
Wing R L, Dent(s) and scratch(es), LI - Repair and paint (complete) 308,20

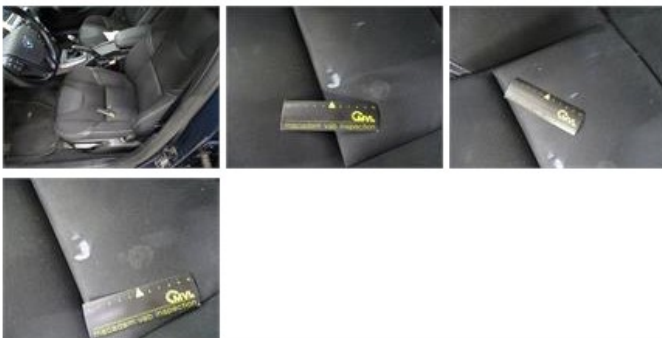
Seat cover F L, Stain, Cleaning 25,00

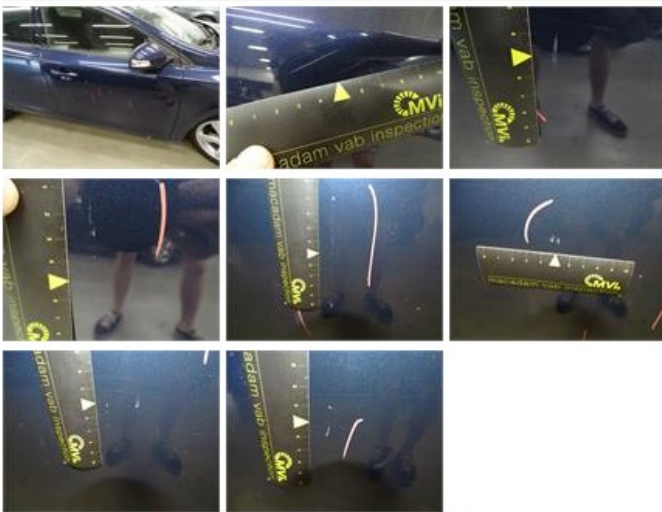
Door F R, Scratch(es), LI - Repair and paint (complete) 318,35

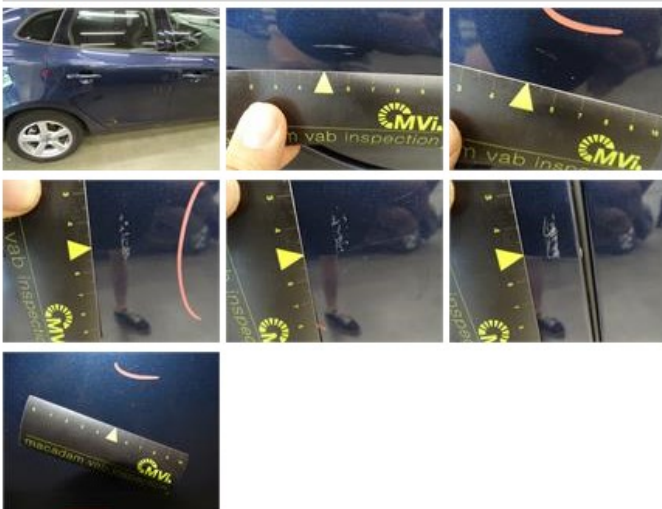
Door R R, Scratch(es), LI - Repair and paint (complete) 318,35

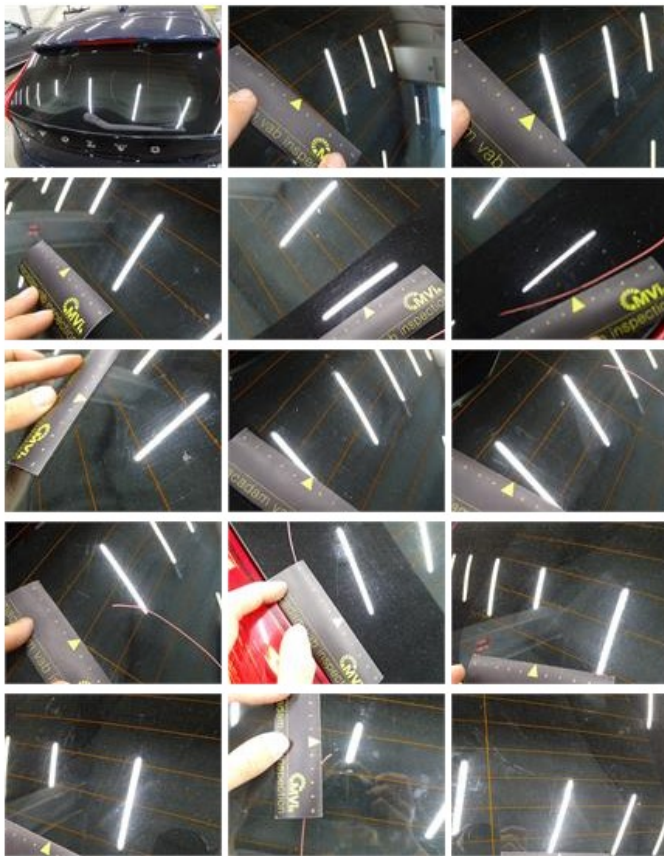
Rear window, Scratch(es), E - Replace 370,00

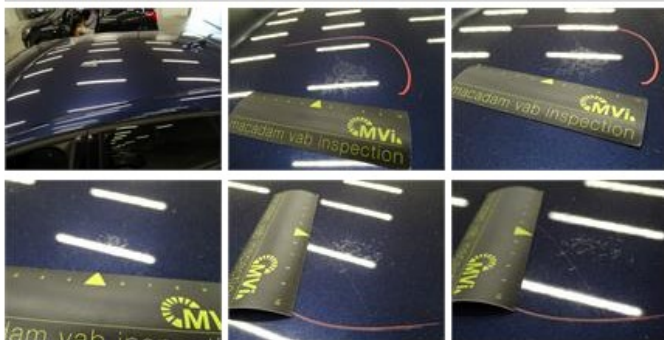
Roof, Chemical polution, LI - Repair and paint (complete)

481,50

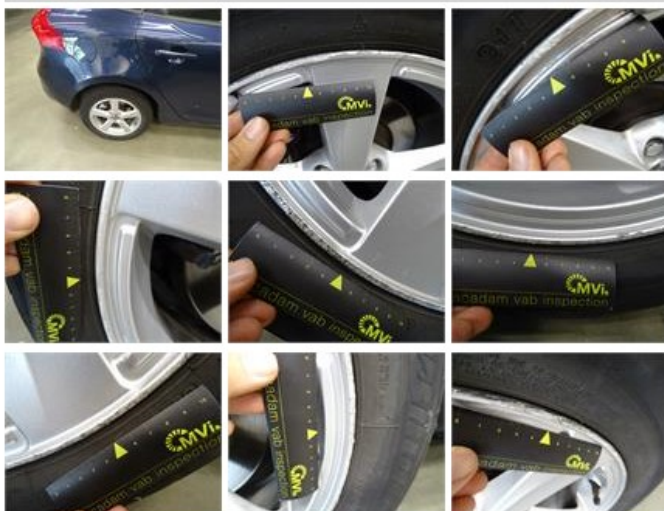
Alloy rim R R, Scratch(es), LI - Repair and paint (complete)

95,00

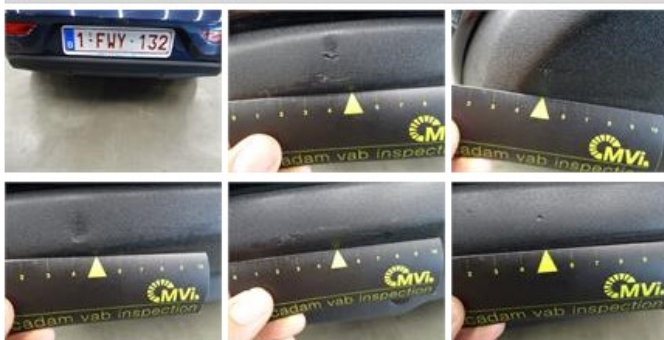
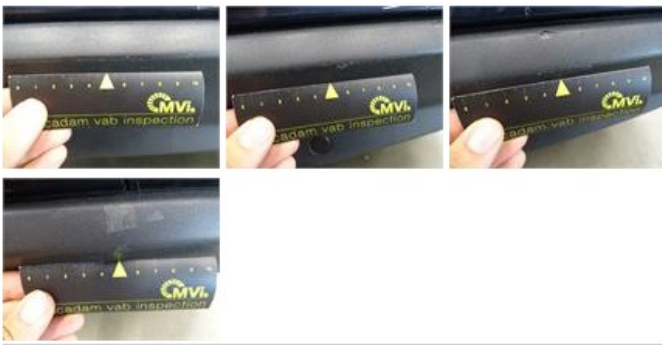
Bumper cover R M, Scratch(es), Smart repair

110,64

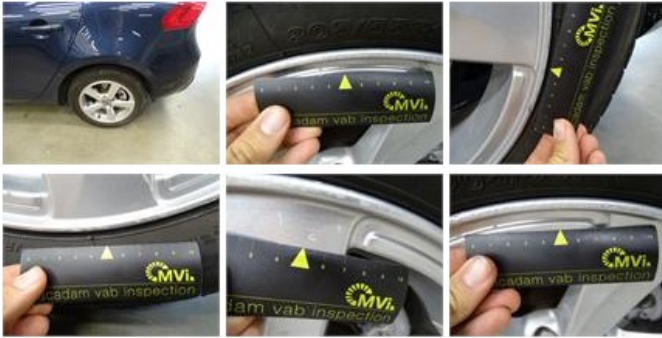
Alloy rim R L, Scratch(es), LI - Repair and paint (complete) 95,00

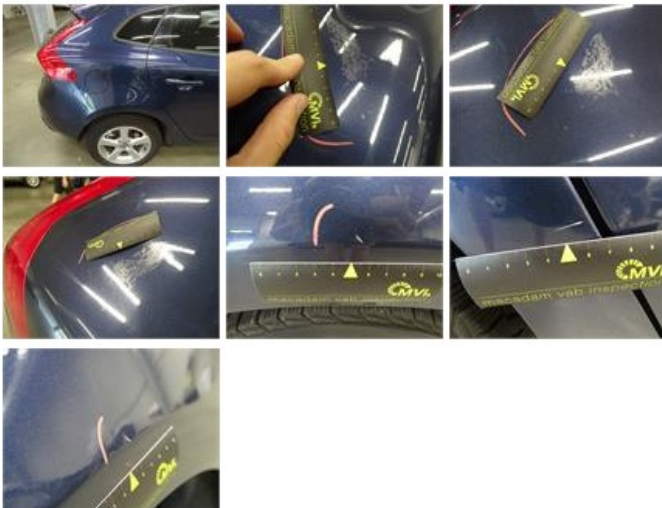
Wing R R, Chemical pollution, LI - Repair and paint (complete) 308,20

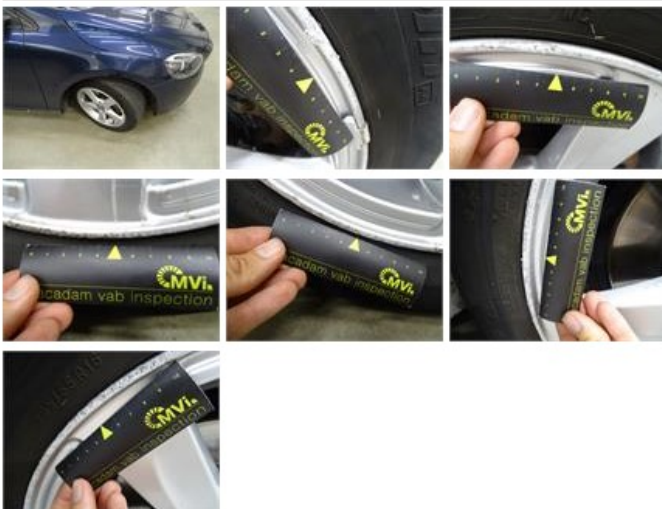
Alloy rim F R, Scratch(es), LI - Repair and paint (complete) 95,00

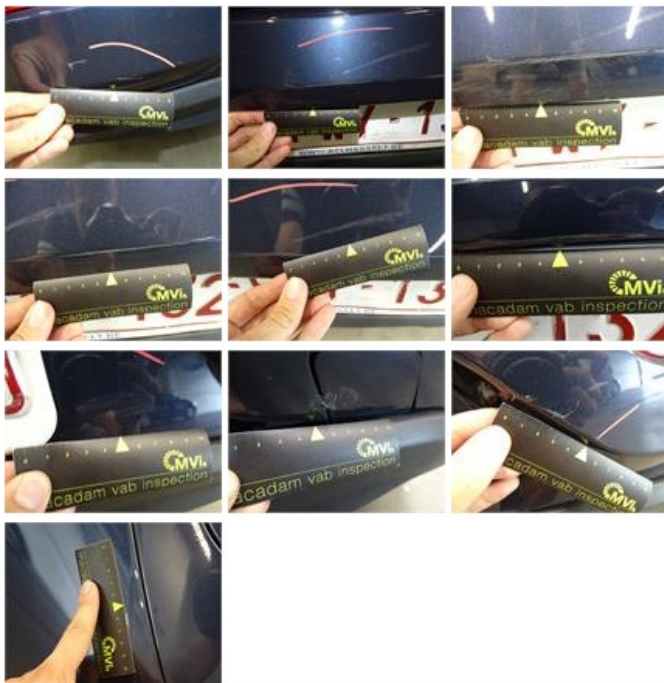
Bumper R, Scratch(es), LI - Repair and paint (complete) 211,80

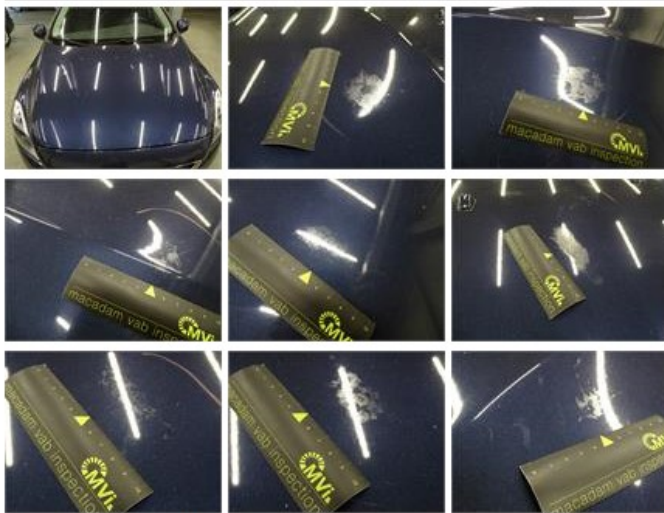
Bonnet, Chemical polution, LI - Repair and paint (complete)

290,08

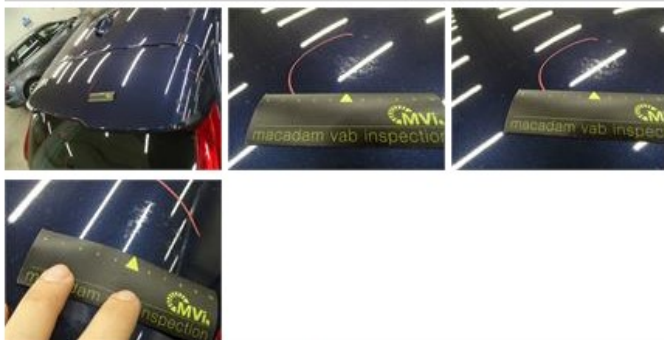
Rear spoiler, Chemical polution, LI - Repair and paint (complete)

115,56
