**VOLKSWAGEN Touran: 1FCT470**

**Limited Technical Inspection**

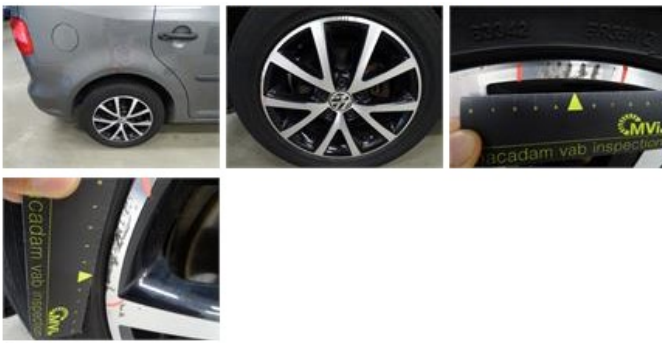
Alloy rim R R polished, Scratch(es), LI - Repair and paint (complete)	95,00
---	-------

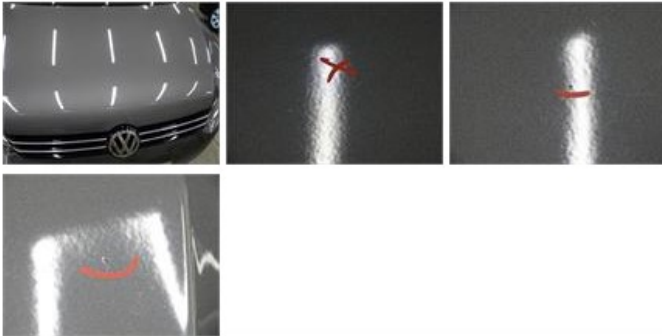
Wing R L, Dent(s), Acceptable	0,00
<i>No pictures to display</i>	
Bonnet, Bad repair, Acceptable	0,00

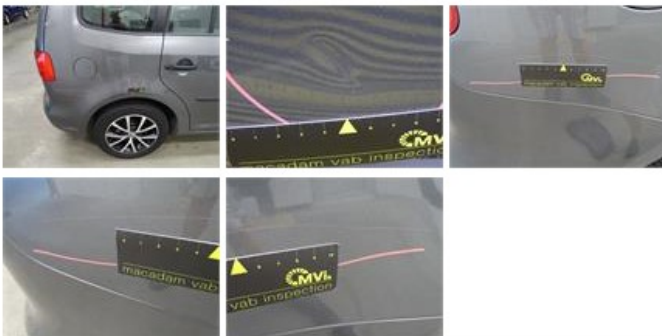
Alloy rim F L polished, Scratch(es), Acceptable	0,00
<i>No pictures to display</i>	
Wing R R, Dent(s) and scratch(es), LI - Repair and paint (complete)	308,20

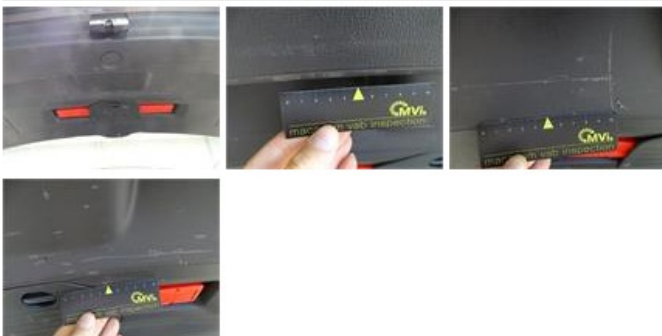
Trunk lid covering R, Scratch(es), Smart repair	110,64
---	--------
