SEAT ALHAMBRA: 1NGN652

Limited Technical Inspection

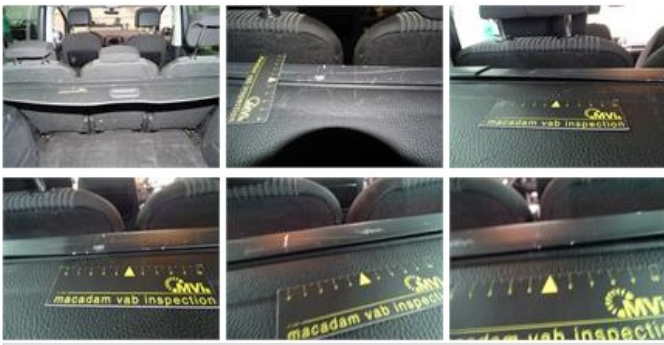
Sidewall panel RL, Broken, E - Replace

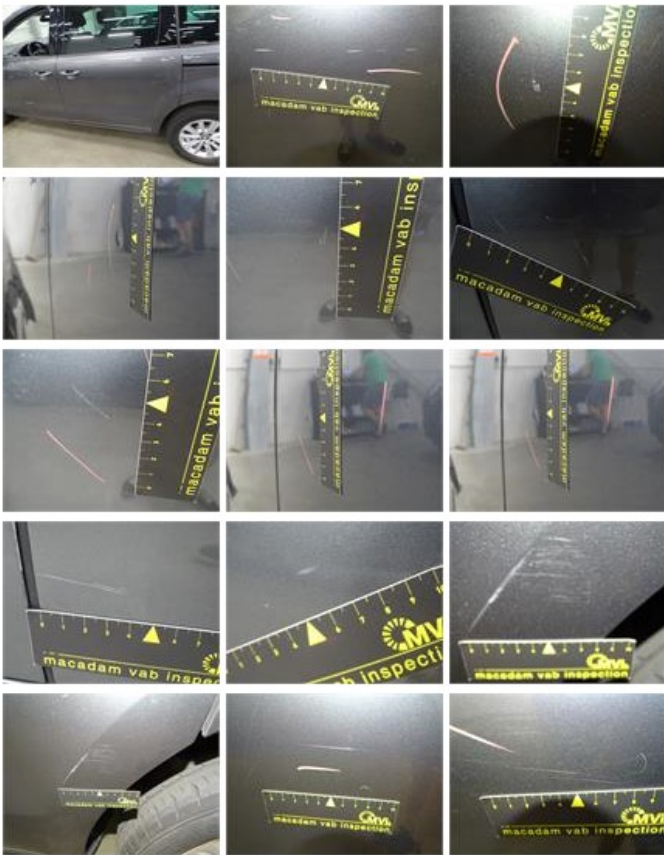
Door R L, Dent(s) and scratch(es), LI - Repair and paint (complete)

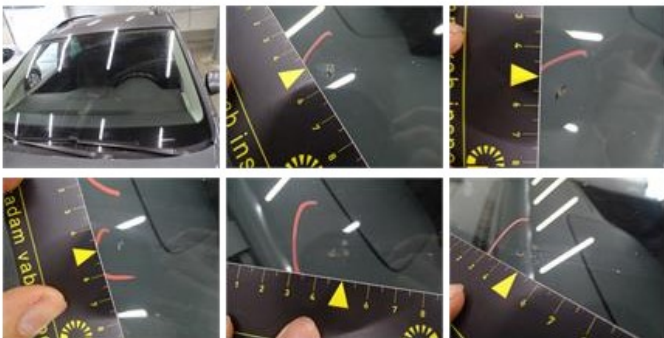
Windscreen, Stone chip(s), E - Replace

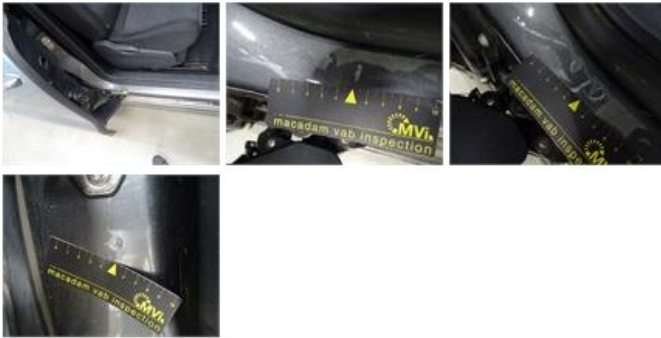
Rocker panel inner R R, Dent(s), LI - Repair and paint (complete)

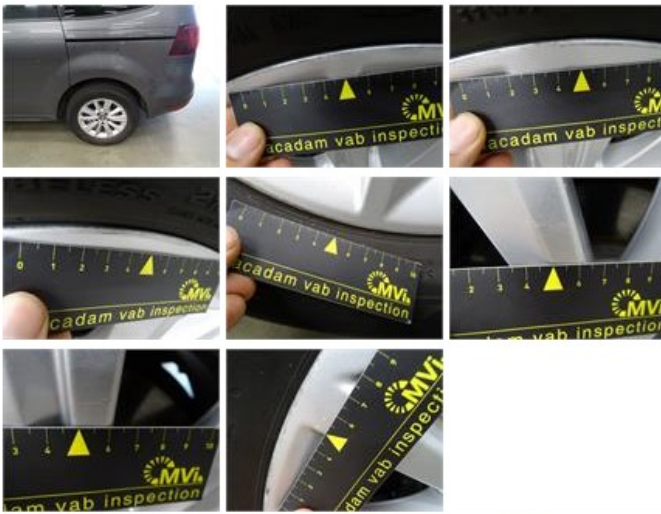
Alloy rim R L, Scratch(es), LI - Repair and paint (complete)

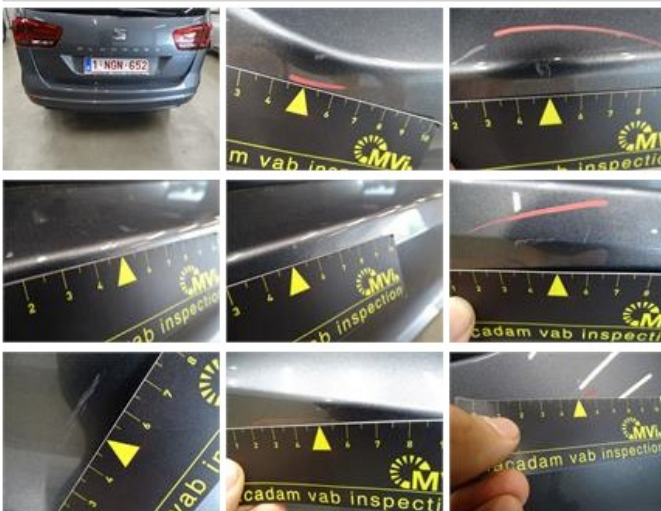
Bumper R, Scratch(es), LI - Repair and paint (complete)

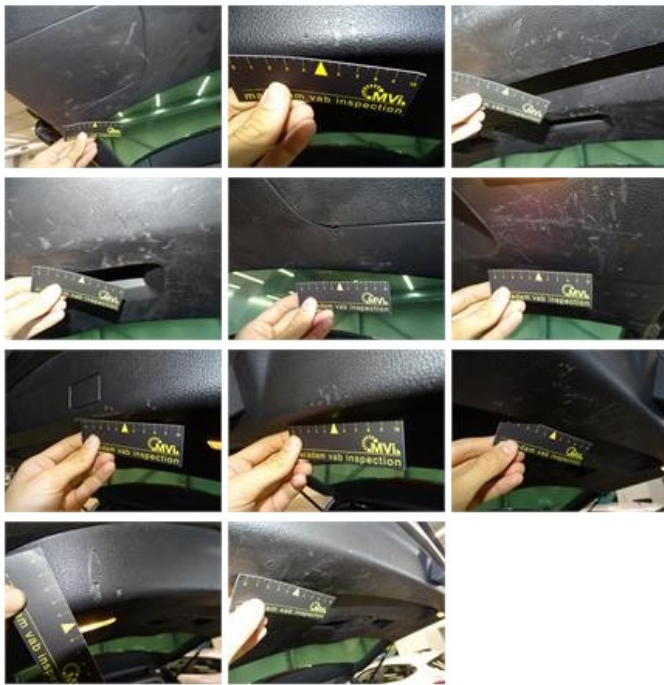
Trunk lid covering R, Scratch(es), Smart repair

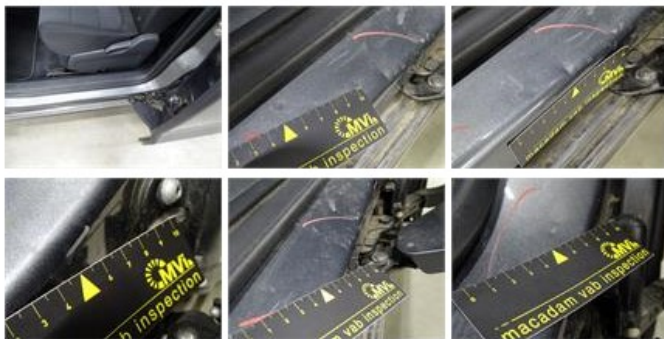
Rocker panel inner R L, Dent(s), LI - Repair and paint (complete)

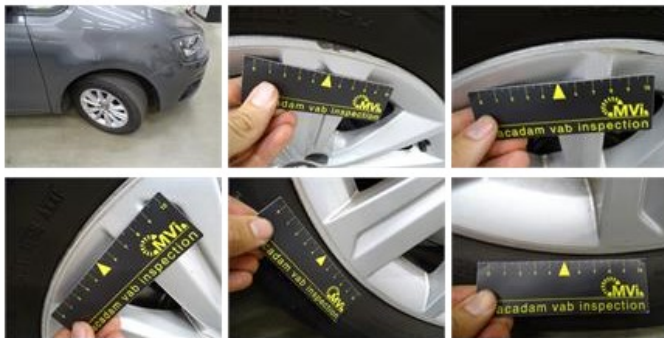
Alloy rim F R, Scratch(es), LI - Repair and paint (complete)

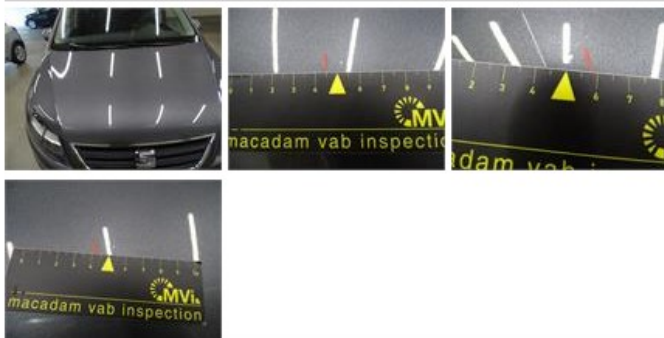
Bonnet, Bad repair, Acceptable

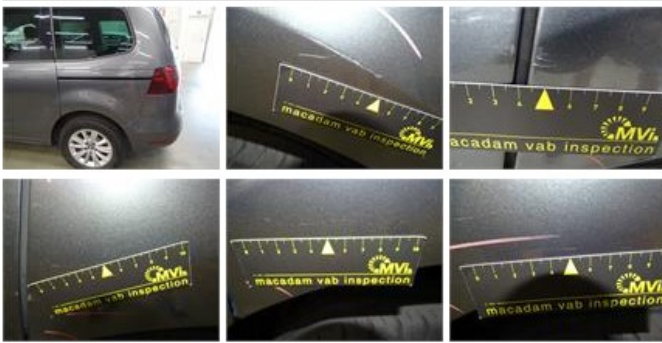
Wing R L, Scratch(es), LI - Repair and paint (complete)

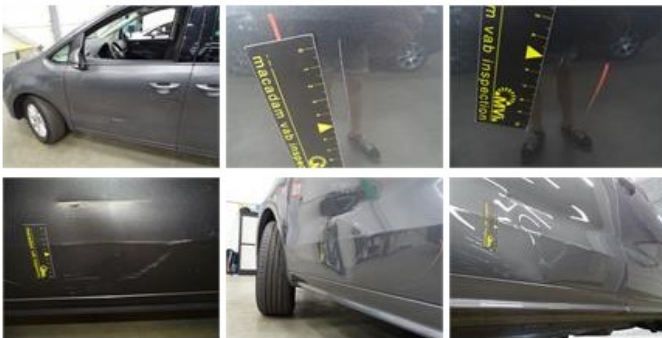
Door F L, Dent(s) and scratch(es), LI - Repair and paint (complete)

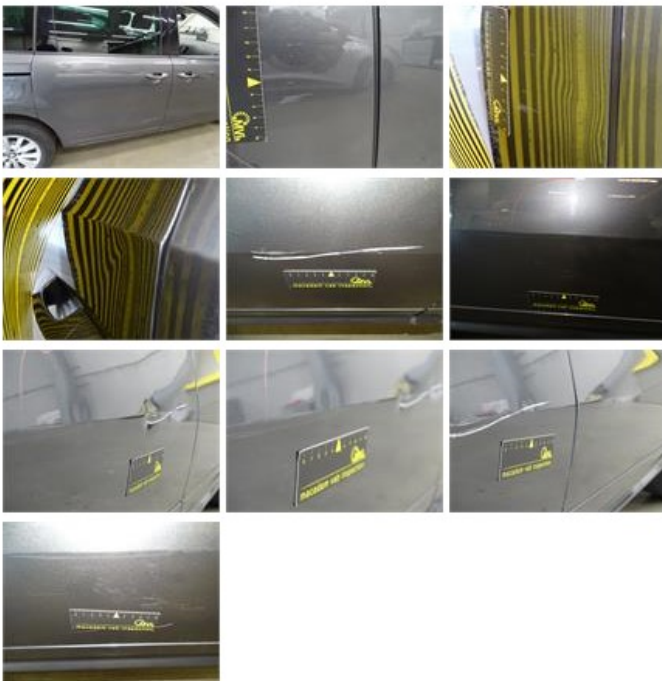
Door R R, Dent(s) and scratch(es), LI - Repair and paint (complete)
